# Investigation status of amplitude jumps on Libera electronics

Borut Repič

WWW.I-TECH.SI Grenoble, DEELS 2019

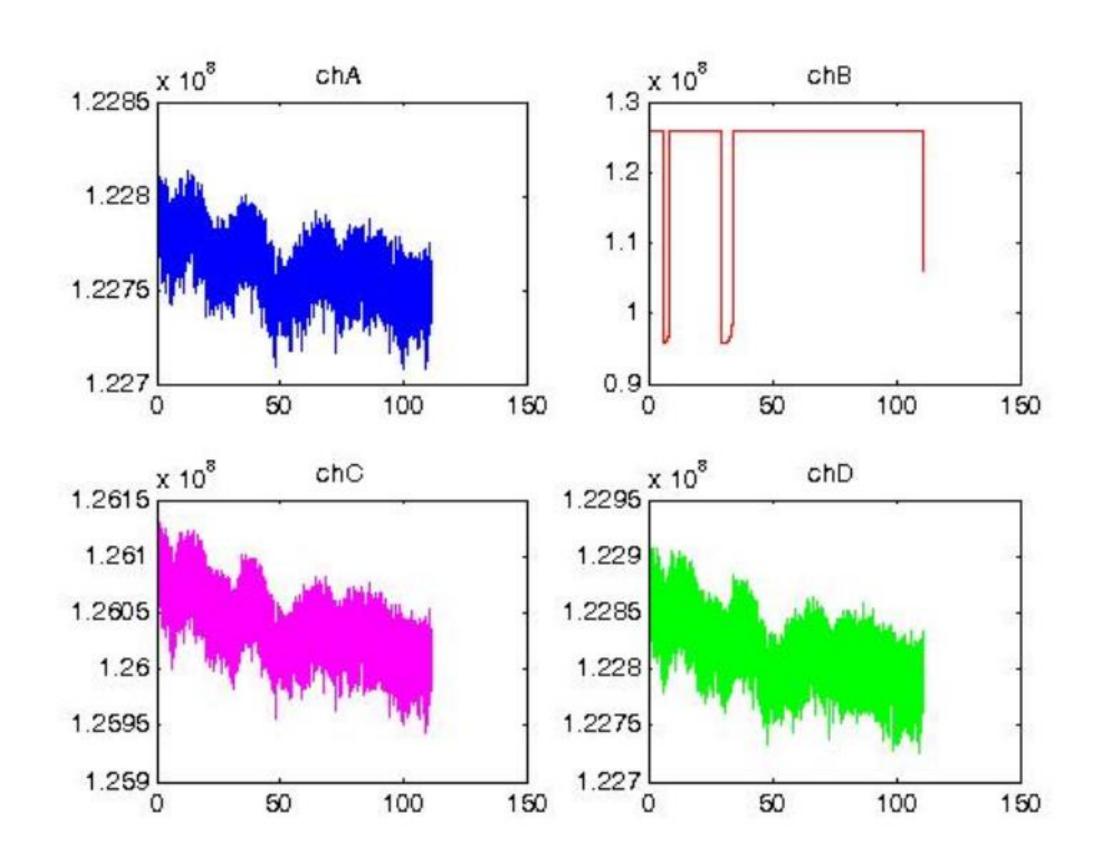
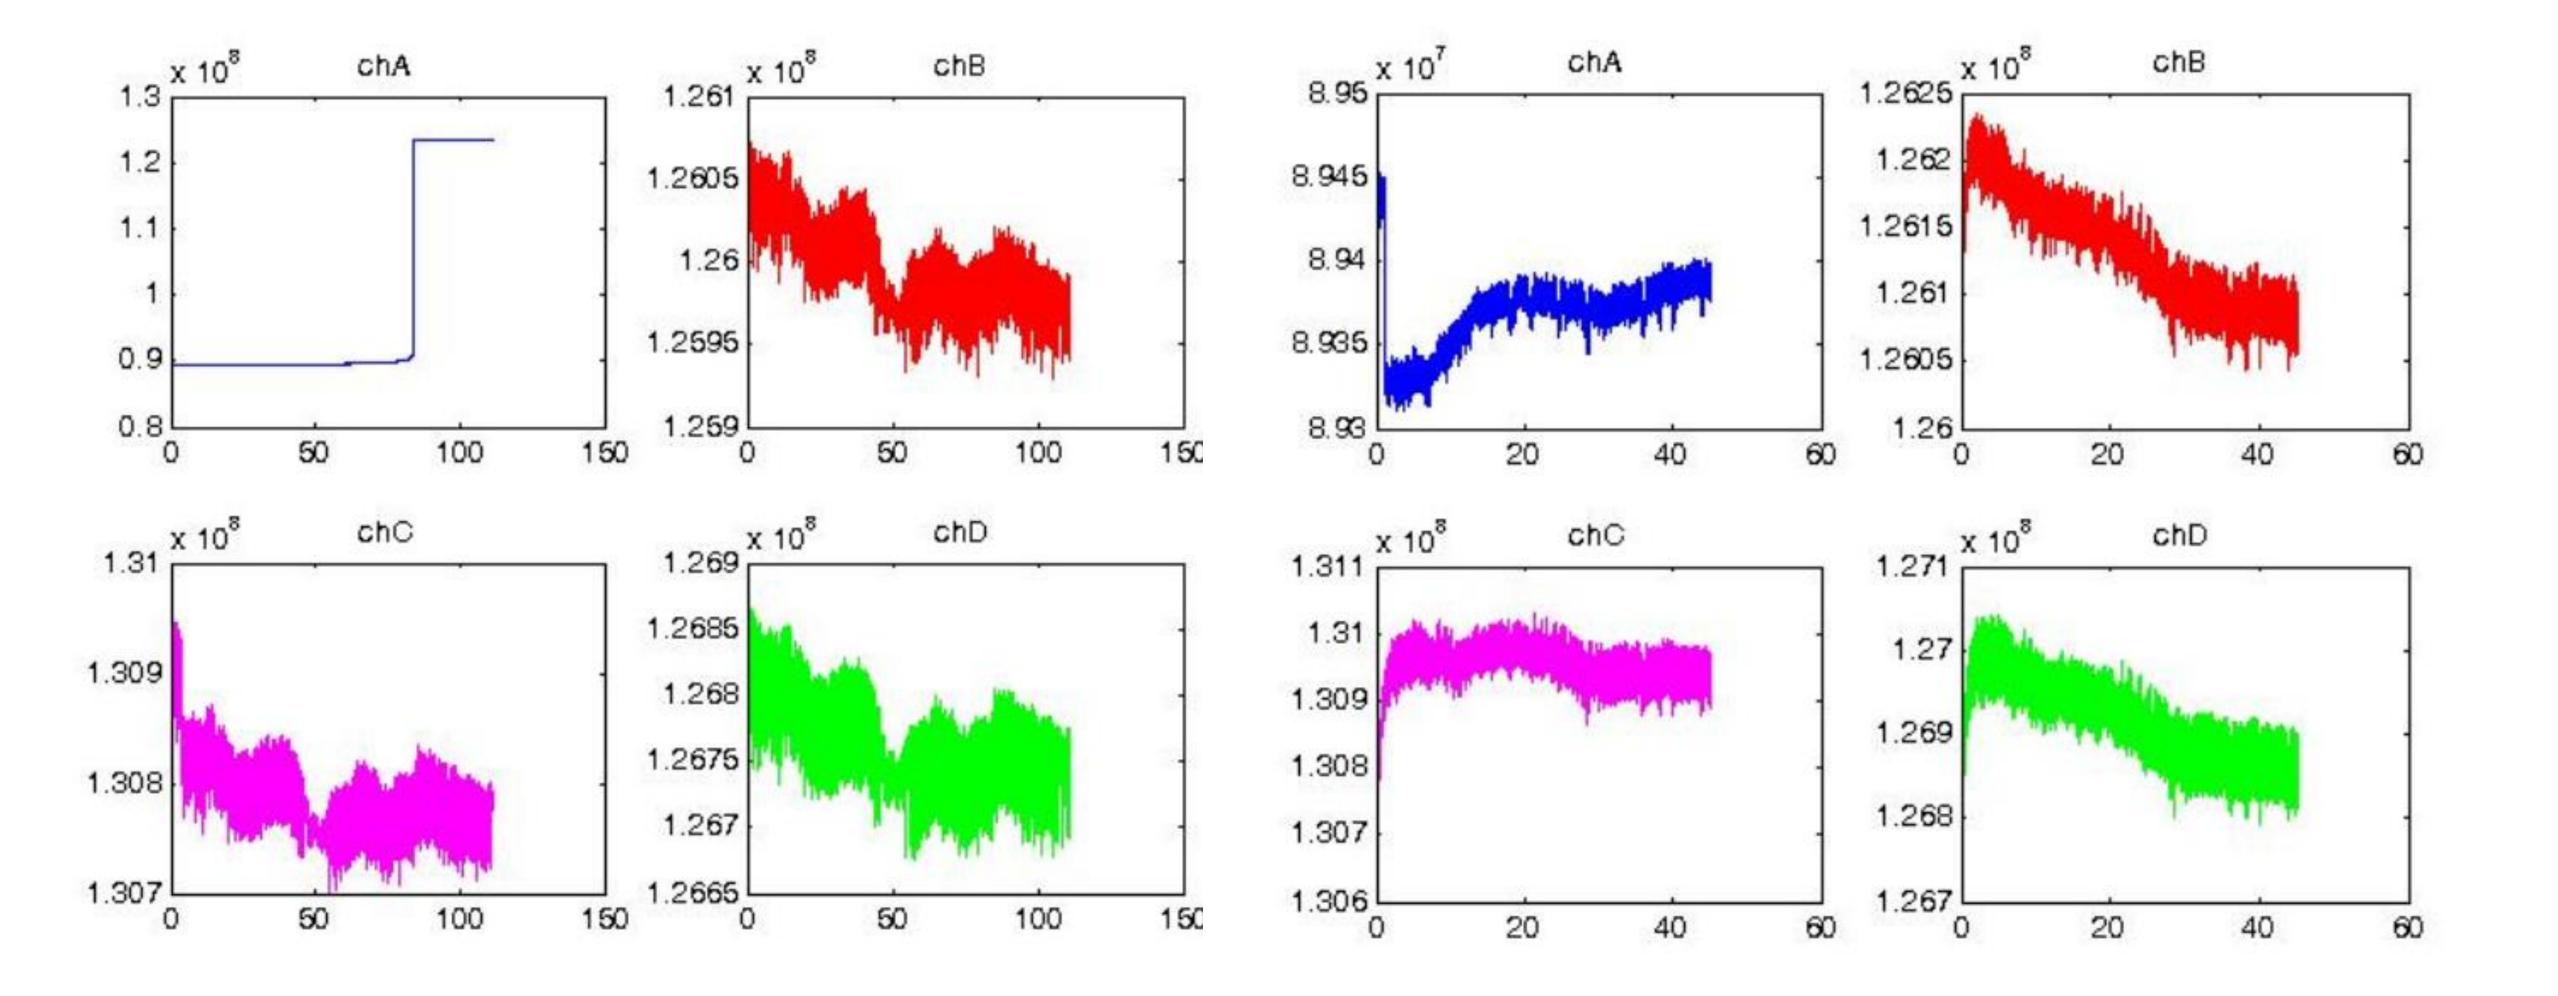
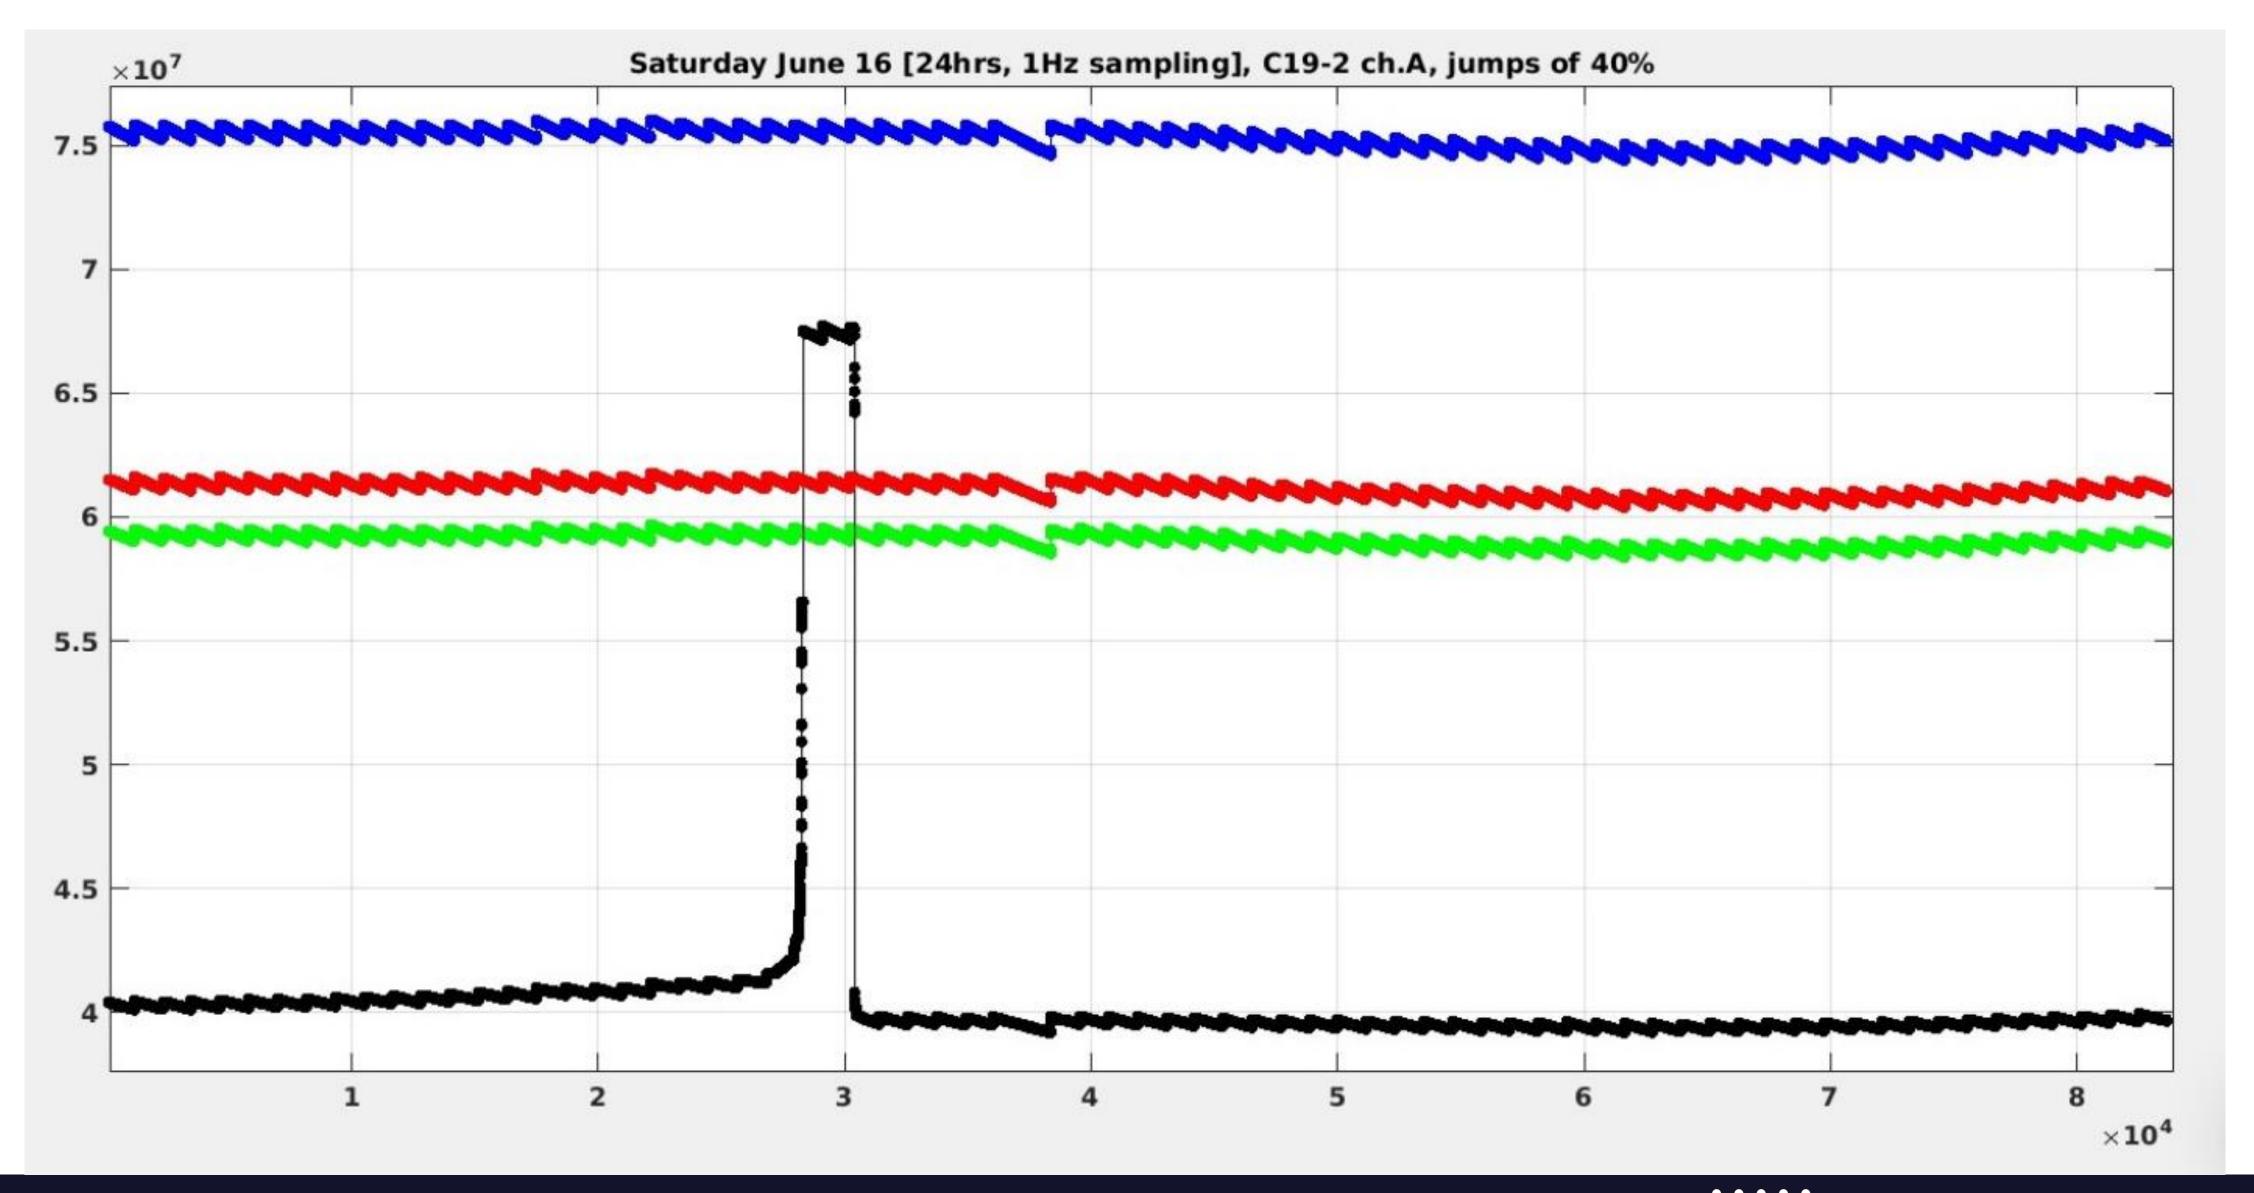
Over a year ago ESRF reported unexpected occasional jumps of button amplitude on LB!

- exclude software (DSC, attenuators)
- reproduction of the behavior in our test lab.
- not always the same channel
- Amplitude and duration of the jumps differs
  from instrument to instrument

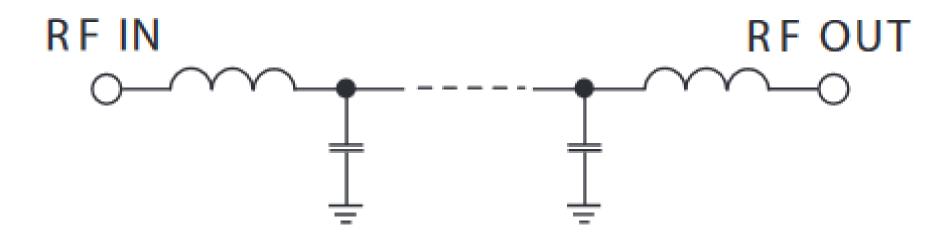
### **Electrical Schematic**

#### Product documentation says:

- 7th order LTCC low pass filter
- High power handling 8W (+39 dBm)
- Small footprint 3.2 x 1.6 mm
- Wide operating temp range -45-85°C
- Temperature stable

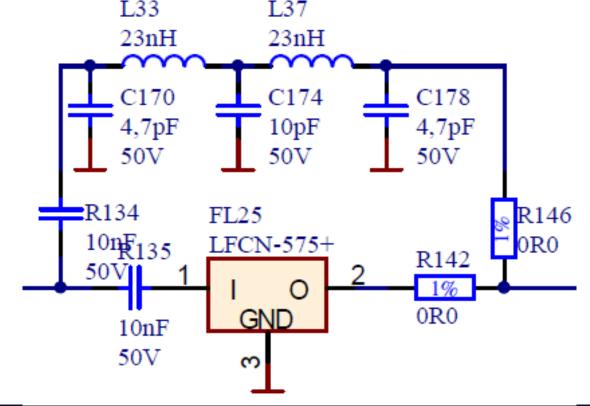
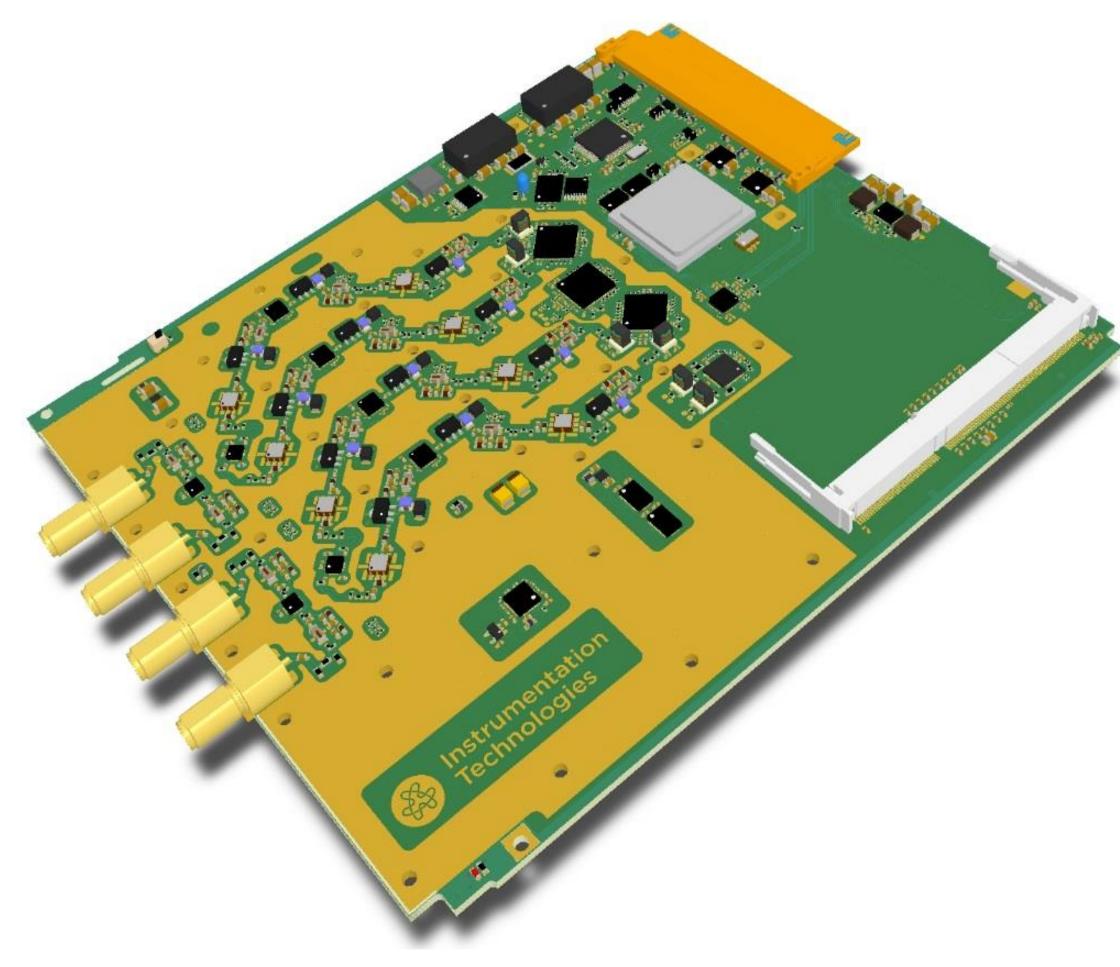
No comparable alternative to LFCN on the market

Preventive actions on new BPM module

for Platform B

- AMC form factor
- Latest Xilinx 16 nm FPGA: Kintex Ultrascale+ (XCKU3P)
- Large data buffers (SODIMM DDR3 slot)
- Switching or direct signal routing (maximum isolation)
- Merging Spark resolution & Brilliance + stability
- LFCN as an option to lumped 5th order

low pass (pros & cons)
