THE AD ELECTRON COOLER ISSUES 2018

Lars V. Jørgensen
CERN, BE-BI-EA

The AD electron cooler double failure

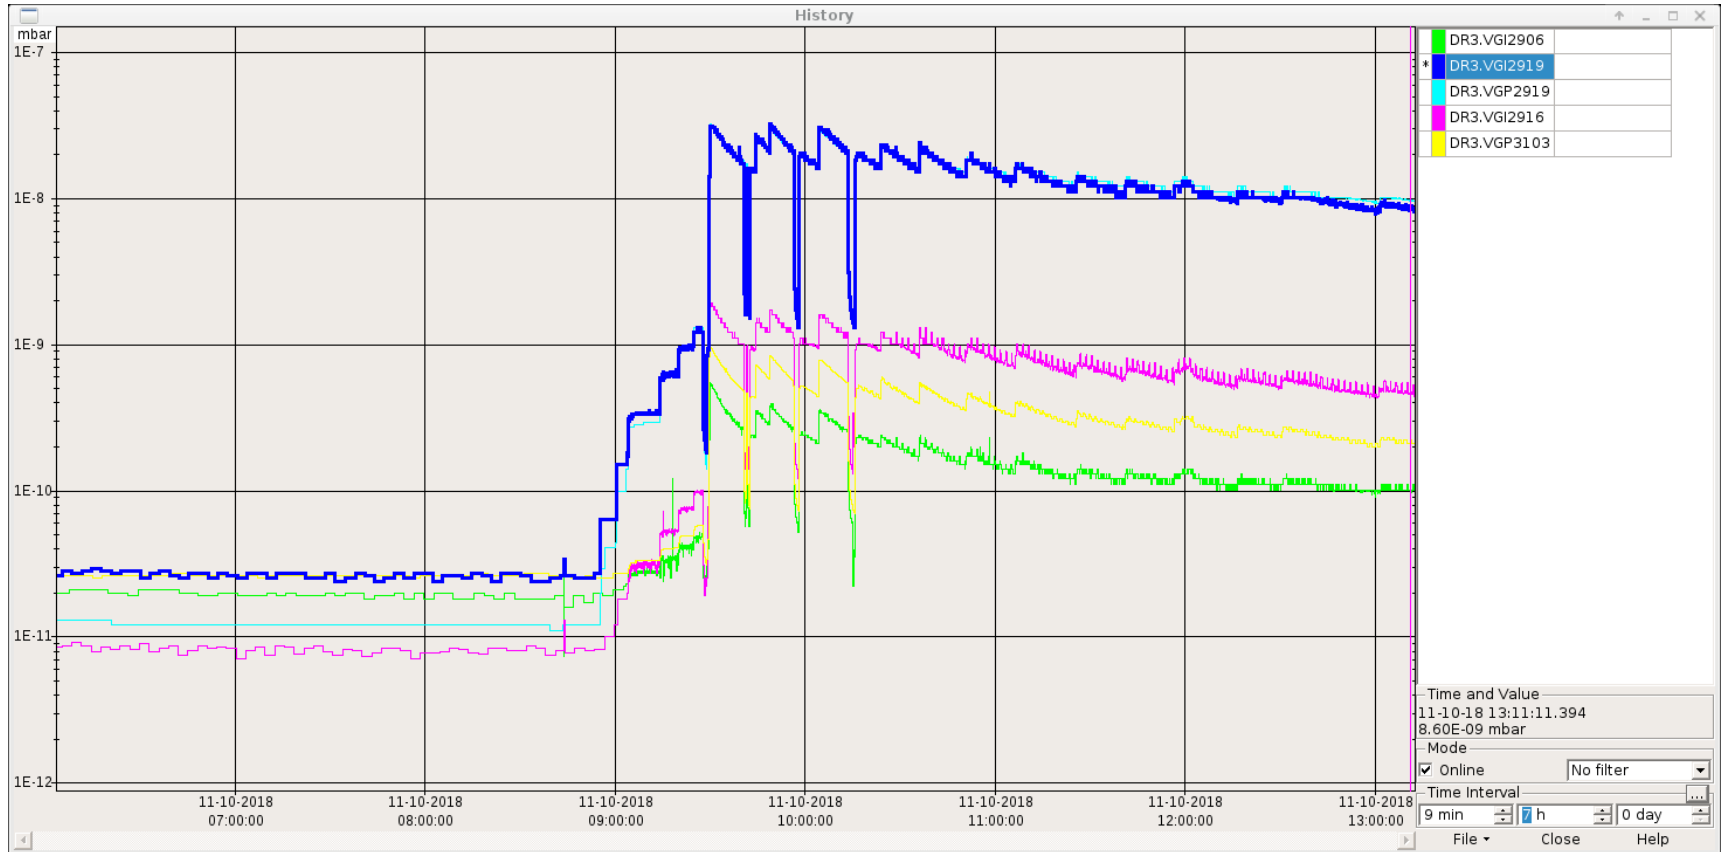
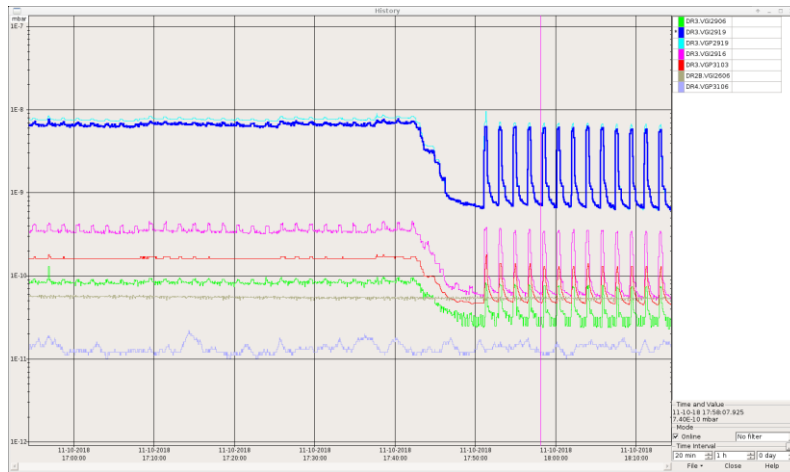
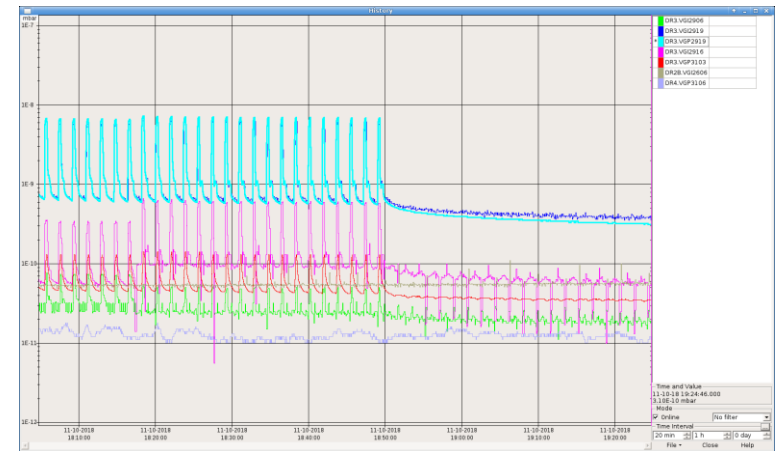
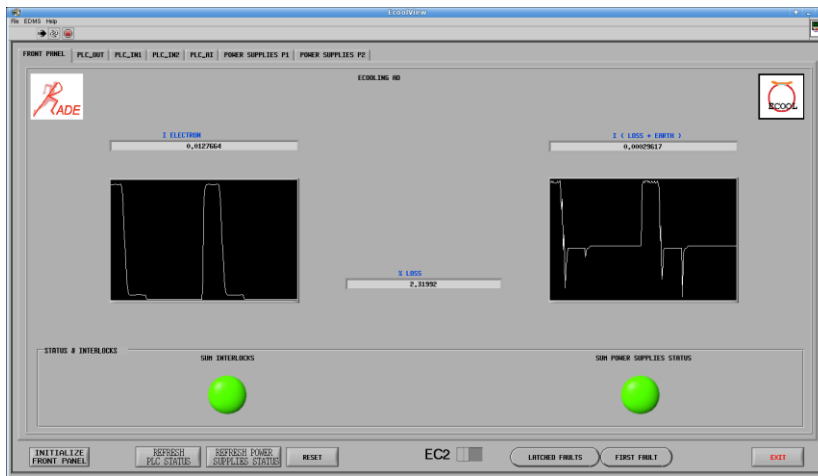
14

- We try to disconnect HV cables from the collector to pin down where the problem is.
- With cables hanging free in air HV on gun and collector all okay.
- We re-connect. HV now okay!
- Wednesday Oct. 10 –filament on – all okay
- Thursday – slowly increasing electron beam with cathode HV.
- Reached nominal 28 kV ~ 18h Thursday Oct. 11
- Start cycling.
- 19h30 Okay to open valves.

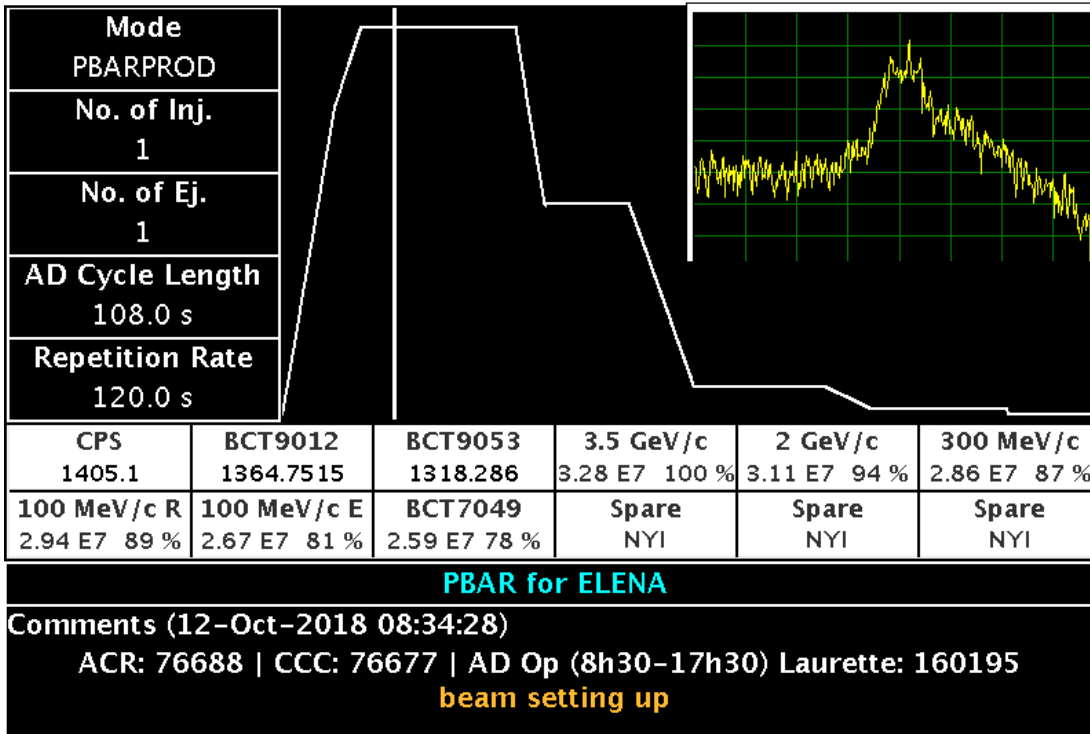
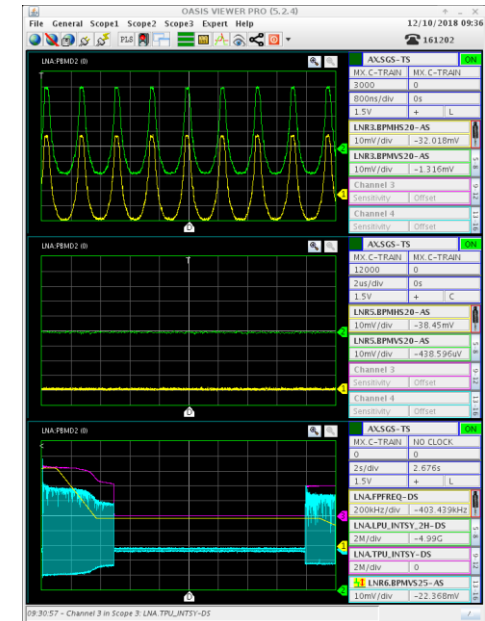
Beam back in AD!

- ...and 12 Oct beam back in AD and also in ELENA!
