AD collector: repairs in 2018 and mechanical considerations

AD Electron Cooler Consolidation Review

26/03/2019

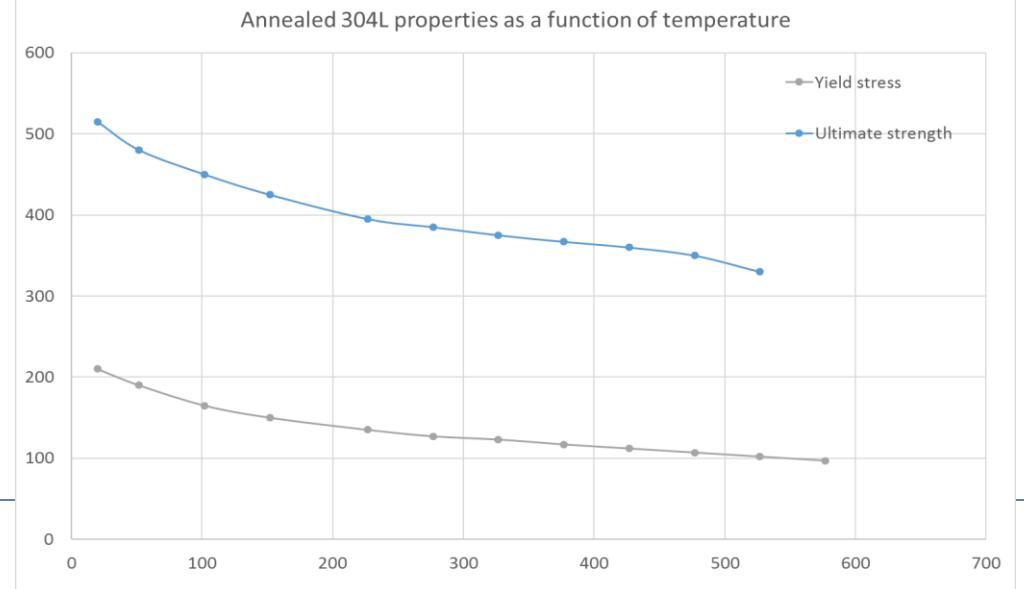
- Analysis were performed in the EN-MME unit to estimate the stress levels in the welds
- Given the uncertainties in the materials, calculations were performed both for 304L and 316LN
- Only the stresses arising from the water pressure were evaluated (no residual stresses from welding, no electron-induced stresses)
- Operating temperature not known: material properties assumed at room temperature (no significant effect expected on elastic constants, but may be relevant for yield stress)

Comparable stresses on both cover 	Top Cover/Bottom Cover	10	5
sides and on all stiffeners	Top Cover/Outer Pin	67	37
 Lowest safety factor is found at the position where the leak developed 	Top Cover/Inner Pin	83	47
	Bottom Cover/Outer Pin	95	38
