The lonely perpetrator in the DCDC FEAST2 case

How an individual transistor threatened the operation of the CMS pixel detector

F.Faccio, CERN, EP-ESE

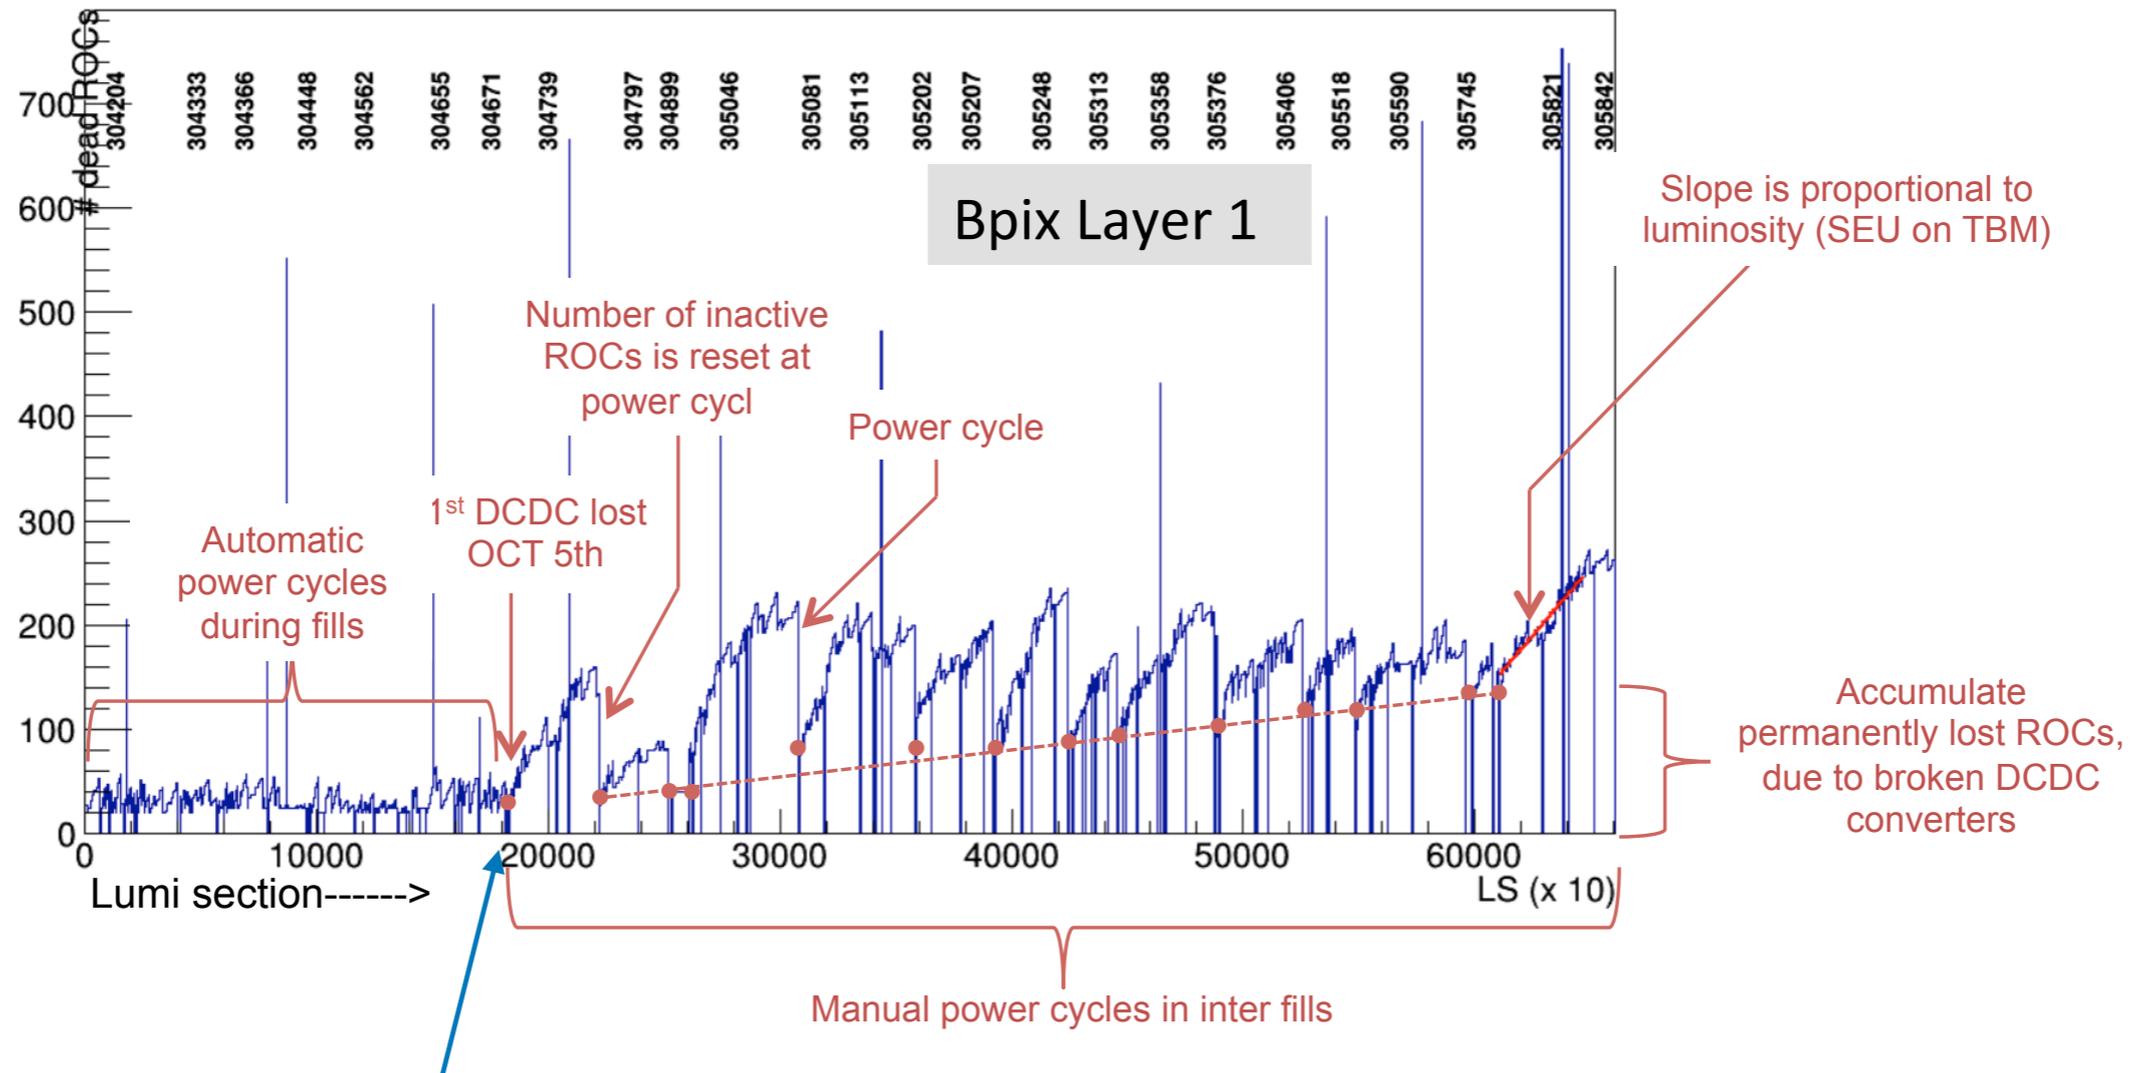
Failure of FEAST DCDCs in the CMS pixel detector

Increase in luminosity, change in beam structure

No correlation with:

- output voltage
- output current
- position in the detector
- anything other than the beam

DCDCs fail during disable/enable cycles

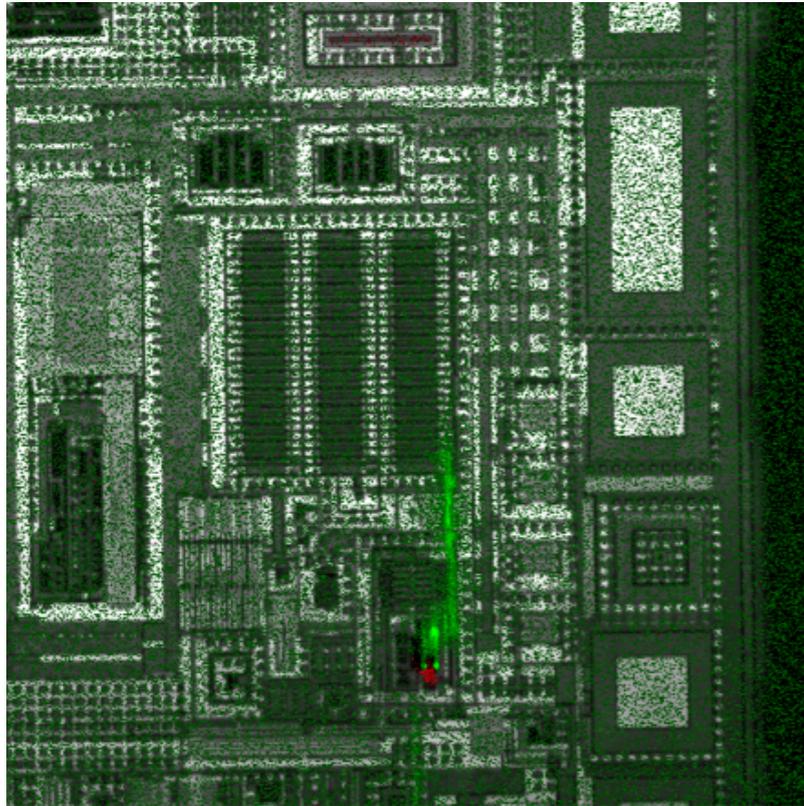
Failure Analysis (FA) with emission microscopy and Optical Beam Induced Resistance Change (OBIRCH) at MASER (NL)

During OBIRCH a laser beam selectively illuminates the metal lines, altering their resistance. The consequent input current change is measured, allowing the mapping of current paths. In broken FEAST2 samples, current flows to the clamp transistors.

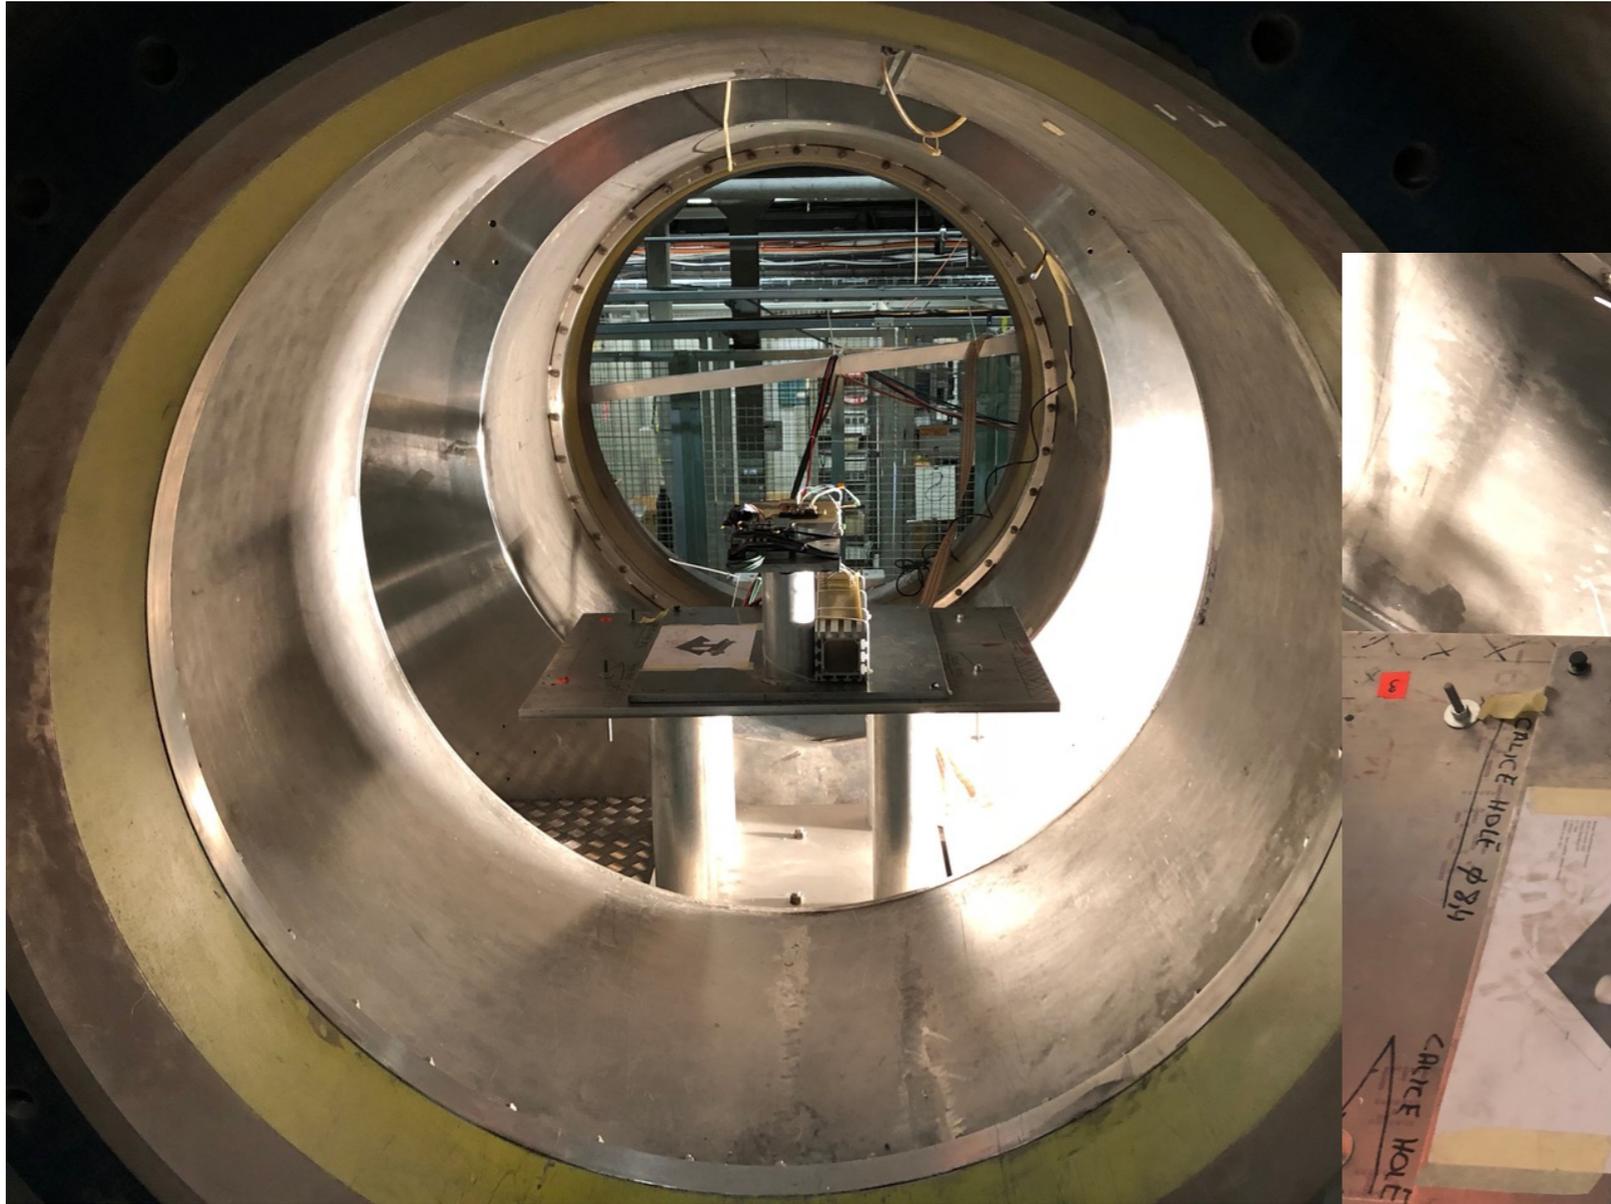
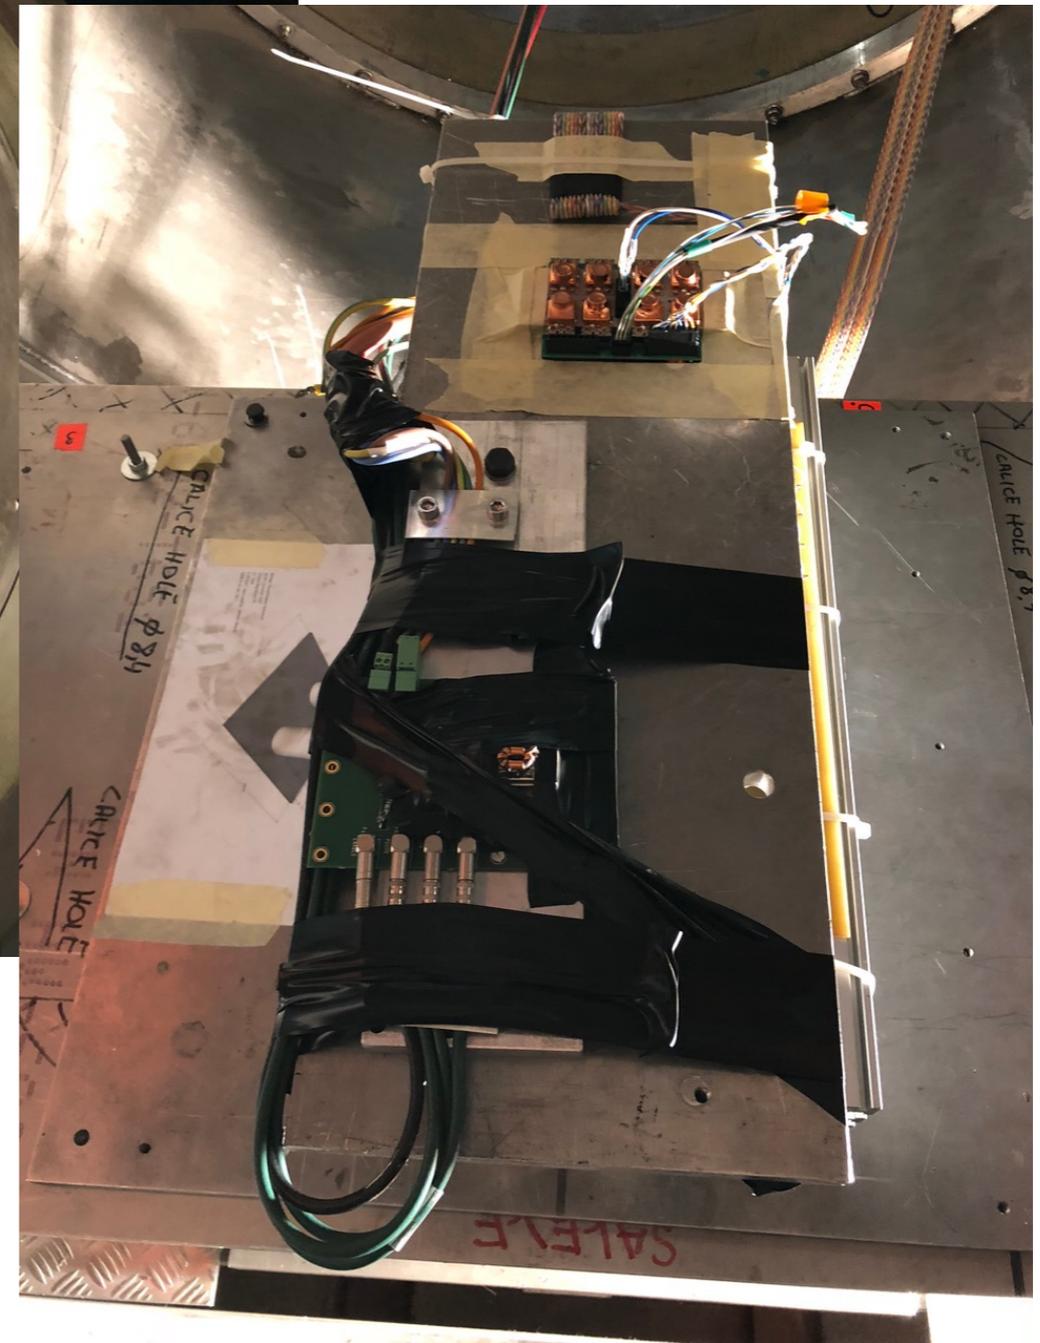
Environmental conditions?

Test in a 3T magnetic field revealed no problem

FEASTMP and CMS modules inside the M1 facility in the H2 beam line in Prévessin (Building 887)

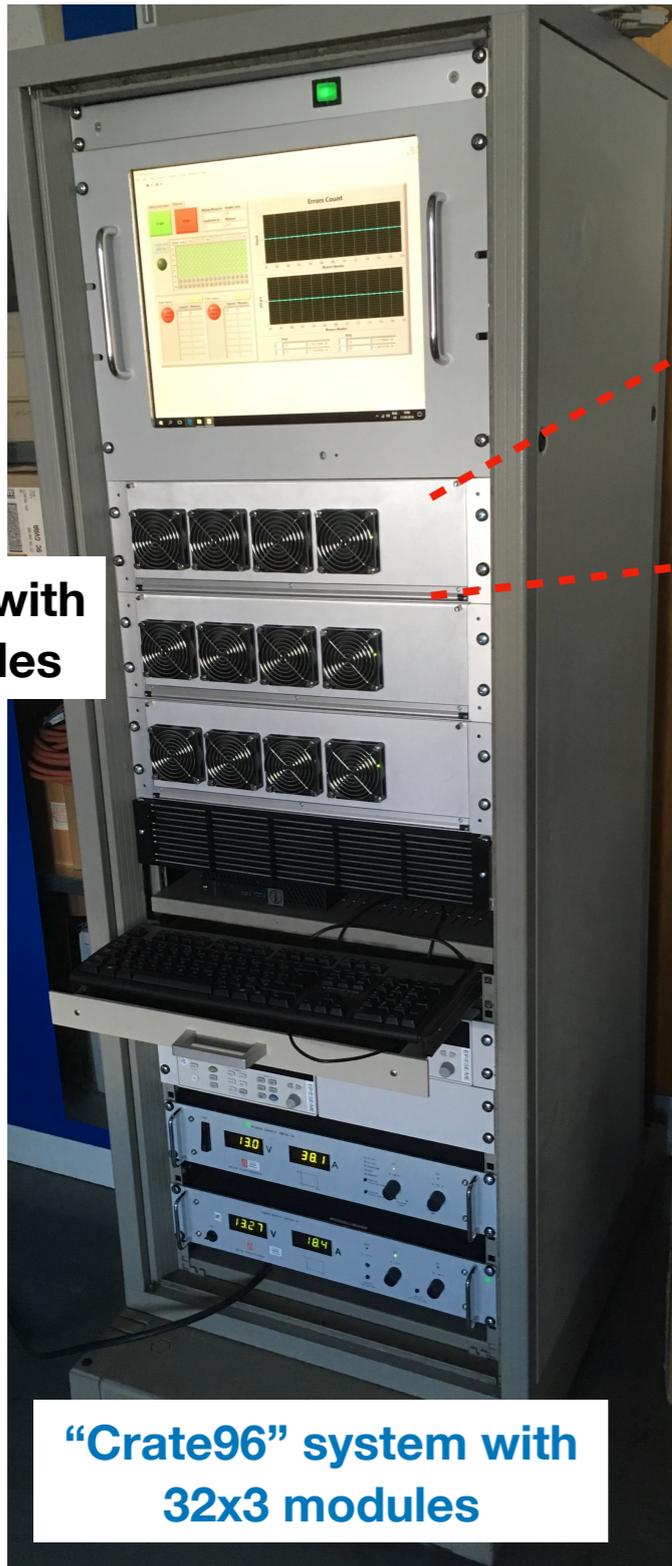
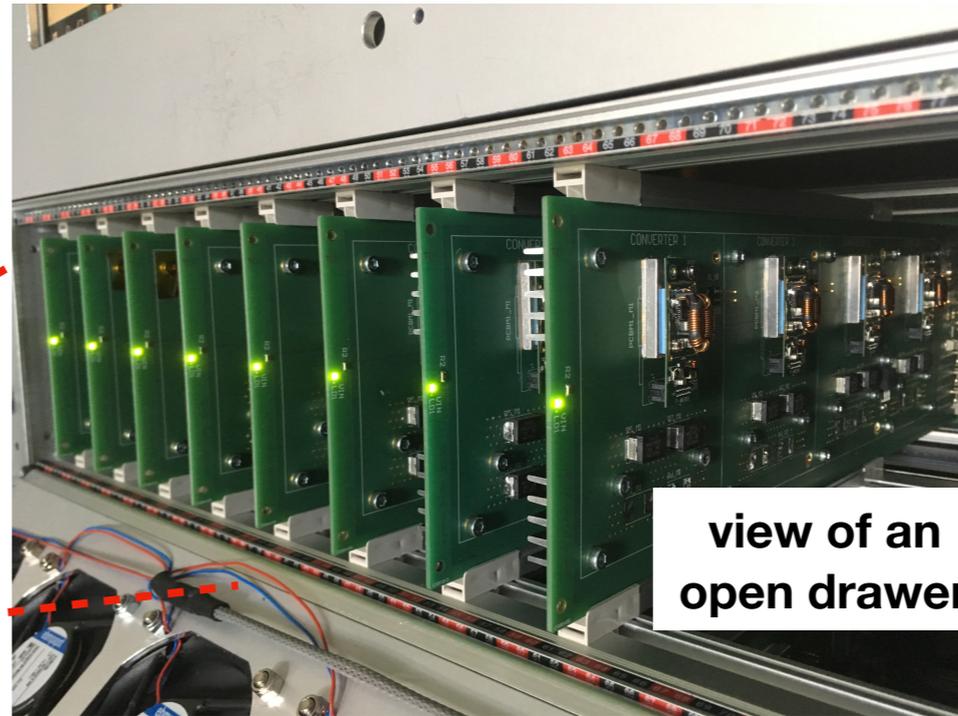
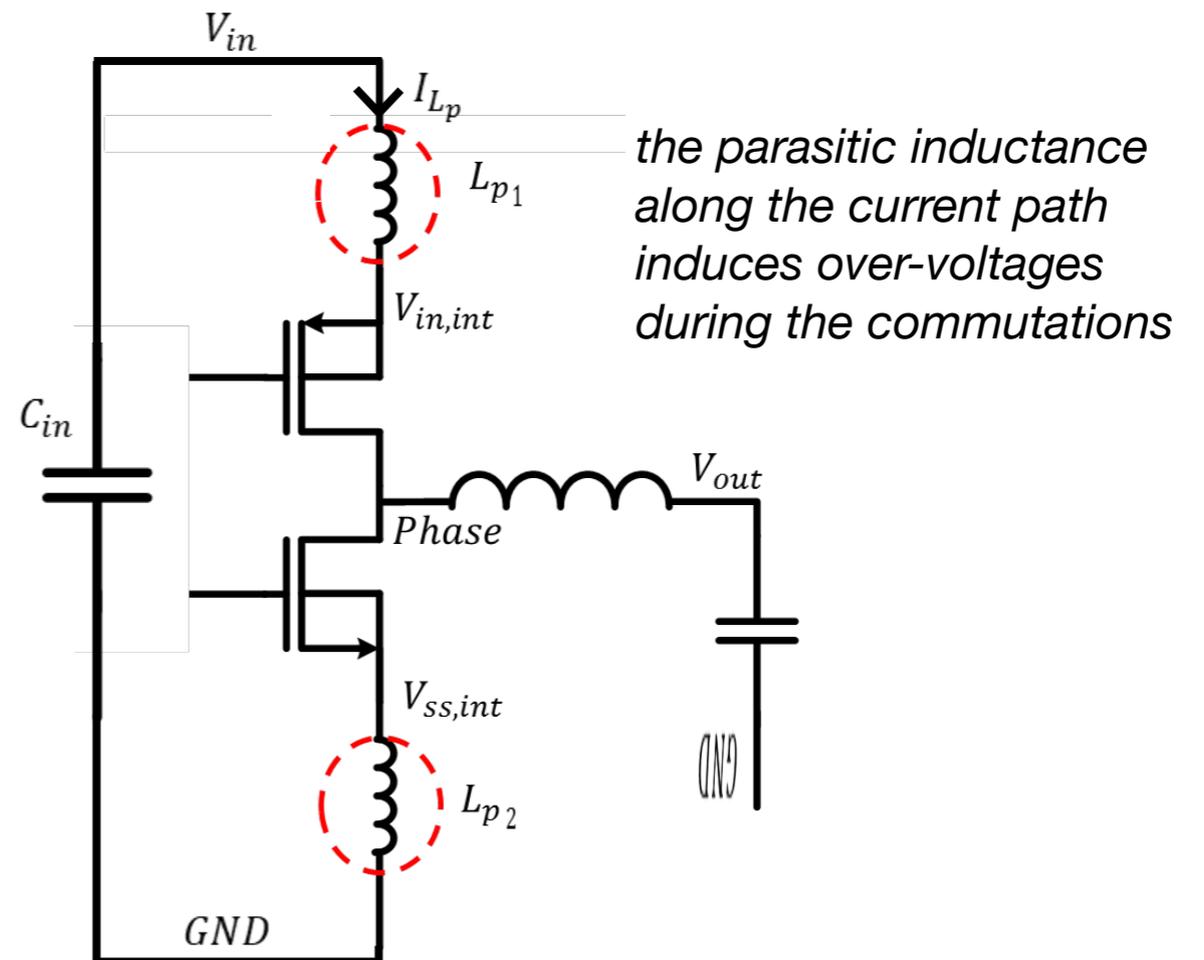
Electrical stress?

Long-term ageing tests on 124 converters did not reveal problems with FEAST2 ASICs

3 drawers with
8x4 modules

“Crate96” system with
32x3 modules

view of an
open drawer

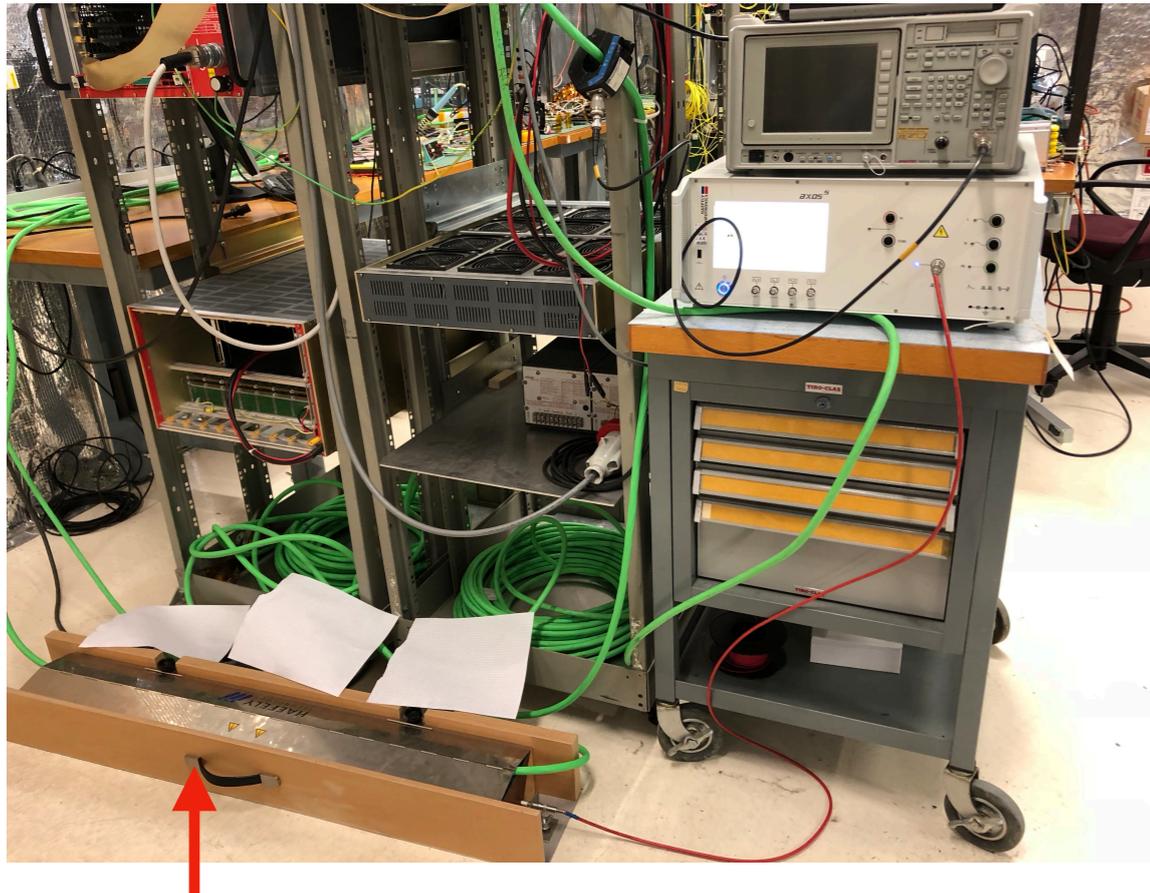
Injection of EM noise by capacitive coupling to the input/output and signal lines. The converter appears to be very resilient

Capacitive high-frequency coupler used on the input bus line

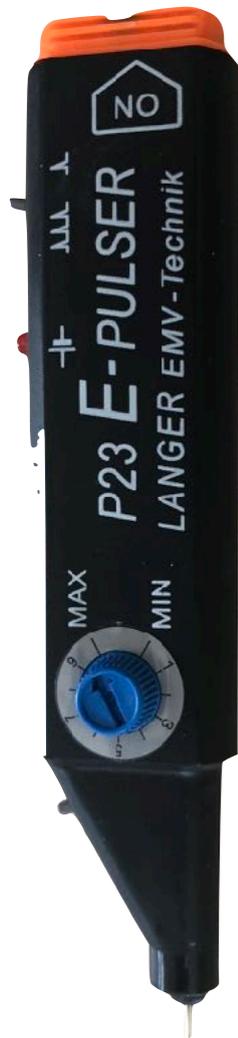
Stress tests with an ESD gun (1.2kV pulses) could produce somewhat similar damage - but the energy injected needs to be really large

An ESD gun is used to inject a discharge to the different pins of the FEAST2 package. To produce any damage, a visible spark has to be produced.

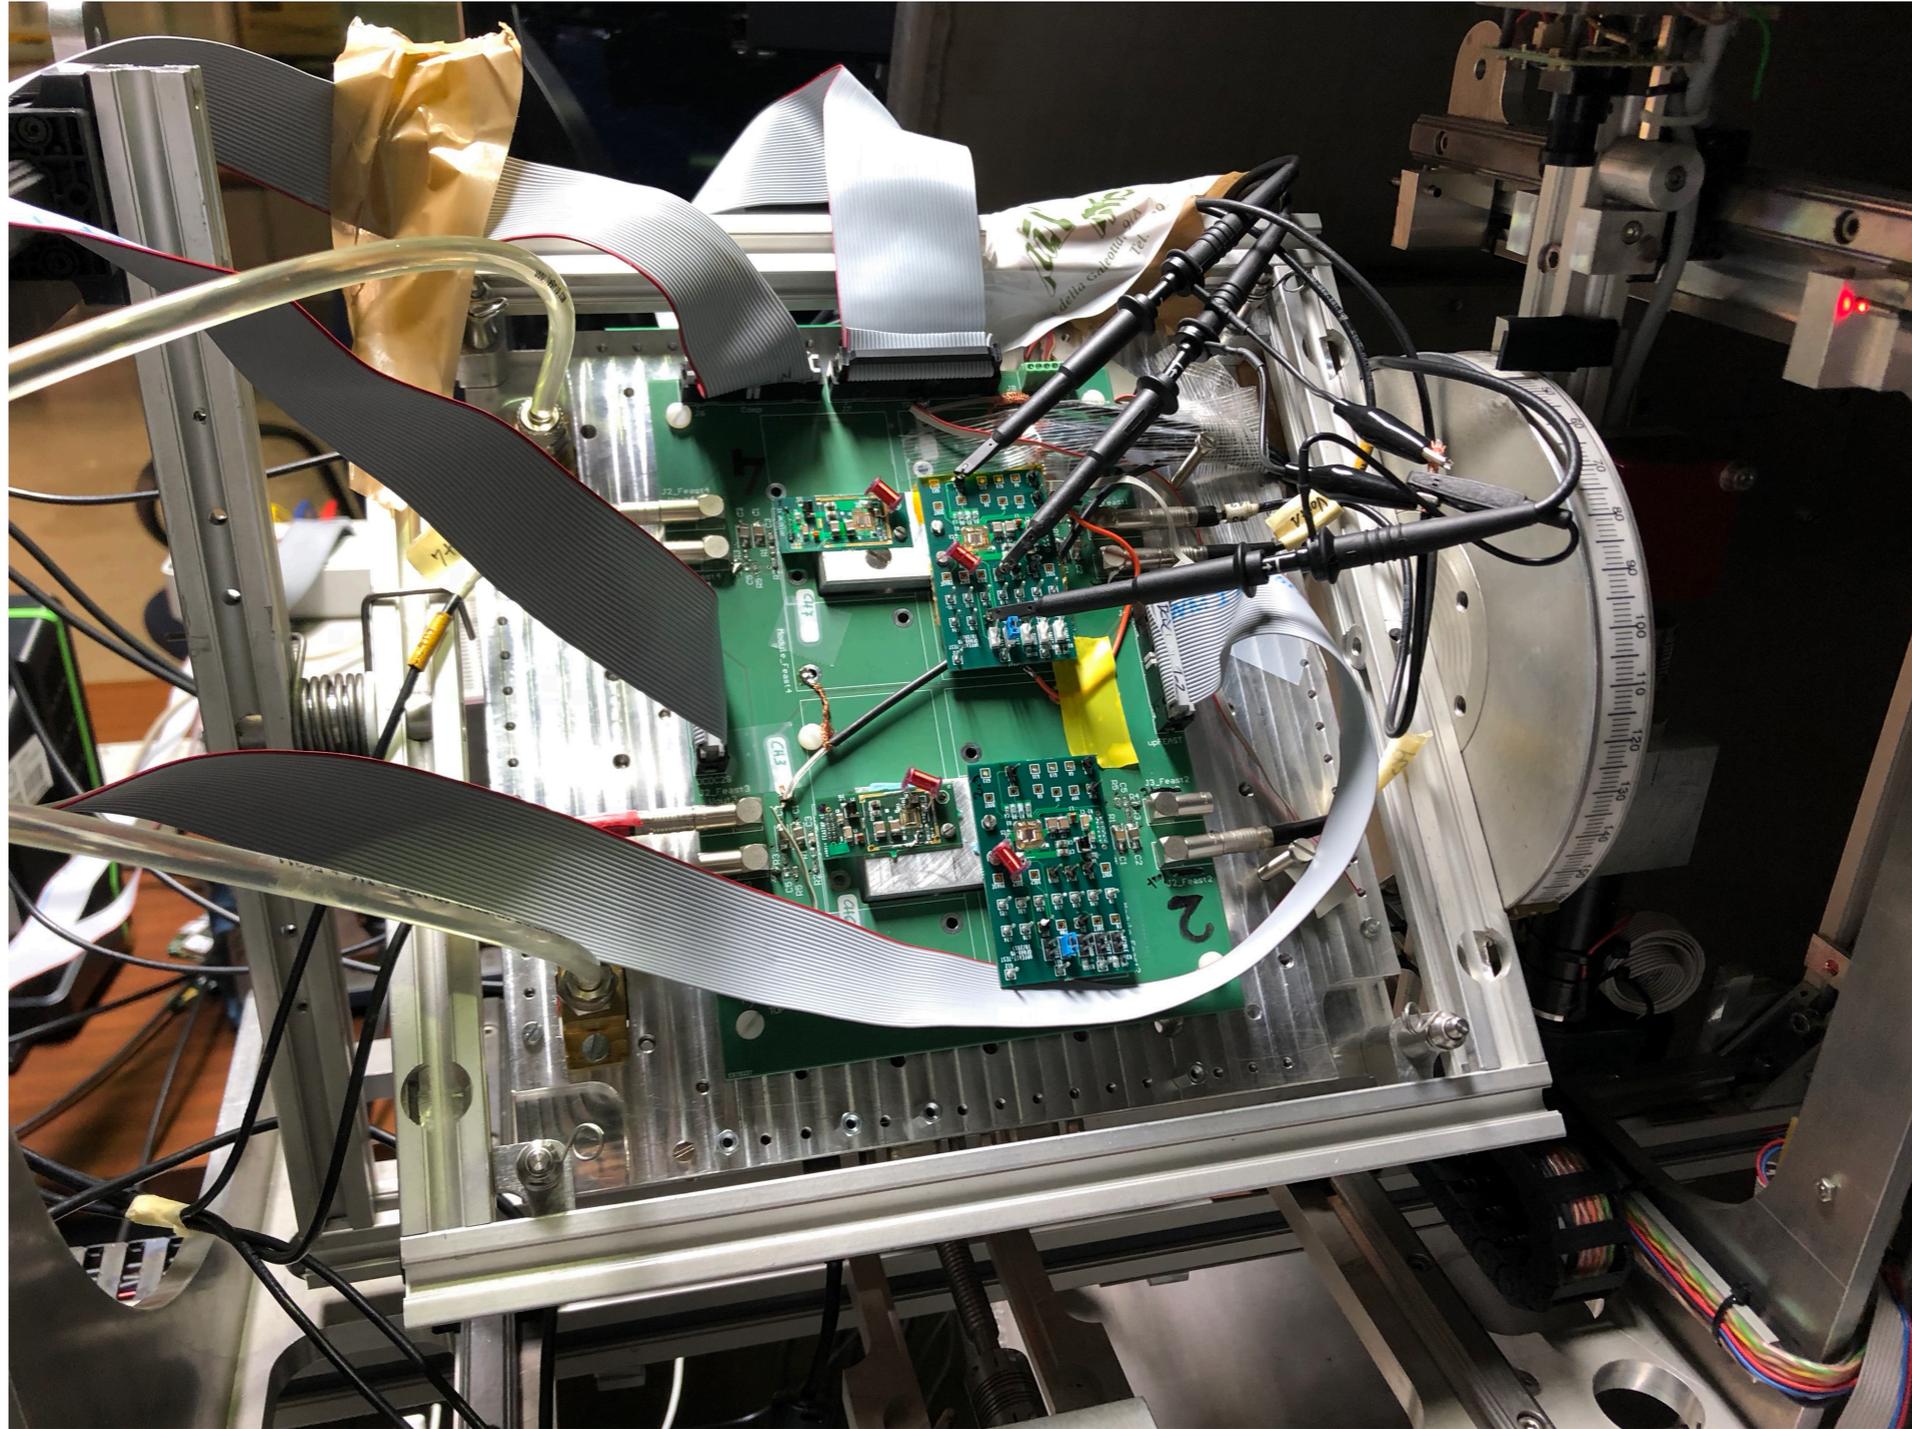
SEE Heavy Ion irradiation on samples pre-exposed to X-rays, Protons and Neutrons did not show any sign of damage

4 modules prepared on a motherboard are placed inside the irradiation chamber where they will be exposed to a Heavy Ion beam. The FEAST2 chips were previously irradiated with X-rays, 230MeV protons or neutrons from a reactor.

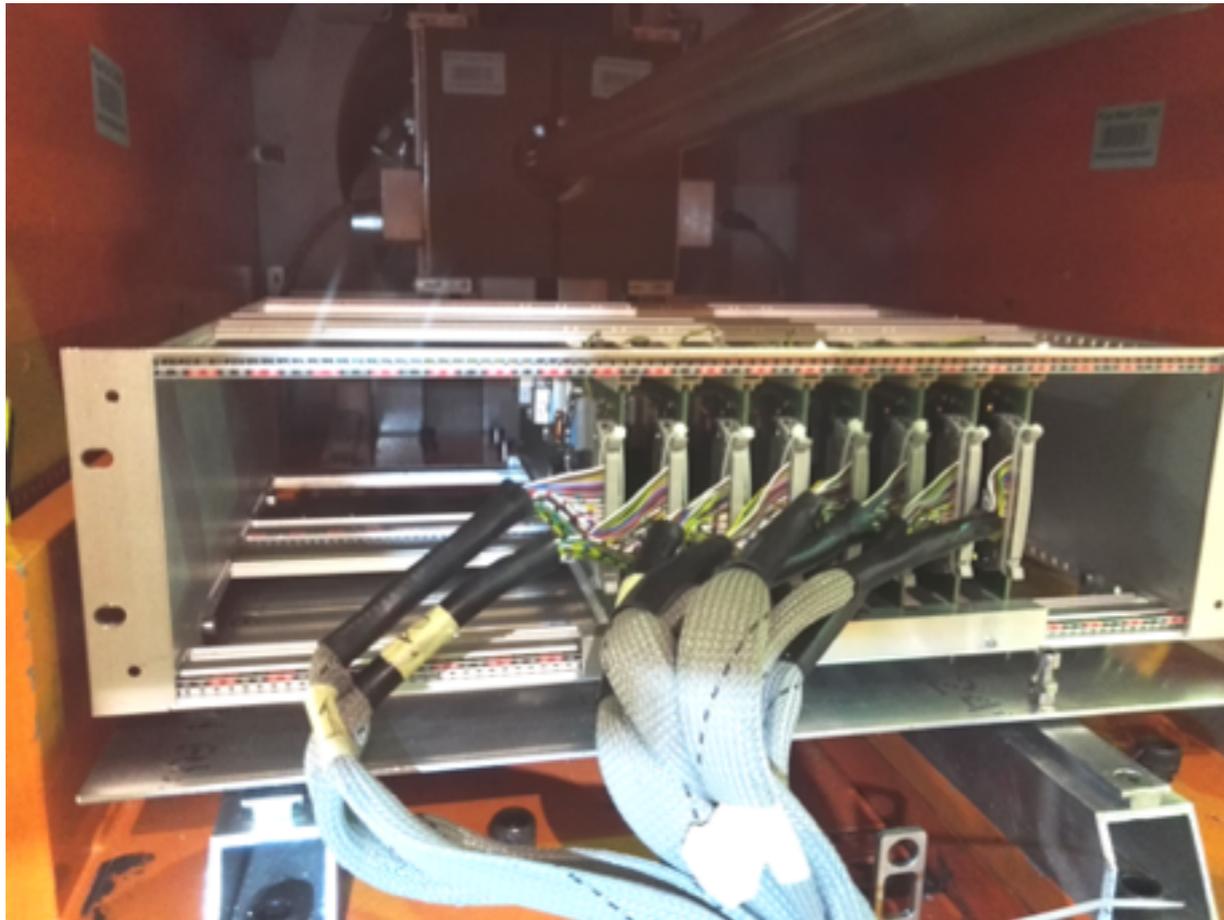
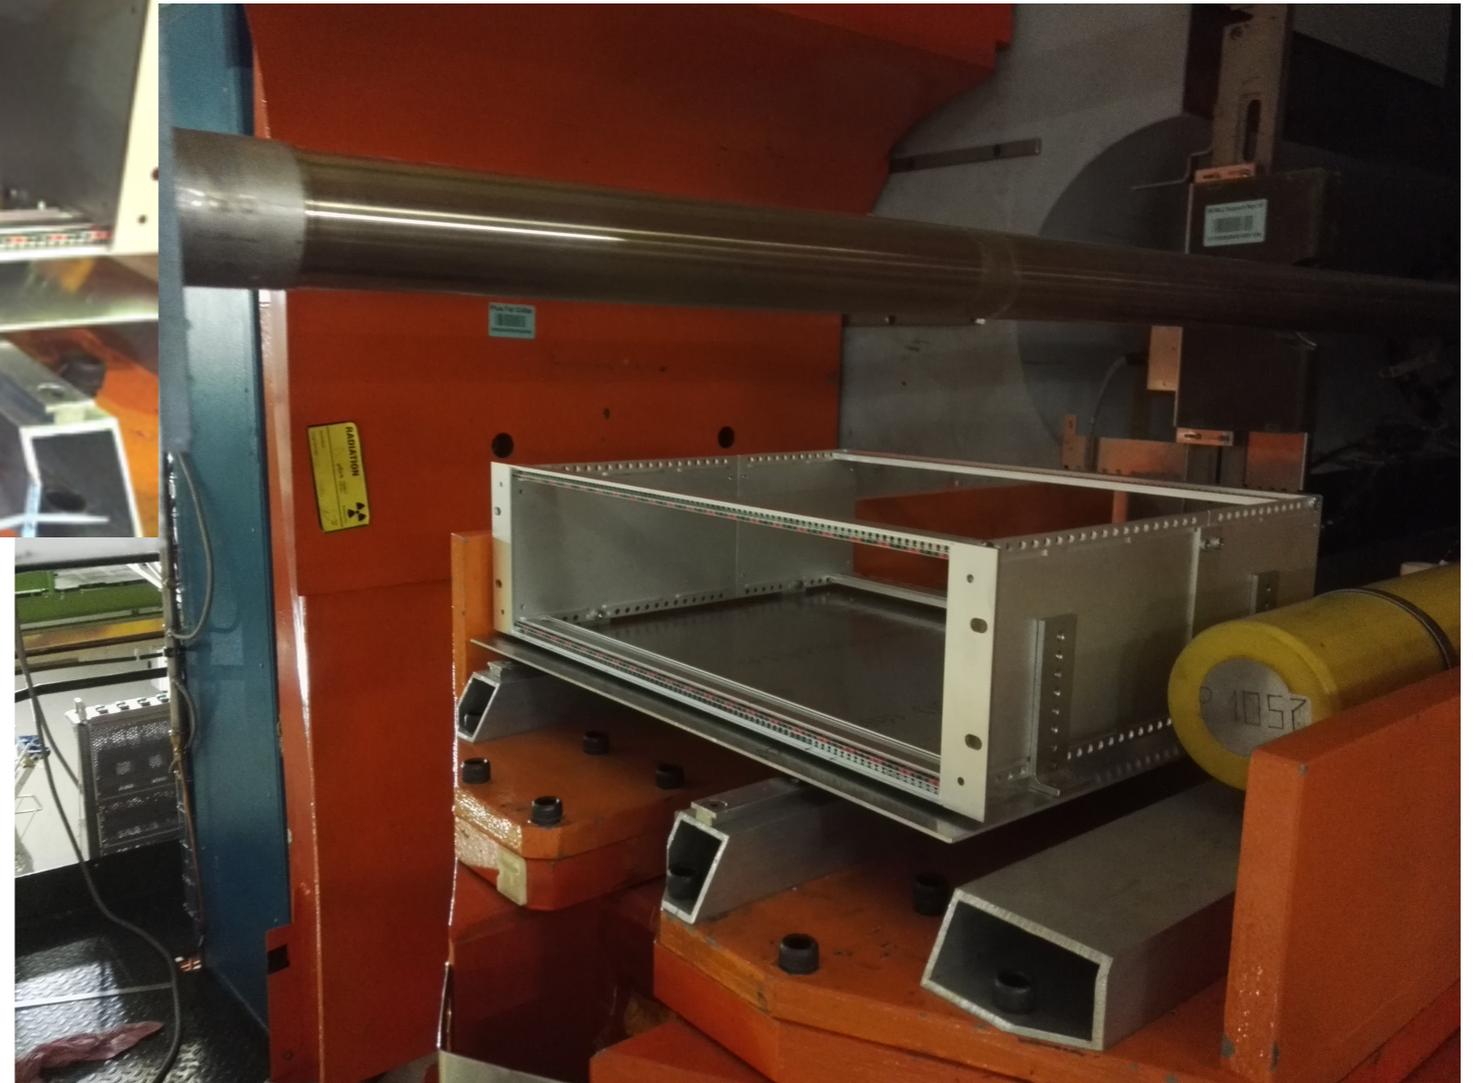
Exposure of 32 FEAST2 in the CMS Castor Table was meant to reproduce some of the environmental conditions (proximity to the beam line, EM environment, radiation environment)

32 sample DCDC modules, both FEASTMP and CMS modules, are exposed and constantly monitored in the CMS Castor Table during the 2018 run.

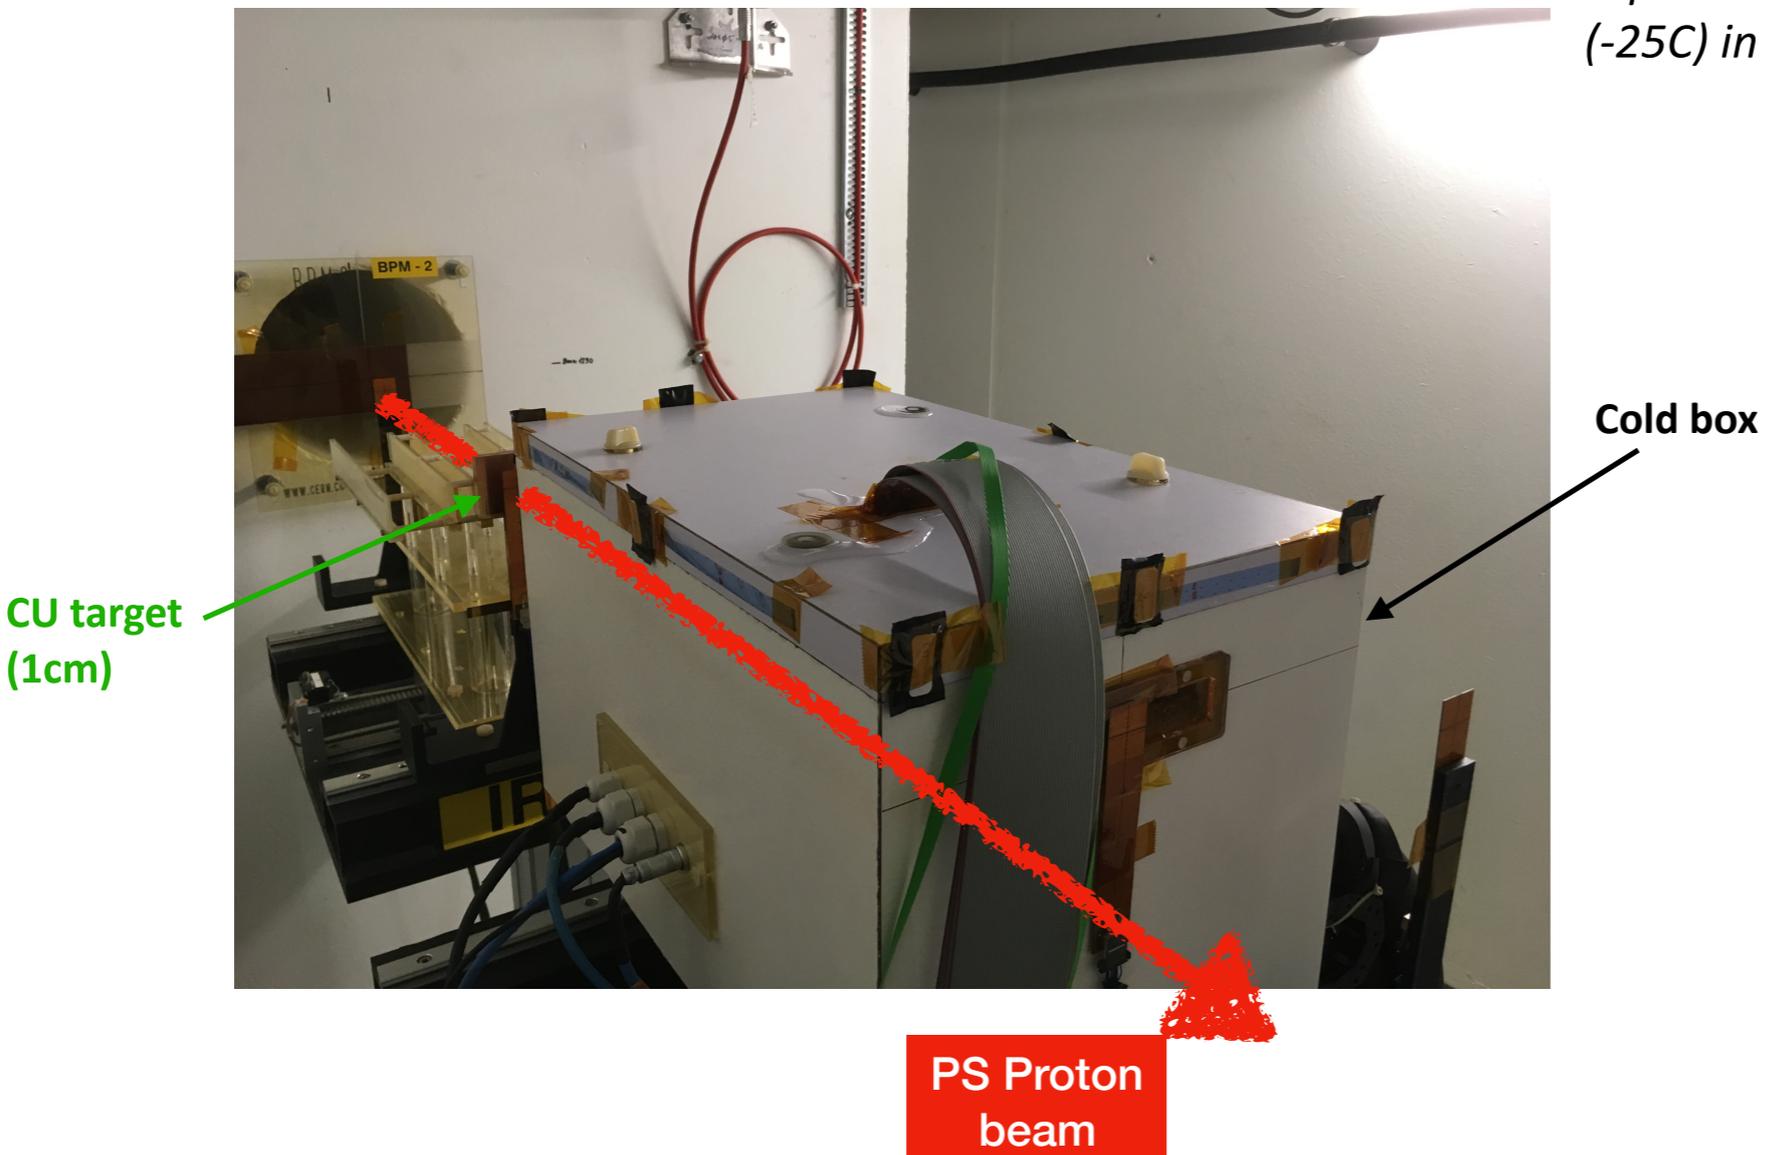
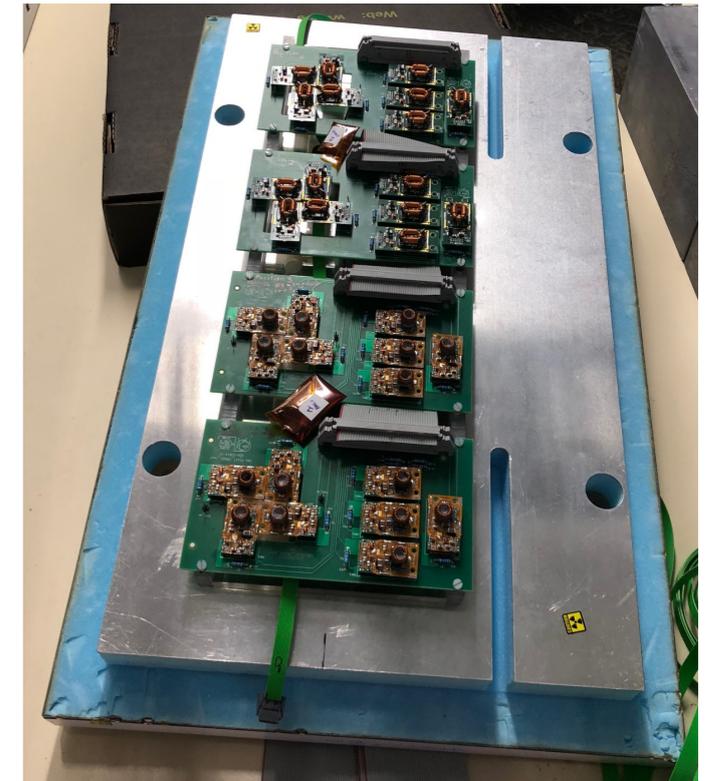
32 modules inside the cold box

Exposure of 32 FEAST2 at -25C at the CERN IRRAD facility

32 samples, both FEASTMP and CMS modules, are exposed and constantly monitored in a cold box (-25C) in the CERN IRRAD facility (May 2018).

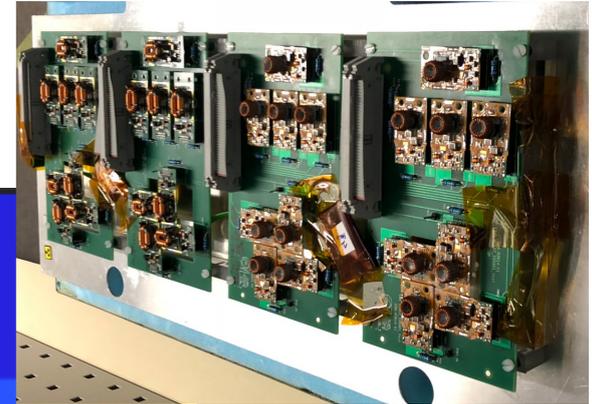
The results powerfully revealed some important correlation:

- **Between the damage and the integrated flux**
 - ▶ The first damage occurs after 9 days, then several samples per day
 - ▶ Only samples closer to the beam are damaged
 - ▶ Samples are damaged also after the end of the exposure
- **Between the occurrence of the damage and the disable-enable sequence**
 - ▶ Also true for the “High-Current”

Red = High-Current damage occurred during exposure

Blue = High-Current damage occurred after exposure

Black = failure

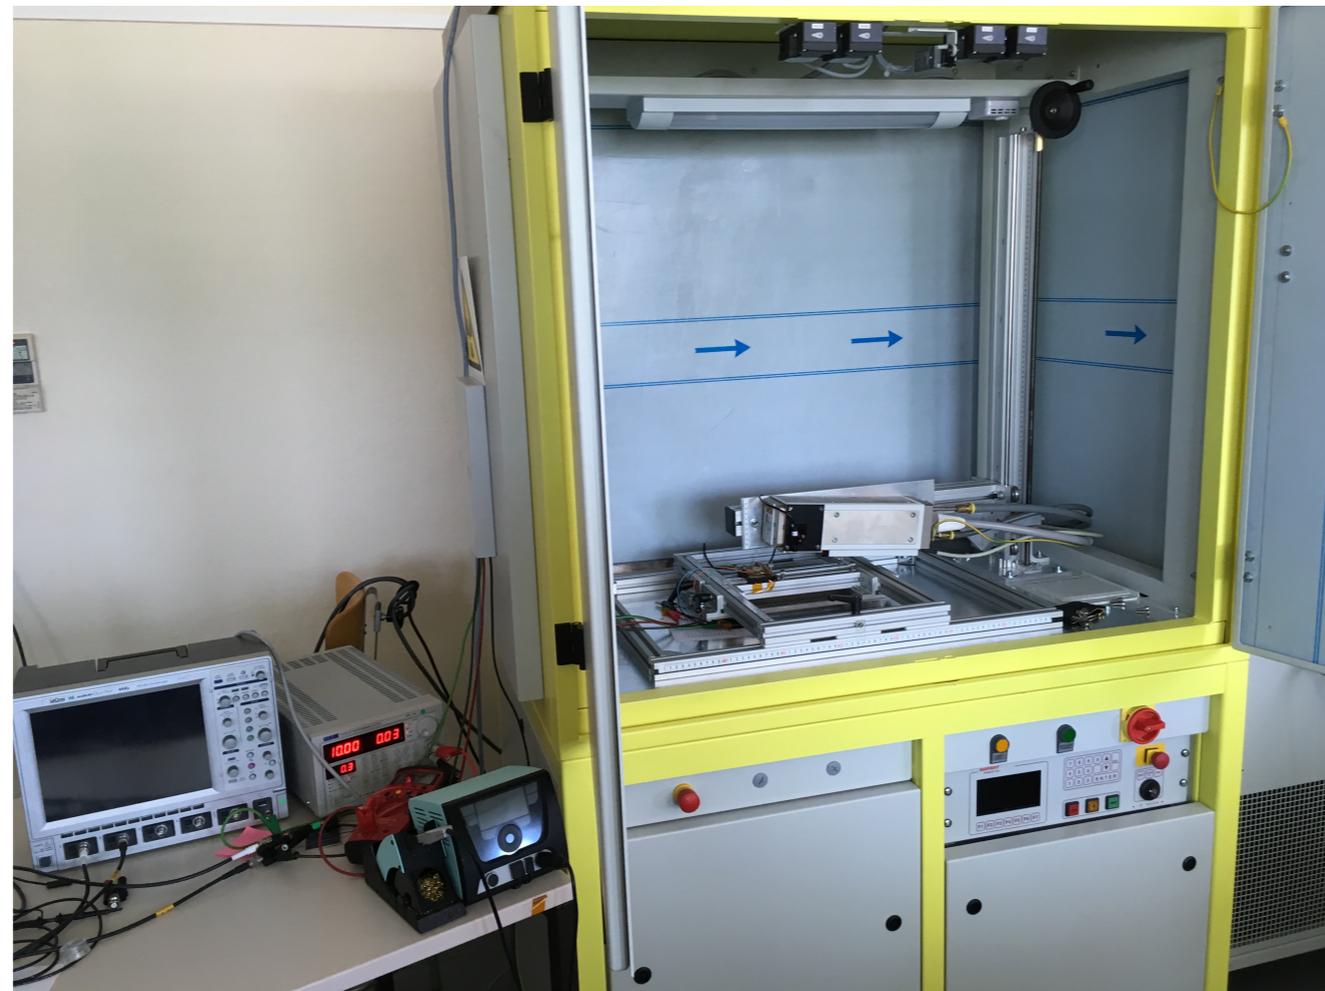
X-ray machine of the EP-ESE group

X-ray irradiation using the same enable/disable cycle as in IRRAD, and monitoring the current under UVLO thresholds, it was eventually possible to produce the same damage!
