The lonely perpetrator in the DCDC FEAST2 case

How an individual transistor threatened the operation of the CMS pixel detector

F.Faccio, CERN, EP-ESE

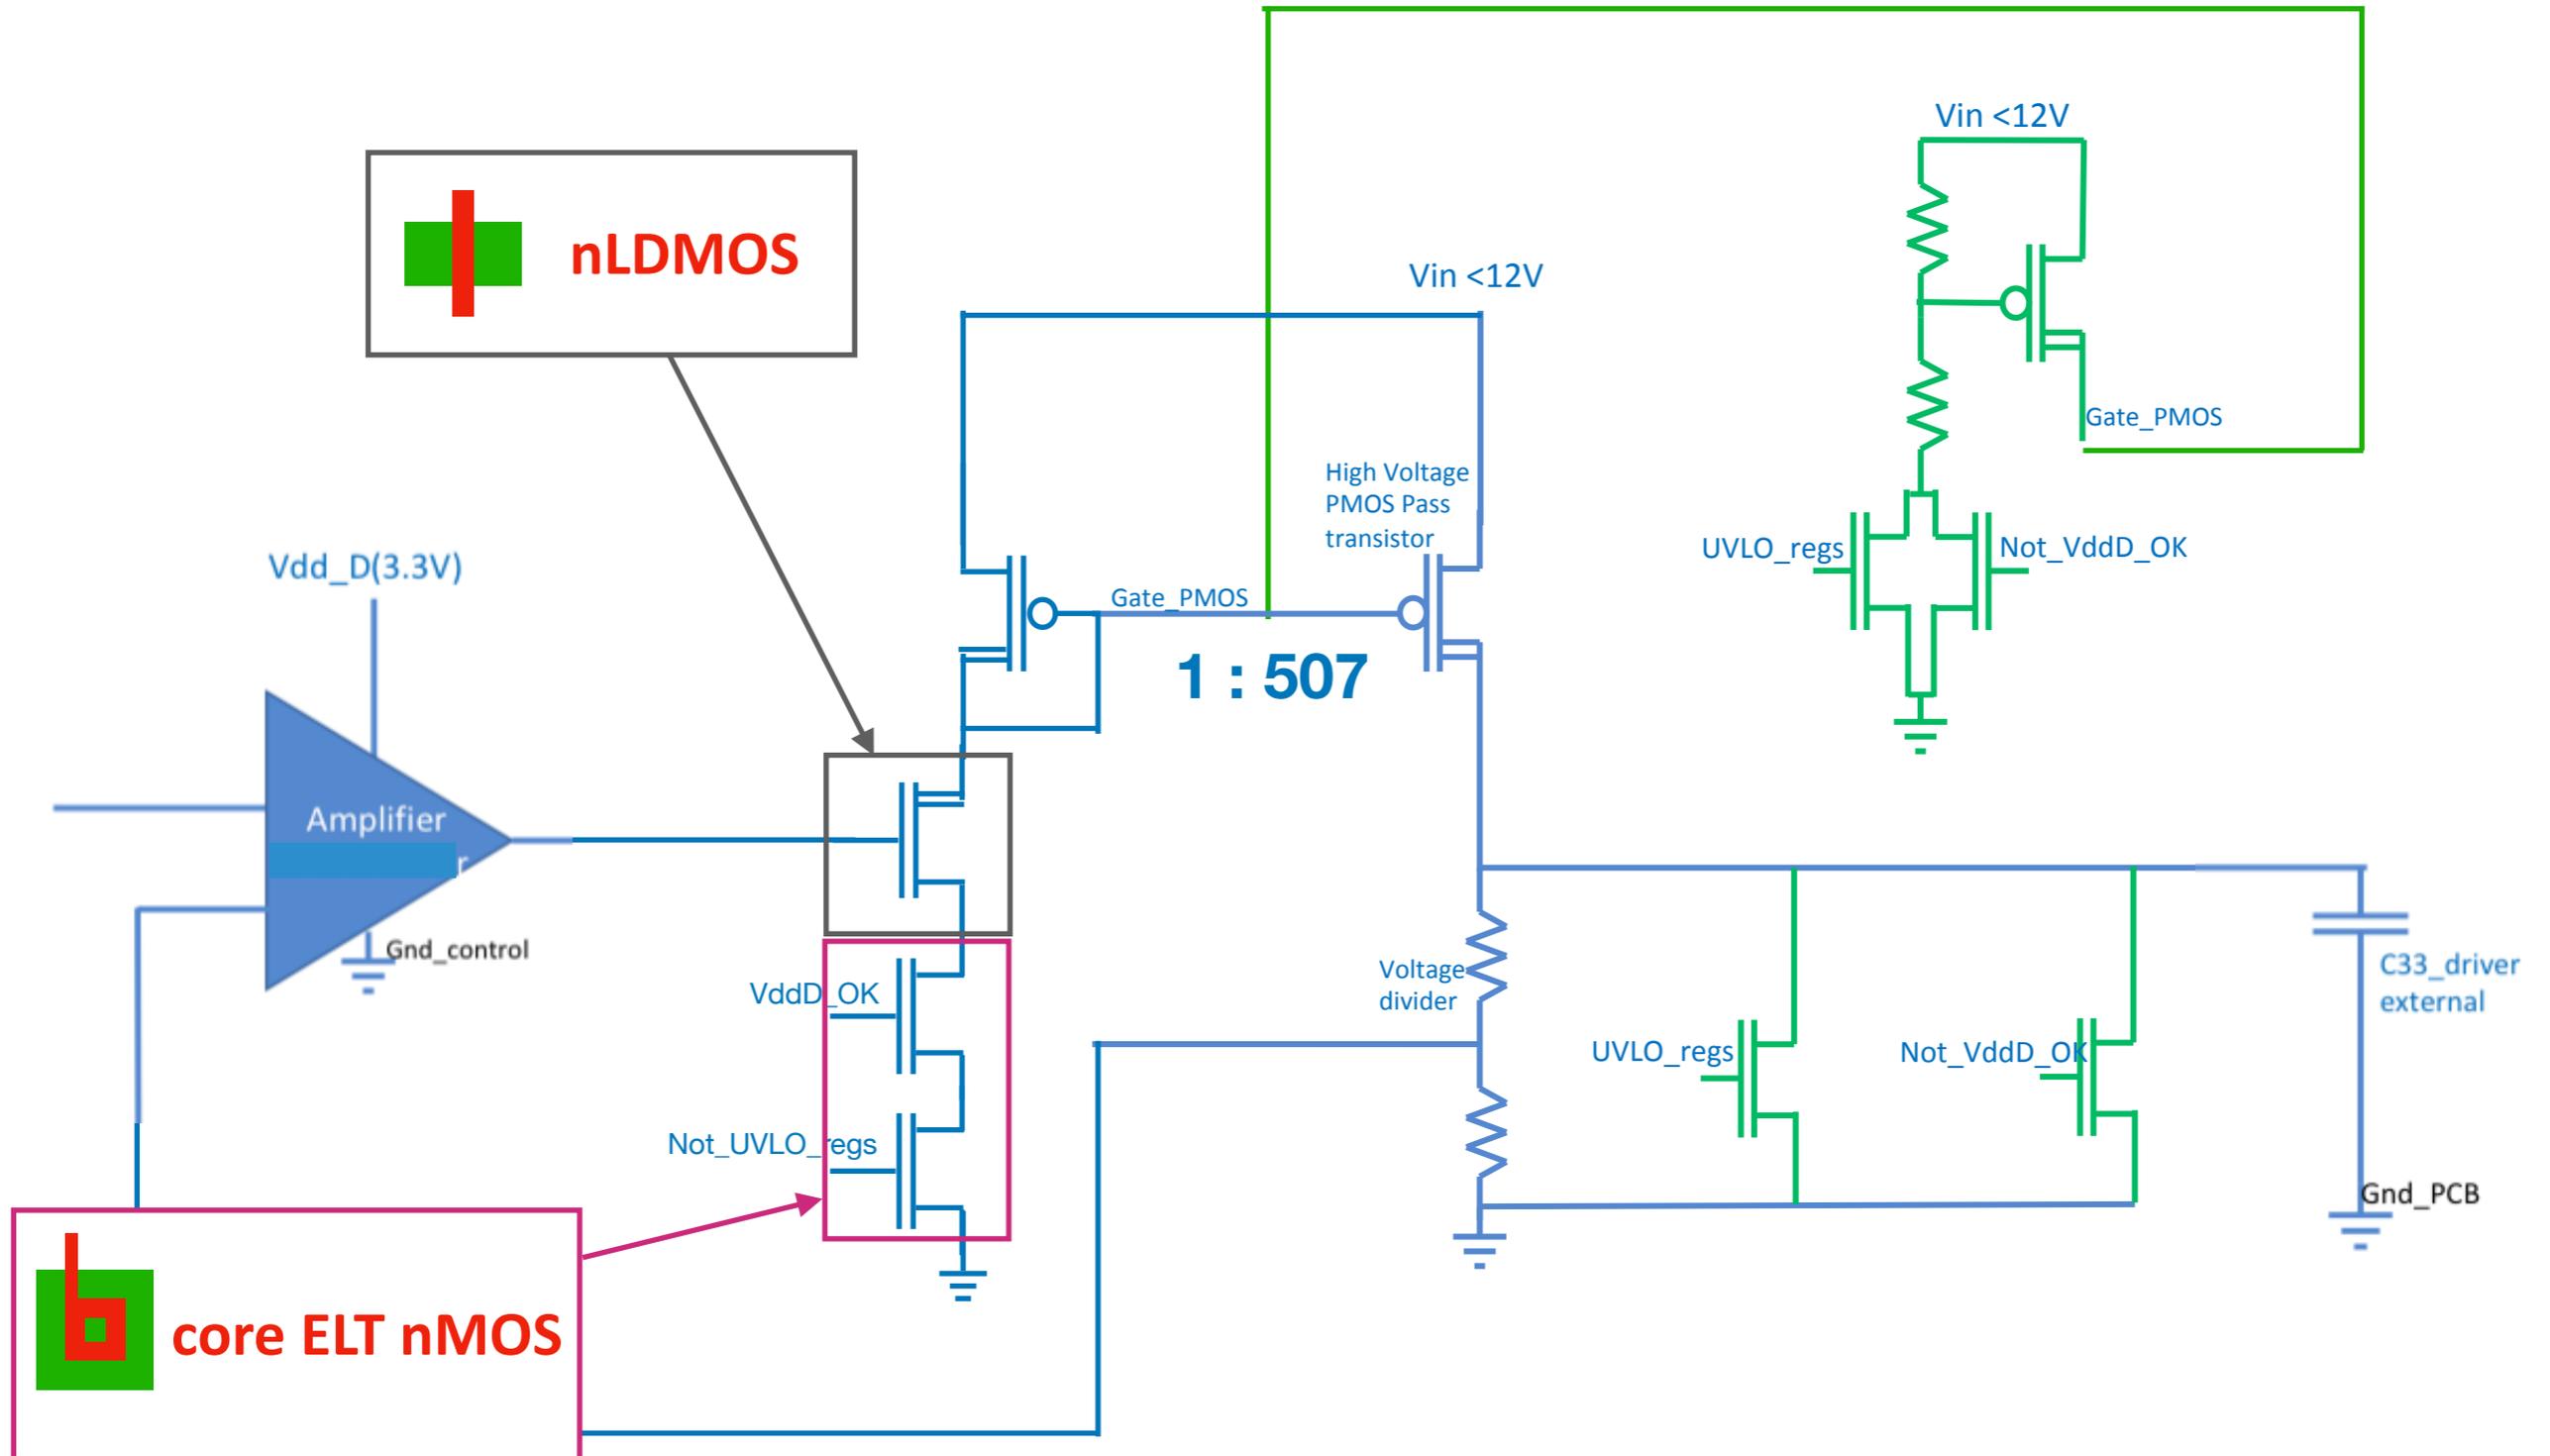
Failure of FEAST2 in the CMS pixel system during the 2017 run

The problem is localised in the linear regulator (V33Dr) that provides the required current to the drivers of the power transistors (HS and LS)

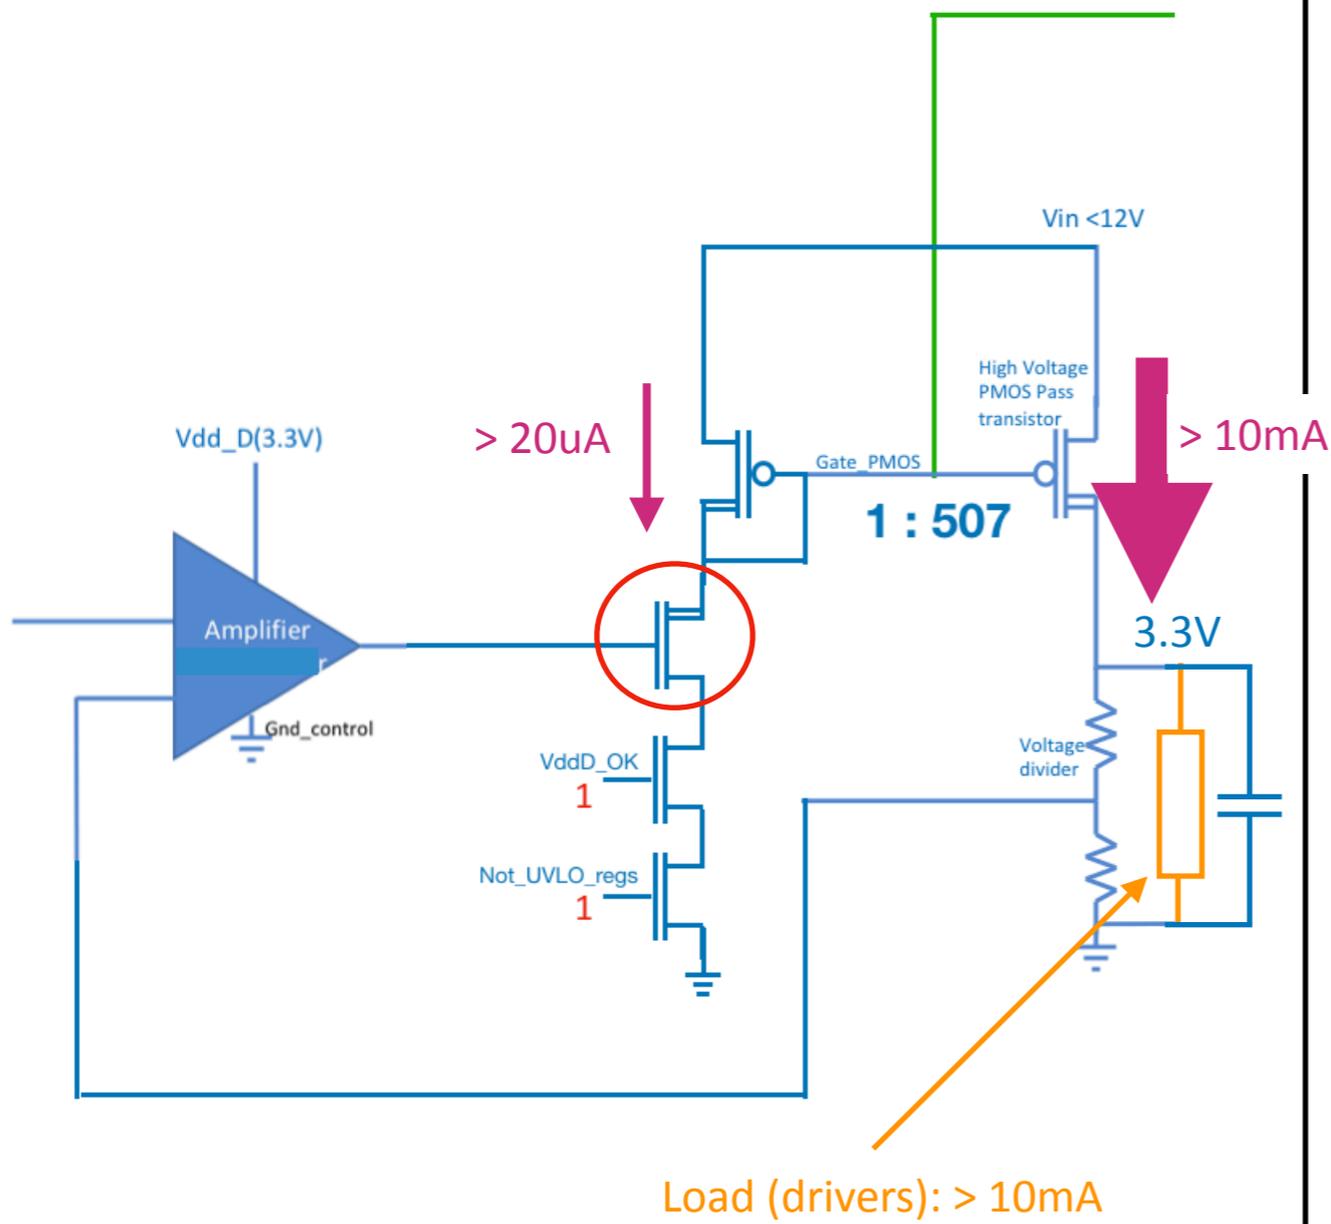
“enabled”

In the presence of a large TID-induced leakage in the nLDMOS, consequences appear **ONLY** when FEAST2 is disabled (no load for the V33Dr regulator)

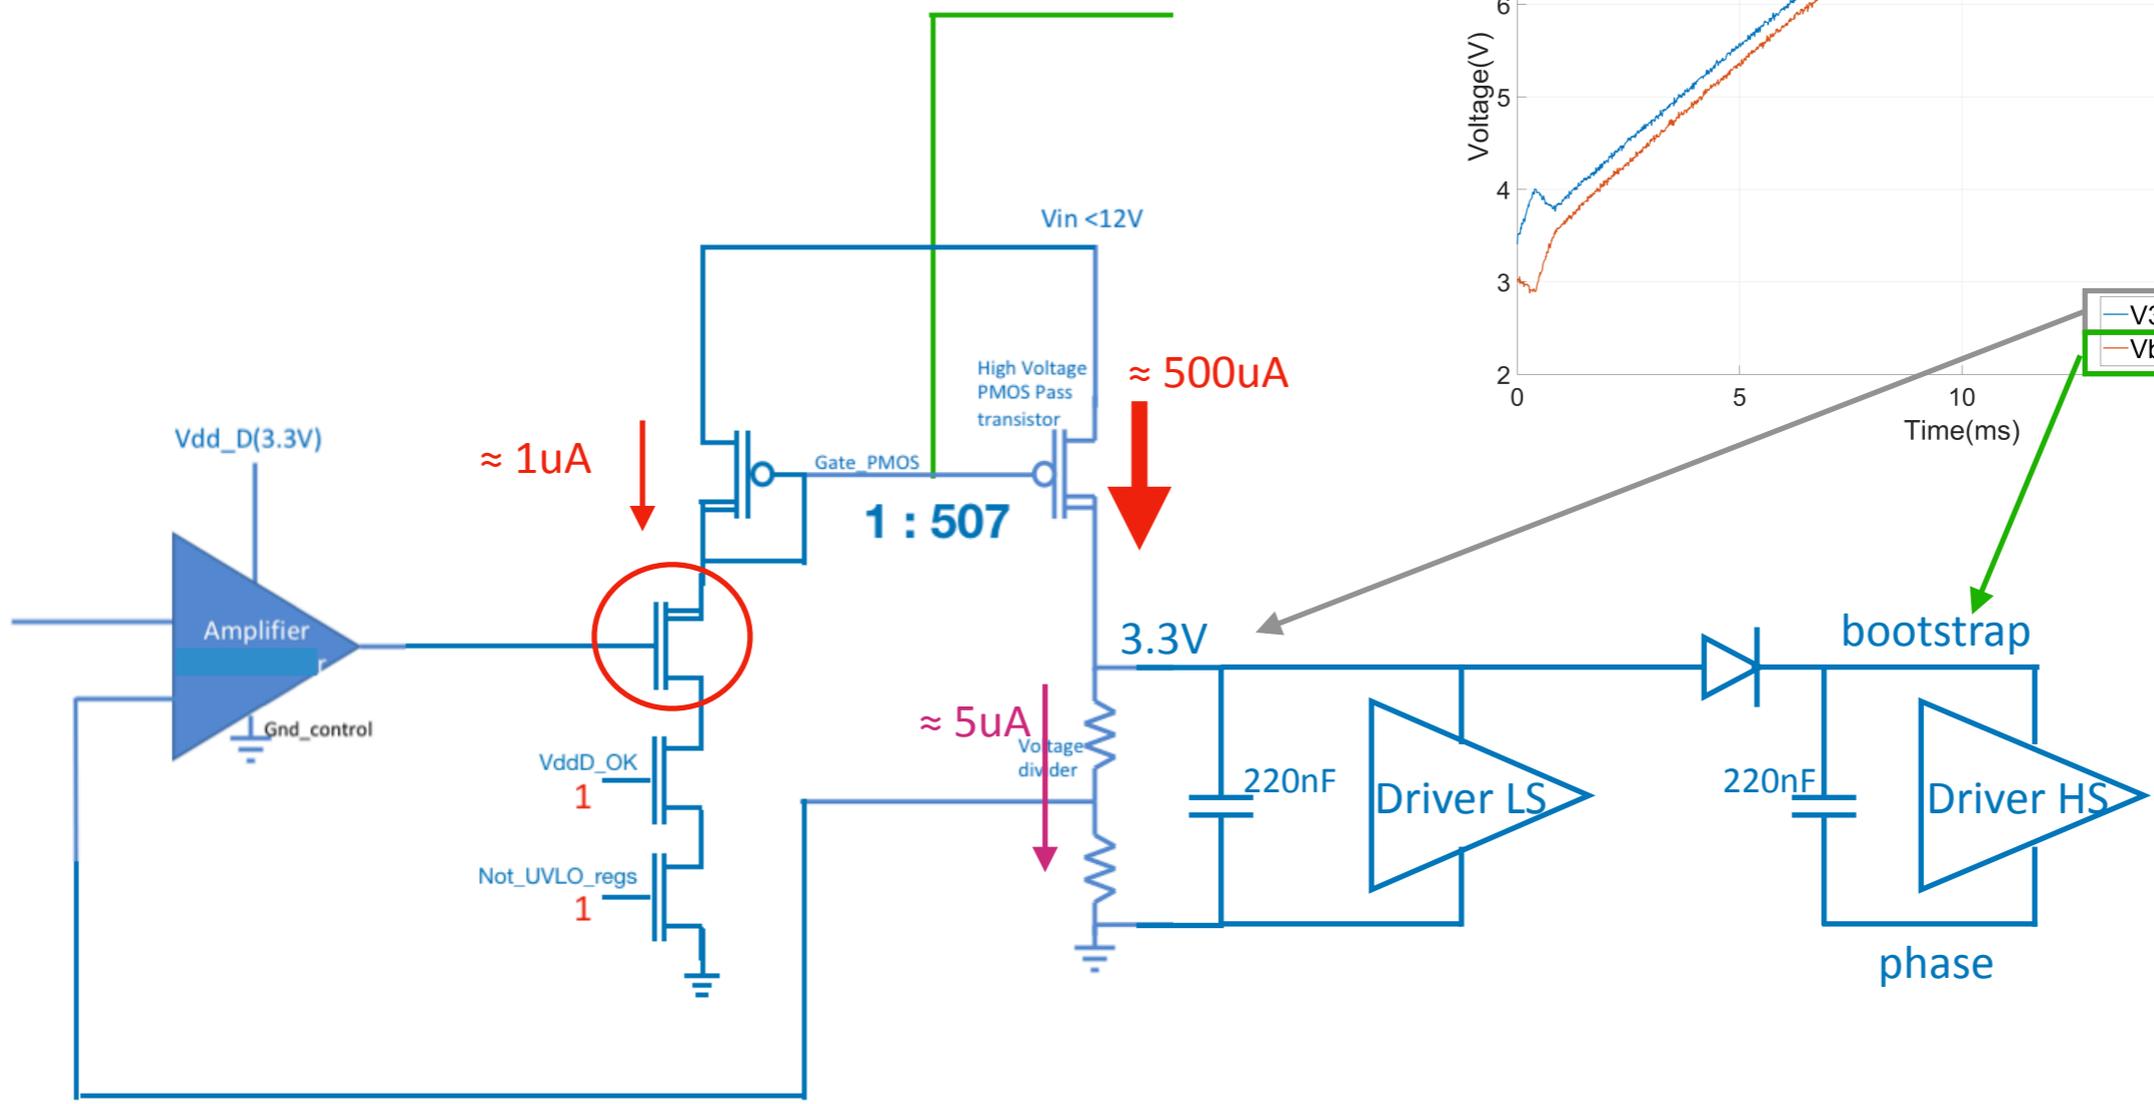
“disabled”

The integration of the current on the two 220nF capacitors has eventually been observed experimentally in June 2018 on samples exposed to TID at our X-ray facility

We observed a “voltage peak” on the V33Dr node when FEAST2 is disabled during X-ray exposures. The voltage peak increases with TID

Peaks of up to 8.5V observed during X-ray exposure

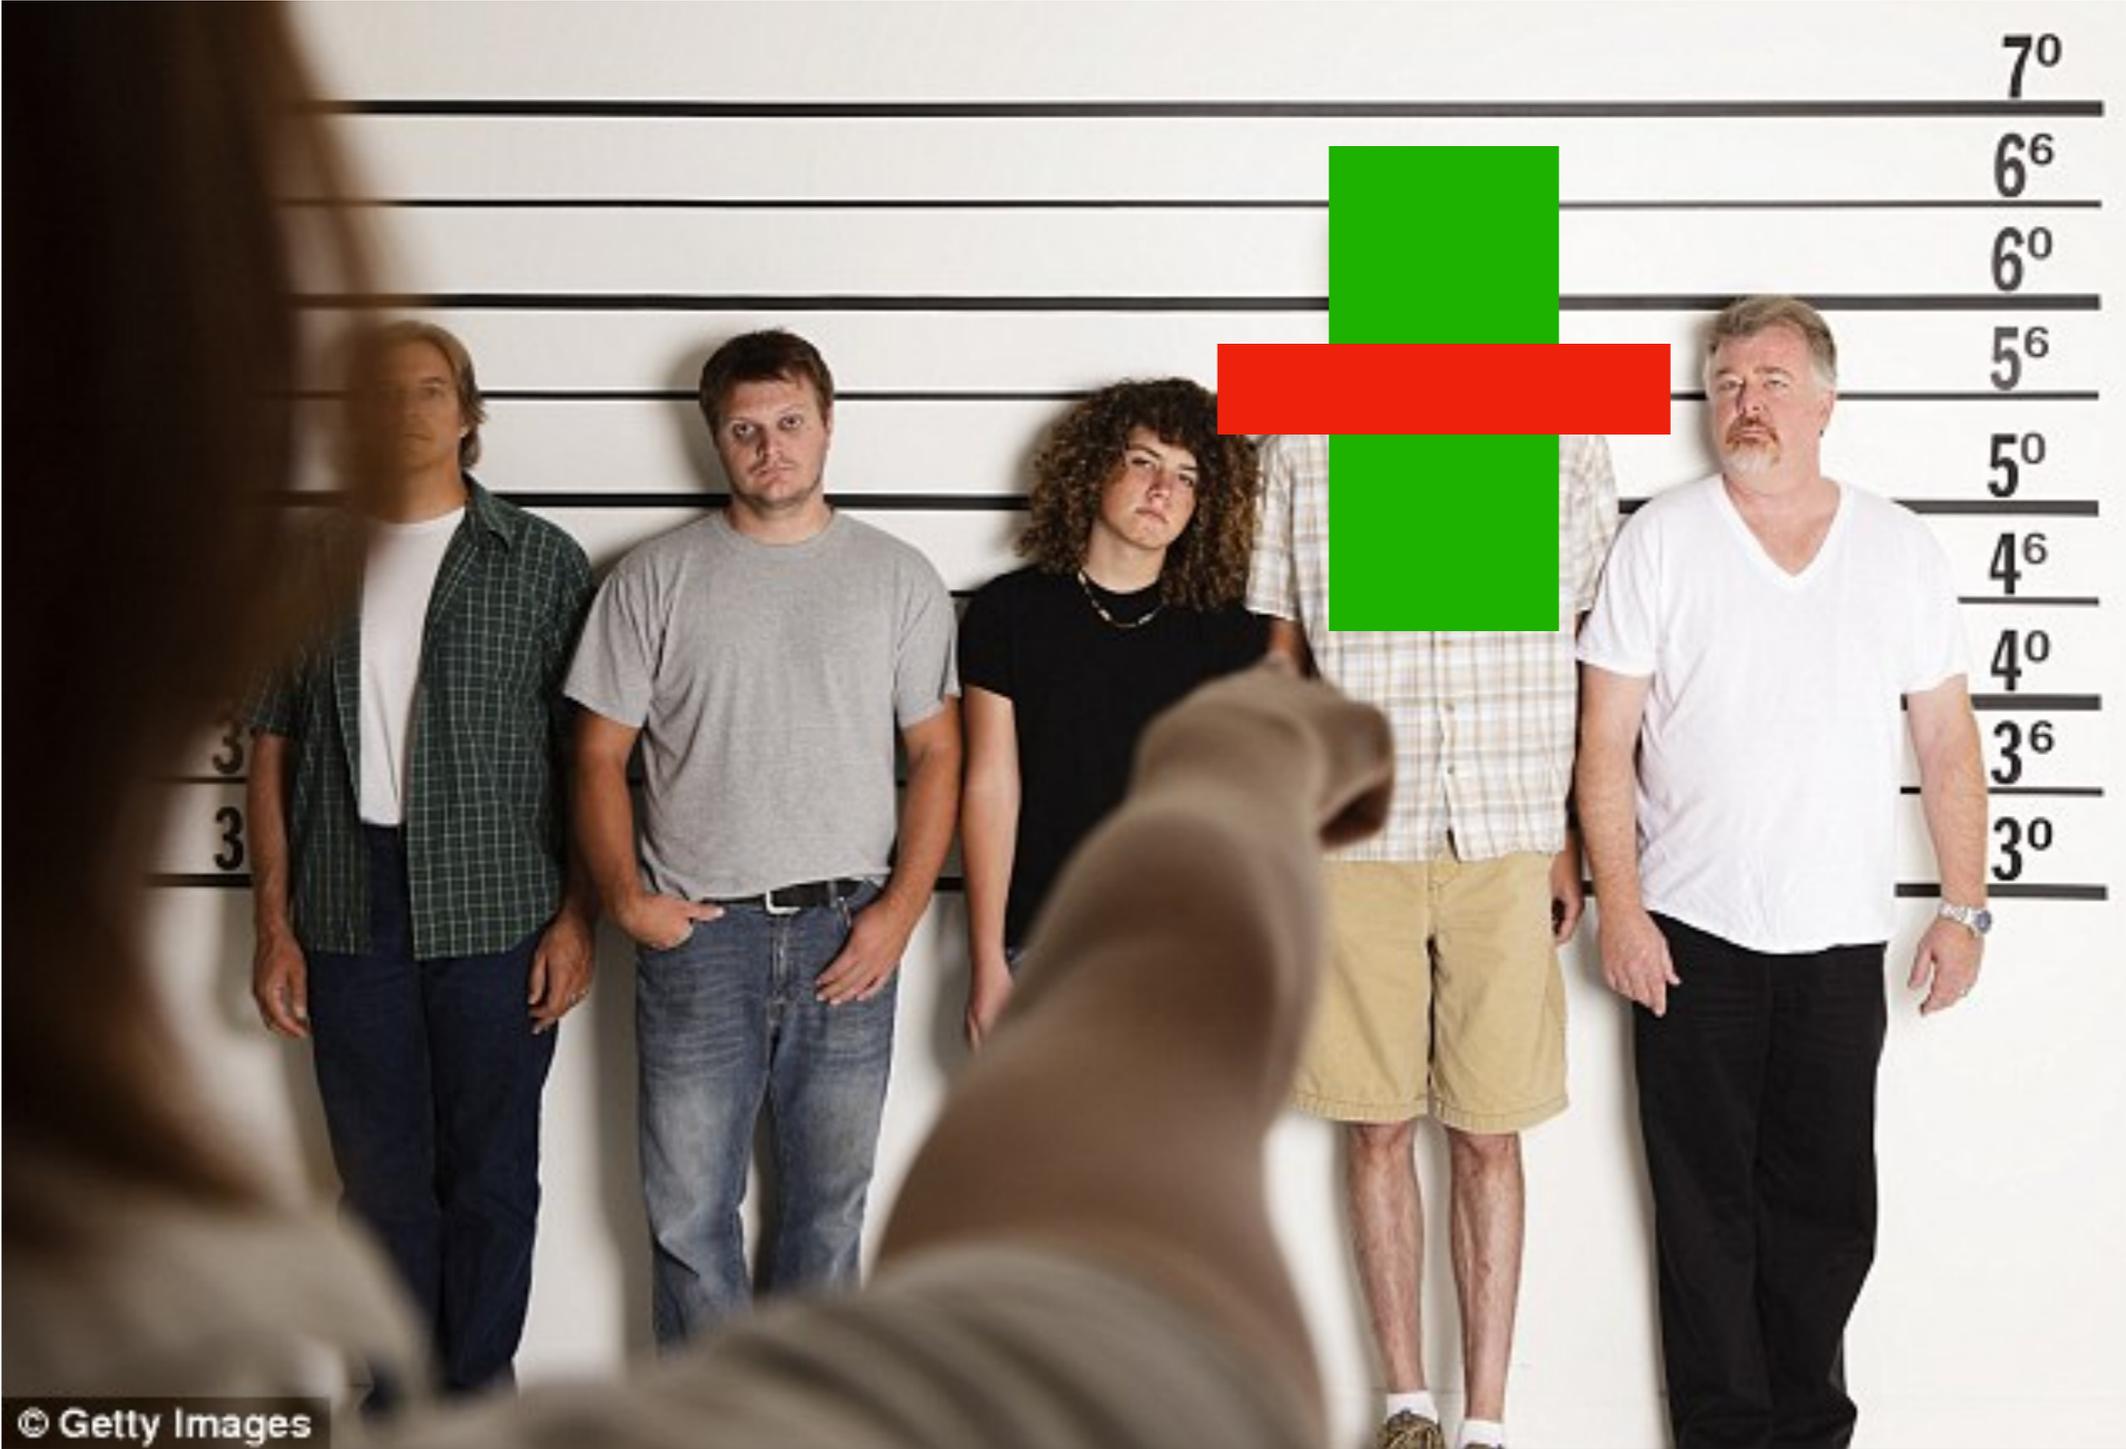
The perpetrator

TBM requires a power cycle
=> FEAST2 is disabled while the leakage is large
=> peak voltage at V33Dr
=> damage

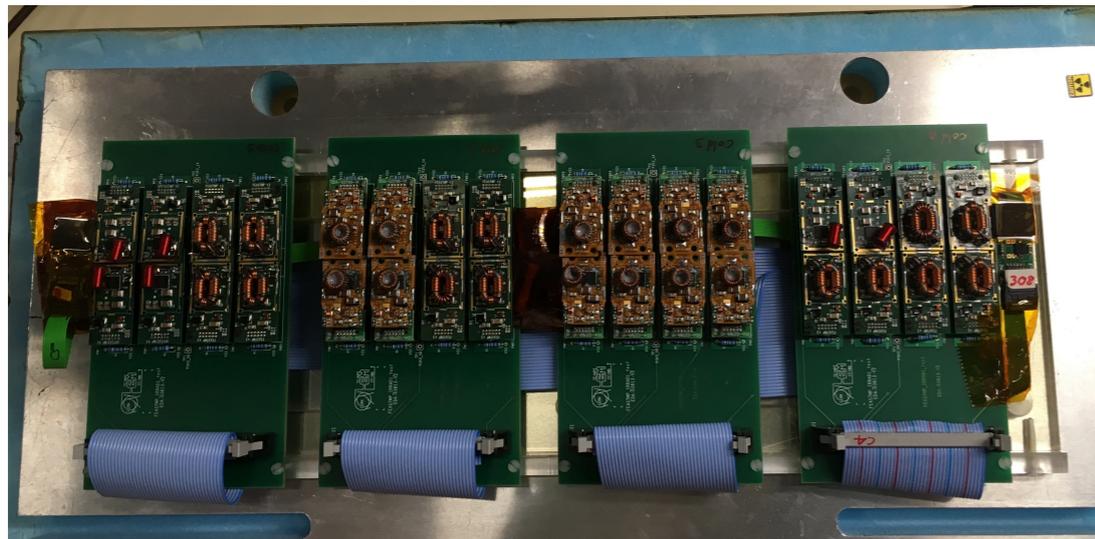
A second run in IRRAD used 64 converters

Samples inside the cold box

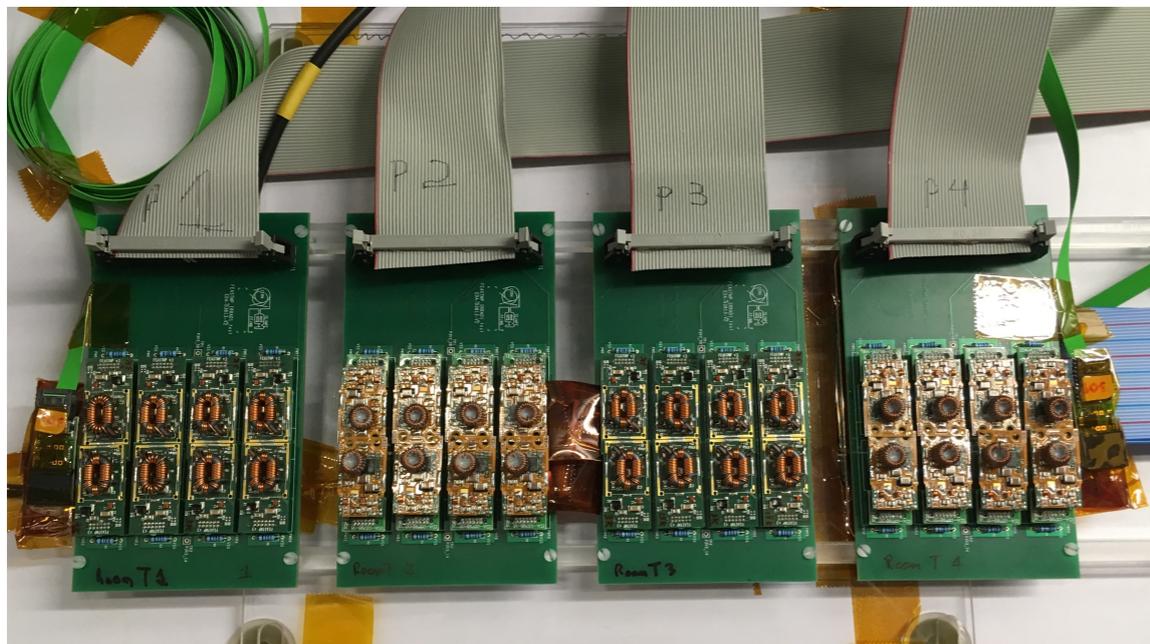
Samples at room T on top of the cold box

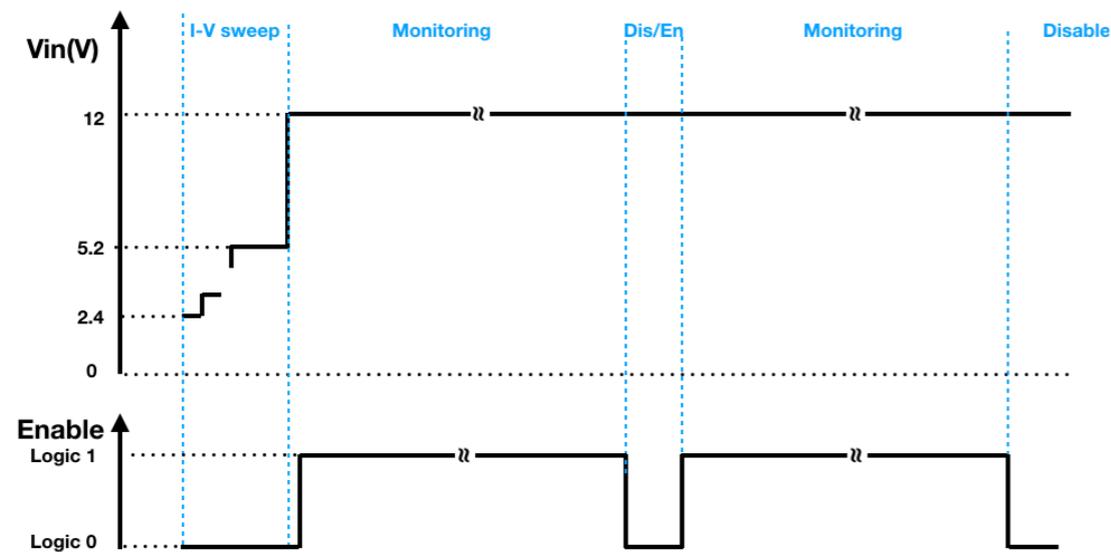
Sequence used during the first run
