LIEBE offline tests report:

Tests and actions performed without LBE, 30/08/2018:

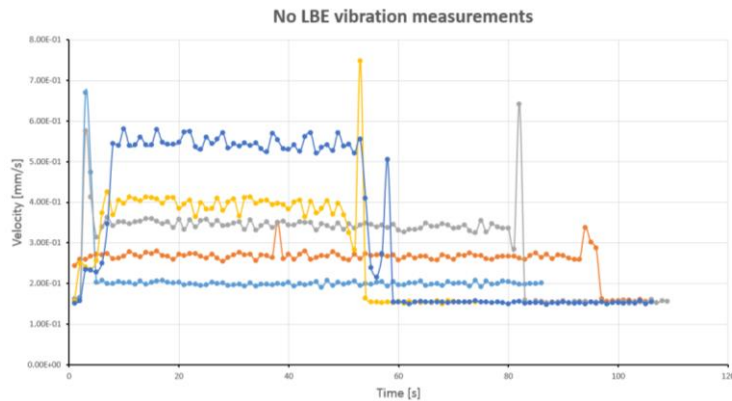
Figure 4: Vibration levels at the start of the tests without LBE

The velocities found are similar to previous tests and within the acceptable levels defined by ISO10816 (Evaluation of machine vibration by measurements on non-rotating parts). Vibration peaks were detected while changing the pump speed but within the margins.

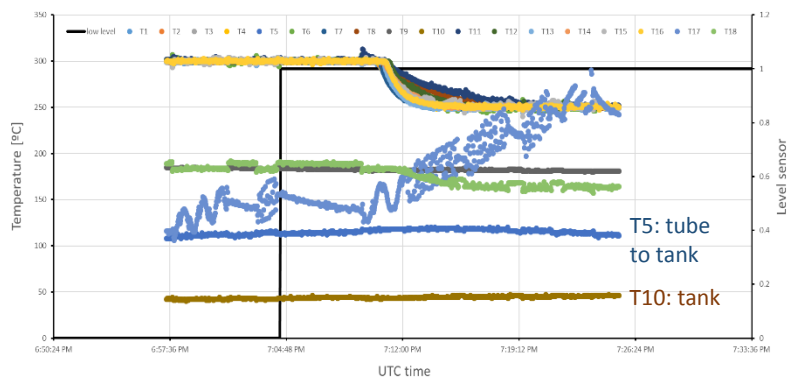
Figure 6: Temperatures on the loop while vibration tests under vacuum.

During the vibration tests the low level sensor turned on. This would mean that most of the LBE was molten even if the tank heating was not used. The tube to the tank showed close values to the melting point but without reaching the fusion temperature, figure.6. The tank thermocouple was showing values lower than 50°C but it was seen afterwards, during the LBE melting phase, that this value was probably inaccurate due to a bad contact with the tank. However, it can be assumed that the tank was much colder than the tube or at least that just a few droplets from the bottom could melt. No cavitation due to a partially filled loop was detected.

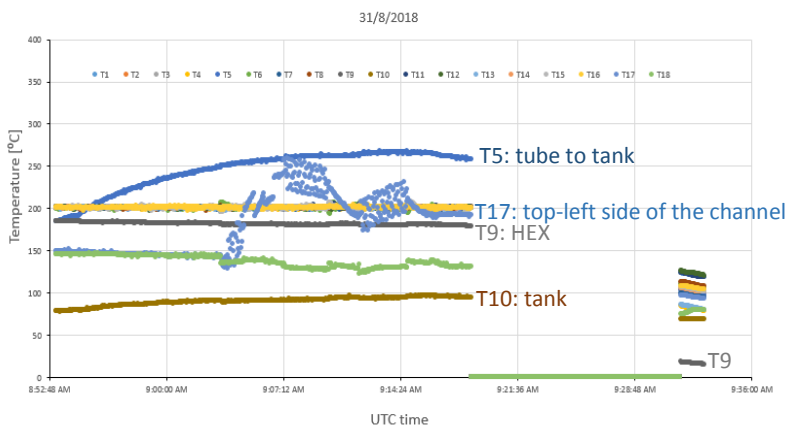
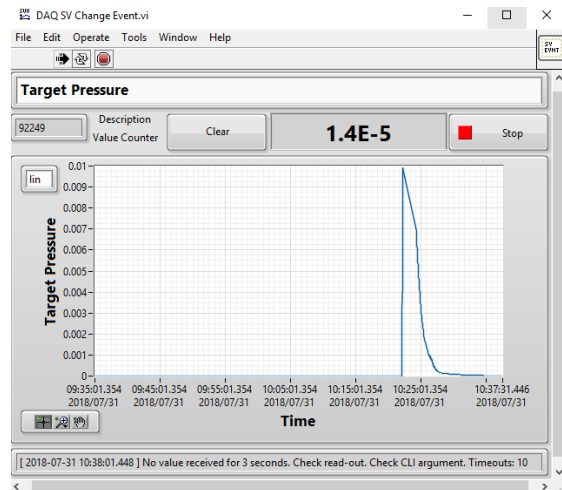
Figure 8: Loop temperatures while heating the LBE tank and target pressure during the melting process (UTC time in LIEBE data acquisition is 1h delayed from the pressure readout UTC time).

After a night outgassing, the standard target heating was used to heat the LBE tank and the tube linking the tank with the loop. The pump was used to heat up the channel to values close to 200°C, see T17 temperatures and the parasitic currents caused by the pump in figure.8. Vibration values were equal to previous tests under vacuum.

Temperatures from TC10 were quite low (<100°C); it was assumed that the thermocouple was not very well placed in contact with the tank. The tube (T5) was well warmed up to 250°C with only 1 heating element. Meanwhile, the tank has 4HE attached, that are powered electrically in parallel with the HE5 of the tube to the loop. While opening the second envelope to check the tank temperature with an external thermocouple, a pressure leak triggered the interlock, figure.6 pressure readout, which cut the power of all systems. The pressure peak was expected due to the remaining argon in the tank from the process of LBE filling. The sharp increase of pressure and the fast recovery of the vacuum are in well agreement with that hypothesis. Moreover, the remaining argon was forcefully on the top of the tank, so most of the LBE had to be molten for this event to occur. In figure.8 it can also be seen the rapidly loose of temperature in the heat exchanger, T9 is at room temperature after 15min without heating elements, which could induce non-controlled LBE solidification in that zone. The level sensors were both on, as before, during all the process.

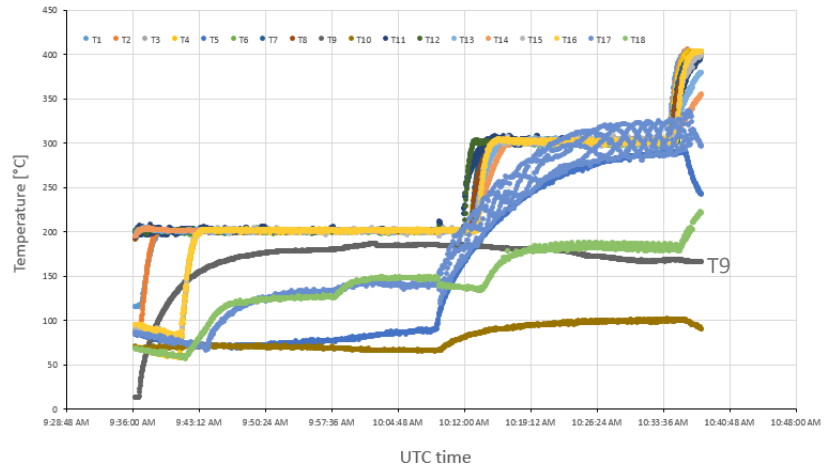
Figure 9: LIEBE loop temperatures after LBE melt, from 10:36am to 11:40am

The LIEBE loop was set to 200°C and the pump to 247rev/min (30Hz) to heat up the channel and start the flow of liquid metal. Meanwhile the LBE tank was again heated to ensure that all the LBE was molten into the loop. The HEX temperature was expected to increase once a flow would be developed. However, T9 decreased from 180degC to 160degC without any water-cooling being used. The loop temperature was increased to 300°C and afterwards to 400°C trying to see an effect on T9 without success, figure.9.

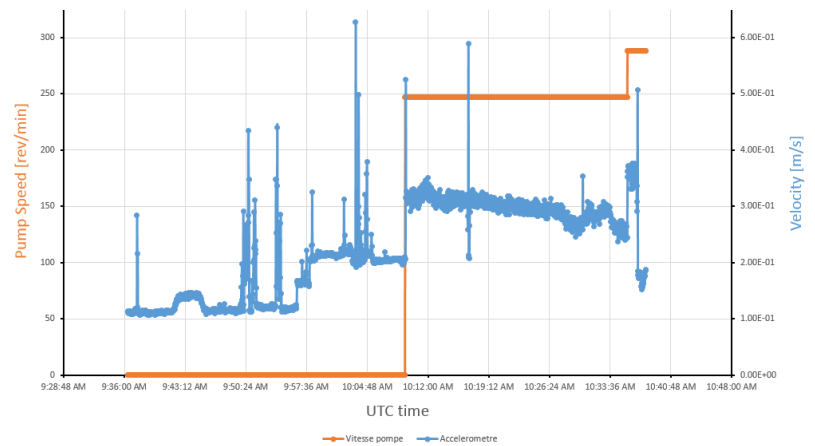
Figure 10: Vibration after LBE melting, from 10:36am to 11:40am

Vibration levels were similar to the ones measured under vacuum. At 247rev/min an average of 0.3mm/s slowly decreasing was detected, compared to 0.34mm/s under vacuum, figure.10. No cavitation was detected in a first instance although a friction noise could be heard coming from the channel, which indicated flow. Unfortunately, there is no clear evidence that a flow of LBE was developed since the level sensors were proven unreliable and no evident effect was seen on the accelerometer. The only hints are the temperature effect on T9, the previous pressure leak and a soft friction noise from the channel. It was then tried to heat up the rest of elements in the loop to see an effect on T9.

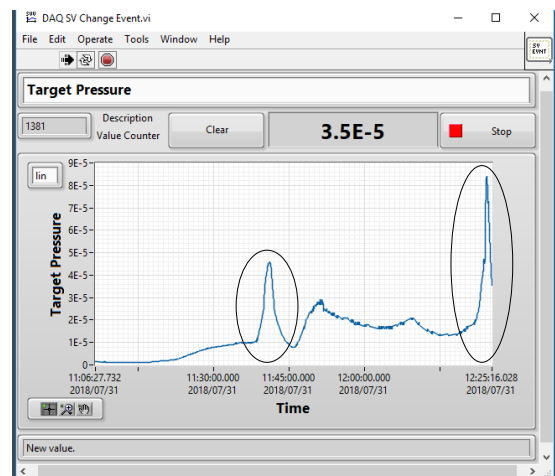
Figure 11: Target pressure from 11:06am to 12:25pm

The PLC controlling the LIEBE stopped at 11:40am (10:40am in LIEBE’s data acquisition), while heating up the loop to 400°C and coinciding with a pressure increase in the target, figure.11 first circle. The pressure interlock did not trigger and resetting of the PLC brought the elements to work again. There is no link between the PLC and the pressure sensor apart from the interlock cutting the power. However, the pump was stopping from time to time and its current control was giving errors “torque program limit, acceleration program limit, deceleration program limit”. It was considered a problem with the control system to be fixed later on. In addition, to be noted for the rest of the report, the acquisition data system just checks the pump velocity input. It does not take into account if the pump is on or not. Luckily, the vibration levels show clearly when the pump is working, figure.13.

At 12:24pm, another pressure peak triggered this time the pressure interlock, second circle on figure.11. Both peaks shown don't have a sharp start as seen in the previous leak at 10:20am. T9 temperatures were around 160°C, above the 125°C melting point of the LBE. Even if other parts of the HEX could be colder due to the low thermal conductivity seen (no effect on T9 from the hot diffusion chamber at 400°C), the accelerometer would detect higher vibration levels due to cavitation in the channel, as it will be seen later in this analysis. Moreover, after the first melt of LBE inside LIEBE some outgassing could be expected, triggered by both the temperature and the flow. Following that hypothesis, the pressure peak coincides with an increase on temperature up to 450°C of the loop, figure.12. This effect would confirm the presence of LBE in the loop. The ion source couldn't be used to check the extracted beam because of the constant power cuts.

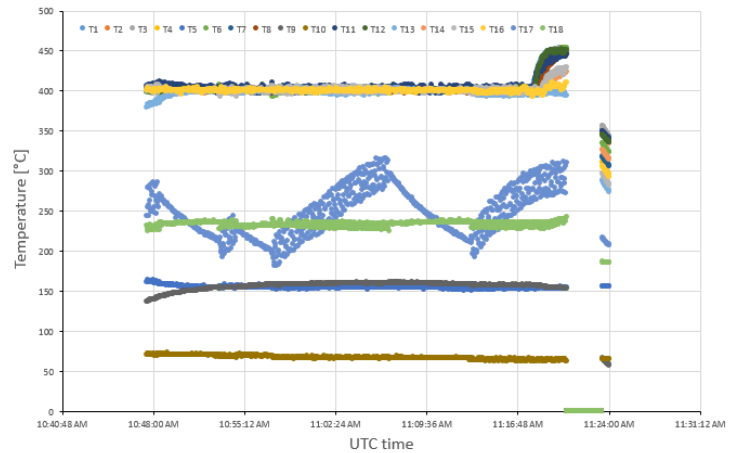
Figure 12: Loop temperatures from 11:48am to 12:24pm

After reset of the PLC system all the elements were fully functional again. The loop parameters were set to the previous status (400degC and 247rev/min on the pump, figure.12 and figure.13). LIEBE seemed stable at that point, with some increase on the pressure following an increase on temperature or pump speed, following figure.11.

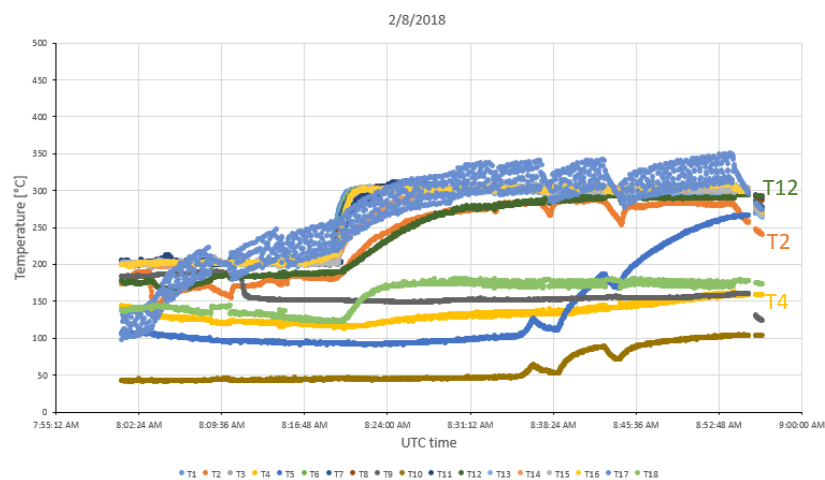
Figure 15: Temperatures in the loop from 9:00am to 10:00am

The tests restarted with the damaged heating elements disconnected from the control system. The loop was set to 200°C to warm up overnight, previously the LBE was solid in the loop, then heated up to 300°C, figure.15. The loss of the heating elements was not very problematic in the case of HE2 and HE12, temperatures on their zones followed quite well the overall temperature set in the loop. On the contrary, not having a heating element at the exit of the heat exchanger was more worrying considering the low temperatures in the HEX. It was also noted that the low-level sensor was off and stayed off the rest of the tests.

of HE4 (from 8:38am onwards), without much effect on T9 that stayed around 150°C, but a reasonable increase on T4, figure.15.

From figure.16 vibration levels stayed very high even after the temperature effect seen in figure.17. From the overall temperature plot in figure.15 it could be argued that the low temperature in zone 4 could be causing a plug at the exit of the HEX. In that case there is not enough LBE in the loop to cause a leak through the ion source, no effect on the pressure inside the front-end was seen either.

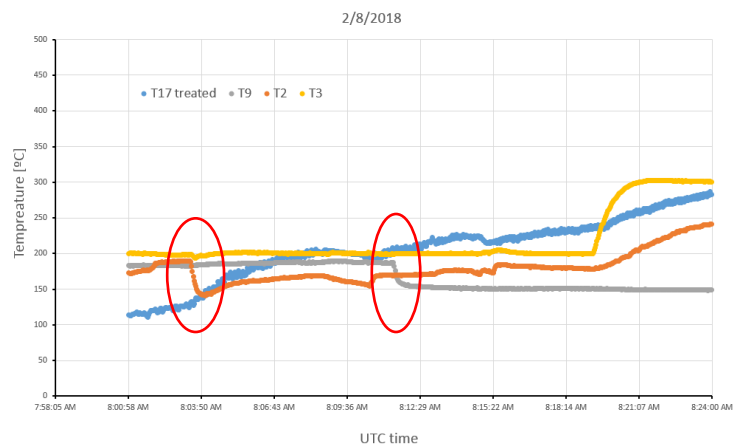
Figure 17: Temperatures after restart of the tests. 'T17 treated' is a 10s average of the raw data for clarity.

Having a closer look to the temperatures, the HEX temperature lowered drastically from 180°C to 150°C (8:10am). T2, positioned at the tube exiting the pump channel, also suffers a drastic decrease on temperature but earlier in time, at the start of the EM pump. Since the HE element was not working there, the zone is highly influenced by the temperature of the LBE flowing. The decrease in temperature could be explained by the flow of relatively cold LBE, just molten, coming from the channel (T17 and T2 cross in time there). In that case,

the following drop on T9 would mean the unclogging of the HEX and the start of the flow on that zone. Just molten LBE, 125°C, could cool down the weakly heated HEX. The consequence then is that the loop was clogged while the EM pump was working and developing a flow for roughly 10min. Moreover, it proves a difference between the temperature readouts from TCs, very close to the heating elements, and the actual temperature of the LBE inside. Comparing with, for example TC3 (just underneath TC2), it shows just a very small drop at the start of the flow. The effect is hidden by the HE element maintaining almost constant 200°C on the surface. The heating elements of the tank were used trying to compensate the loss

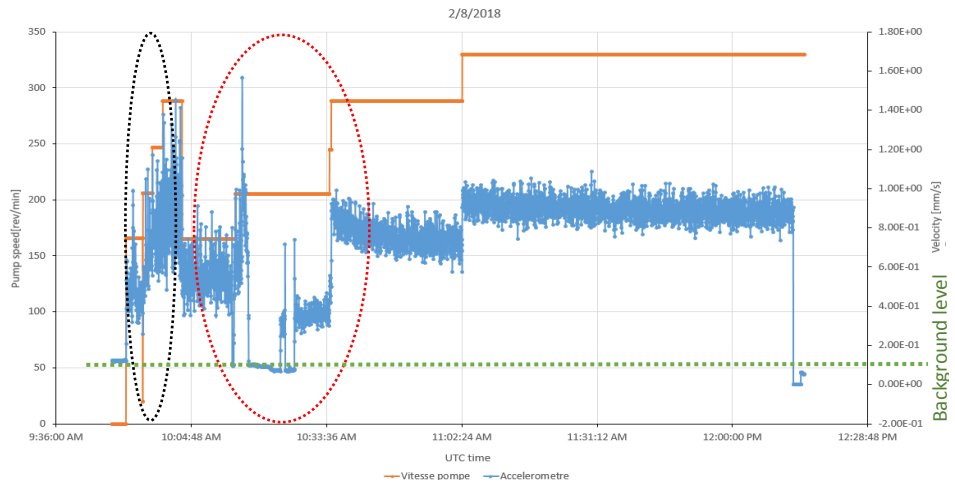
Figure 19: Vibration and pump speeds from 10:45am to 13:20pm

The EM pump was used to recover the temperature in the channel once thermal equilibrium was reached on the HEX (150°C) and most of the loop, figure.19 and figure.20 first circle in black. High vibration was detected by the accelerometer, similar to figure.16. A closer look to the temperatures at the restart of the loop show similar phenomena seen previously in figure.17, figure.21.

After stabilization of the pressure, lower vibration values were detected, figure.19 10:30am. It seemed that a full flow was then developed. For the first time during the tests, T9 reached higher values than 200°C, figure.25. Temperature effects of increasing the pump speed could be seen and even the water cooling was tested. Different temperature equilibriums, between 150°C and 250°C, could be reached using different water channels. Unfortunately, electro valve 1 was not reacting to the controls. The reason is still unknown.

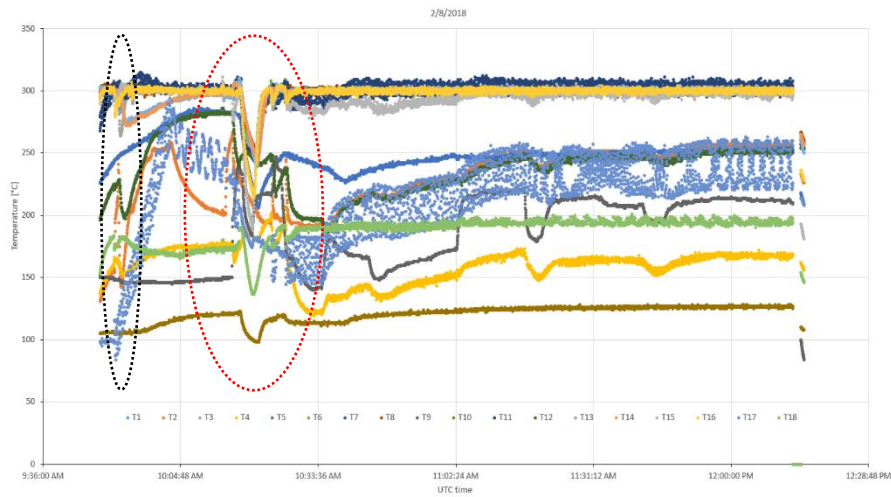
Figure 20: Loop temperatures from 10:40am to 13:10pm

After one hour operating in these conditions the source reached 300A (1800C) the transfer line was at 190°C and the chimney connecting the diffusion chamber and the transfer line at 145°C. While preparing the mass scan, another sharp pressure leak, as figure.18, is reported to bring down all the elements. The HEX loses 100°C in some minutes and the target is unable to quickly recover afterwards, end of figure.20.

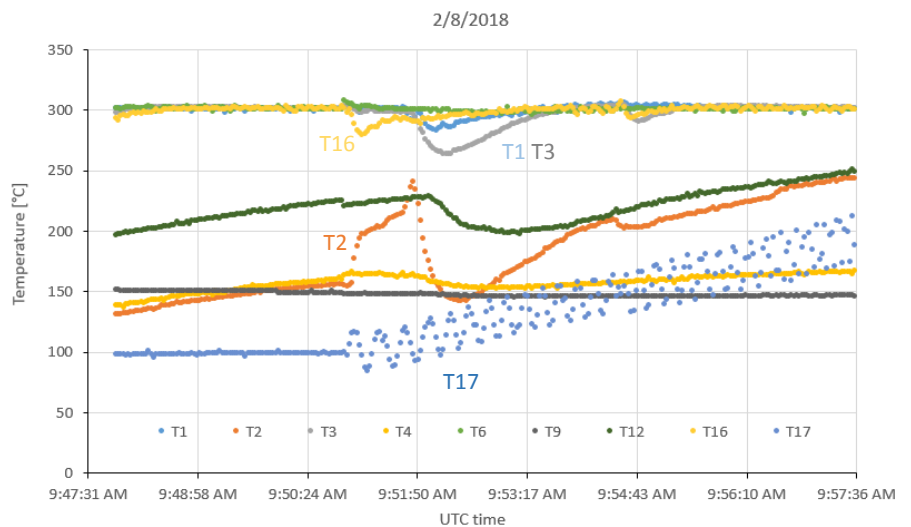
Figure 21: Closer look to temperatures in the first circle in black from figure.20, from 10:47am to 10:57am

It seems from the temperature data that zone 2 was blocked for 1 minute, following figure.21. When the pump starts T16 reacts immediately with a slight decrease in temperature from the colder LBE coming from the channel. Instead, T2 increases temperature quite drastically until presumably the LBE melts in that zone releasing the flow, when the temperature quickly lowers to the channel temperature T17. At the same time T1 and T3, on top and underneath respectively from zone2, react to the flow.

So, even if TC2 was showing temperatures above 150°C, the LBE inside was not molten, which induces to think that the same thing happened in the HEX but with a much bigger section of LBE. T9 was stable at 150°C, the HE could not heat up more. Around 11:10am a sudden increase of pressure was seen, figure.22. The pressure increase is rather slow with the ion source ramping up at that moment. Considering the hypothesis that a plug existed on the HEX and even if the pump speed was reduced to low values, 165rev/min (20Hz) since there was concern about the vibration levels, probably at that stage the LBE was filling the diffusion chamber. Moreover, at that time the ion source was hot for the extraction of stable beam, which would evaporate the LBE getting close to it. It was decided to stop the pump and heating elements for precaution, second circle in red in figure.19 and figure.20, and the pressure stabilized, figure.23.

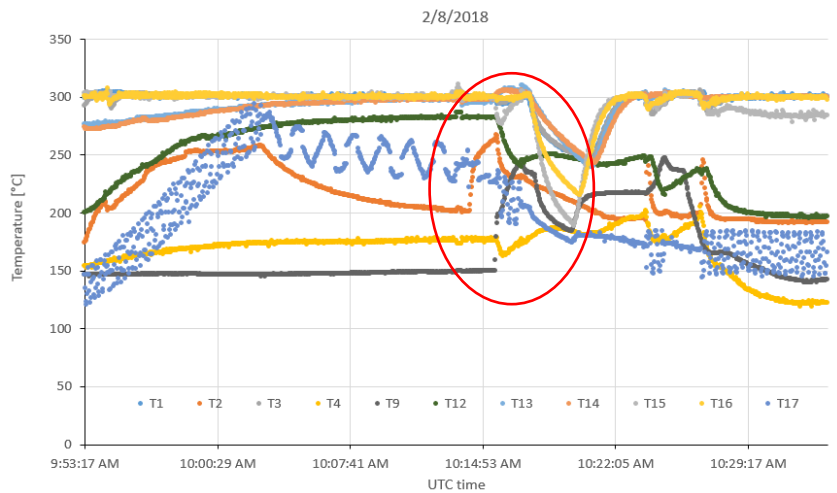
Figure 24: Closer look to the temperatures in the second circle in red from figure.20, from 10:53am to 11:36am

Following closely the temperatures in this period, figure.24, after reducing the pump speed around 10:05am T2 temperature slowly decreases following the LBE temperature from the channel. At 10:12am, coinciding with the pressure increase in the target, T2 temperature increases showing a possible plug. As soon as the flow seems to be restored, from T2, T9 temperature increases drastically matching T12 (irradiation chamber temperature in green) and then lowers following the tendency of all other temperatures because of the HEs being down for precaution, circle in red, figure.24.

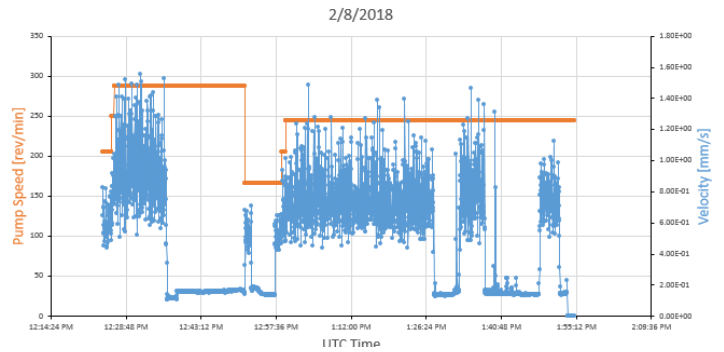
Figure 26: Vibration and pump speed from 12:20pm to 2pm

It was tried to quickly recover the flow bringing up the HEs as fast as possible and using the pump to heat the channel. High cavitation was detected once more, figure.26. The HEX temperature lowered very rapidly and only reached back 120°C after some minutes. It seems clear that the loop was plugged again. The ion source was quickly recovered and a mass scan was attempted. However, the anode showed short-circuit when putting any voltage. A clear sign that the source was coated with LBE. Nevertheless, in a first instance the ion source was ramped down to see if it was a dilatation problem from the cathode. From the target pressure, similar behavior as figure.11 was seen. The pressure was reacting to the increases in pump speed and loop temperatures. Then, again, the pressure interlock triggered, figure.28.

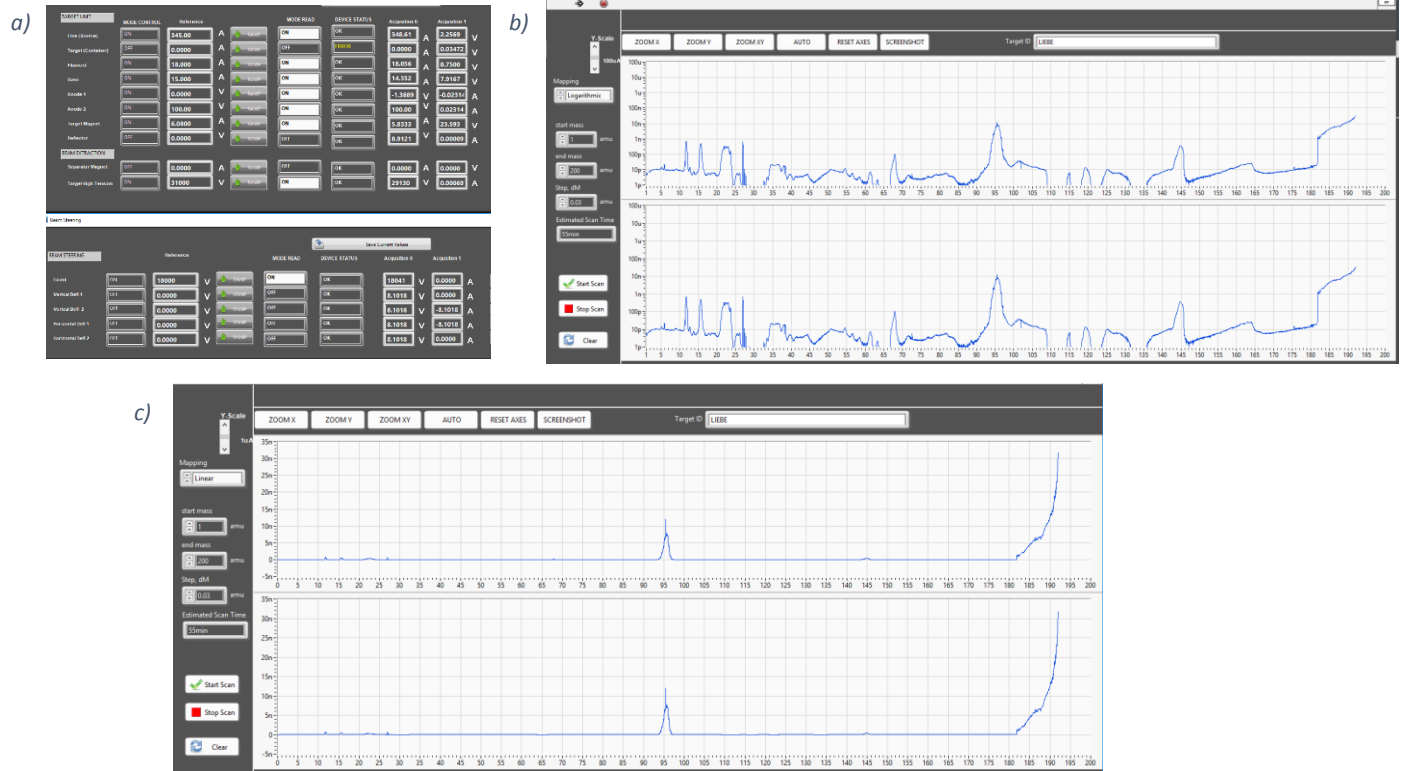
Figure.29: a) Parameters of the ion source b) Mass scan in logarithmic scale, c) Mass scan in linear scale

With the LBE cold it was possible to use the anode and a mass scan was done. It was noted that the current drawn by the high voltage power supply was high. The transfer line heating was tested and the temperature reached was 340°C with oven at 15A. The parameters of the source and the results are in the following figure.29.

The mass scan didn't reach the final mass set to see the lead and bismuth contamination in the beam. However, it can be seen from the mass spectra that the current increases drastically when getting close to 200 mass. Manually setting the magnet to 208Pb the current value found was 170nA. After the scan, the loop was left overnight warm, 200°C on all HE, and the ion source also at nominal temperature to try do a mass scan with a flow of LBE next day.

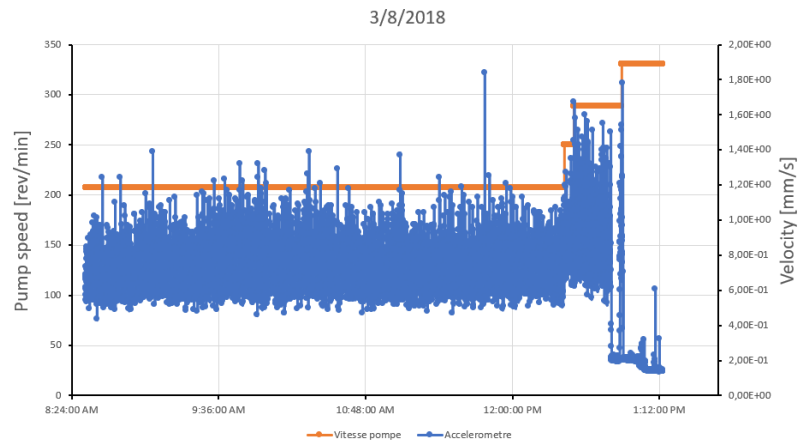
Figure.30: Vibration and pump speed during the mass scan

High vibration was detected, which could indicate a plug from what has been analyzed previously. The only particular effect that can be seen in figure.31 is the slow loose of temperature in T9, once more, no water-cooling was being used. Consequently, it could be argued that the loop was not unplugged during all this time. However, the vacuum is reported to be good during all the scan. Moreover, it was possible to operate the loop for almost 5h straight for the first time, but this could be explained by the loop not getting unplugged. The fact that the pump was set to a slow speed, can be also a factor to unplug the loop and to affect the pressure in the front-end.

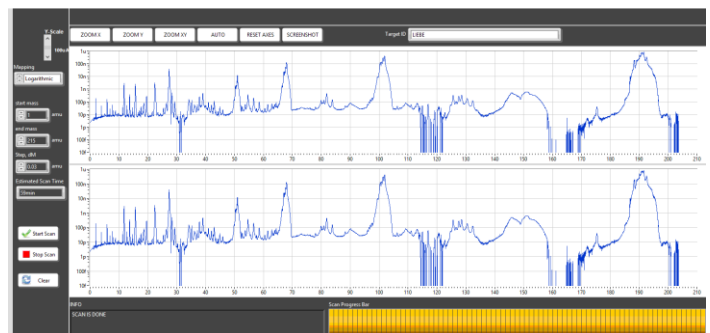
Figure.32: Mass scan on the 3/8/2018

After a night with the target warm, it was possible to put voltage on the anode. The pump was set to 206 rev/min and a mass scan was started with the loop conditions that can be seen in figure.30 and figure.31. It was tried to keep the same conditions throughout the mass scan, figure.32. Again, the mass scan did not reach the Pb and Bi masses. Centering manually on mass 208Pb, 2 μ A of current were seen.
