**ALARA level II – Group 1 - ISOLDE YETS 2017-2018 and operation 2018**

**Justification, optimisation and REX**

EDMS 1570850

24/08/2018

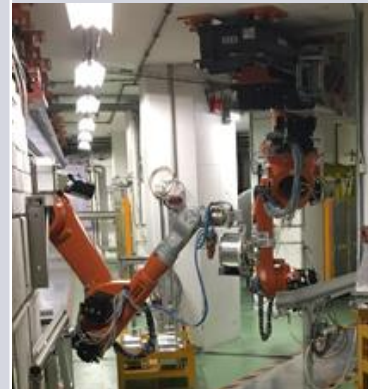
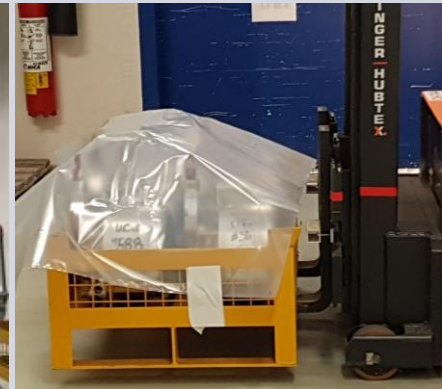
Transport done outside working hours because dose rate at contact of the truck may be > 2mSv/h

Targets placed in the boxes using the KUKA robot and transported by remote forklift

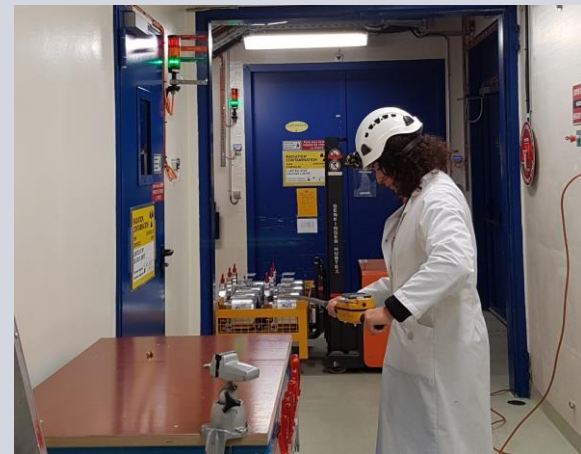
Distance kept free from cabin driver (an empty box or a box with cold targets is placed at the first position inside the truck).

RP measurements on truck done with telescopic monitor

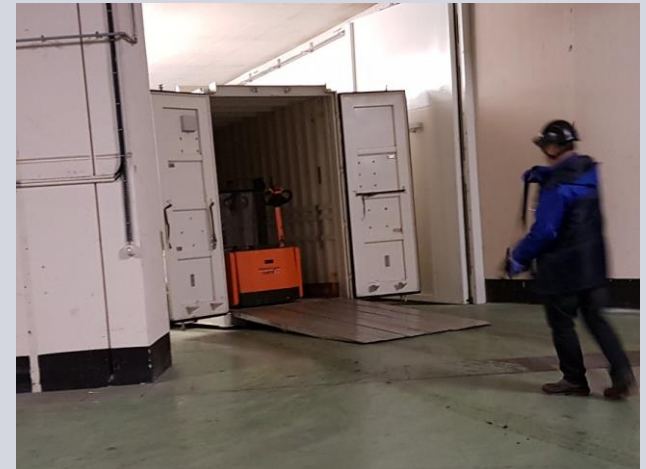
Communication with the robot operator established with walkie-talkies to avoid phone network problems

Forklift used to shield the last box (dose reduced during opening/closing of the truck doors)

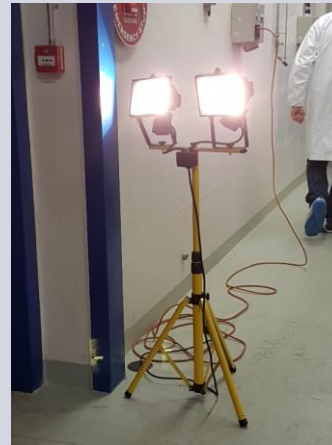
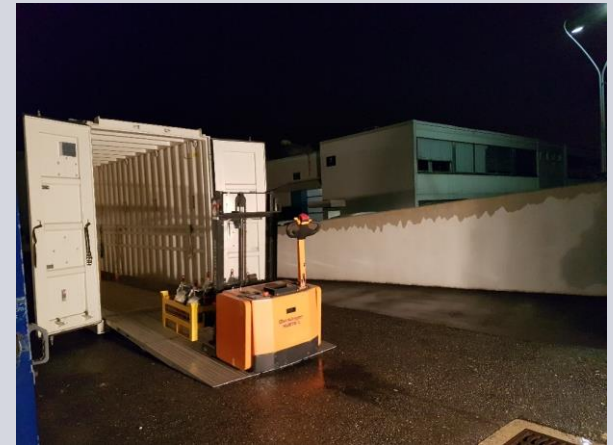
A = additional light projectors added at the entrance of blg 179

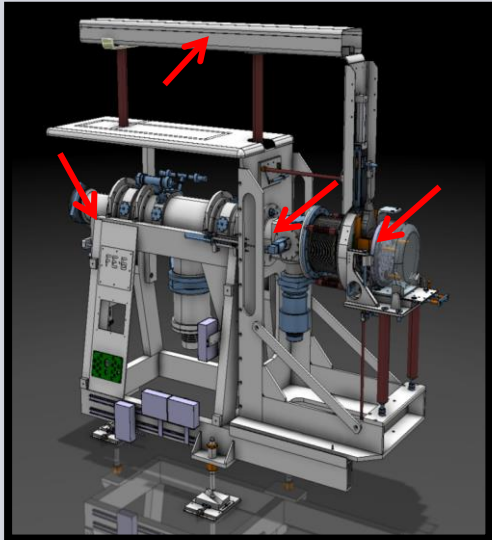
JUSTIFICATION	PICTURE
Lubrication to avoid failure during the operation year.

Cleaning to avoid sparking between ground and HV.	
Visual inspection to detect any anomalies.

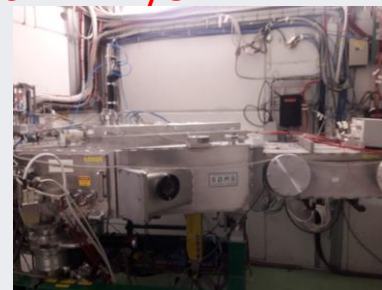
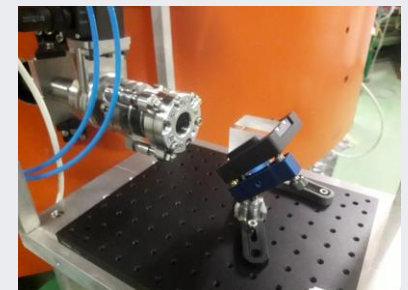
To pull the HRS window out from the flange once the outer window holder has been removed, the use a small suction pad (<30 mm diameter) is needed

**A= add to laser windows exchange procedure (EDMS 1132987 for HRS side and 1108892 for GPS side) / Bruce Marsh – EN/STI**

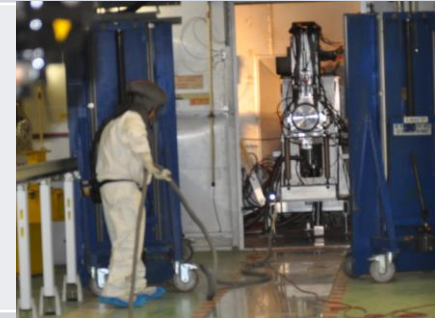
Shielding used to reduce dose rate during cabling installation on Boris Tube

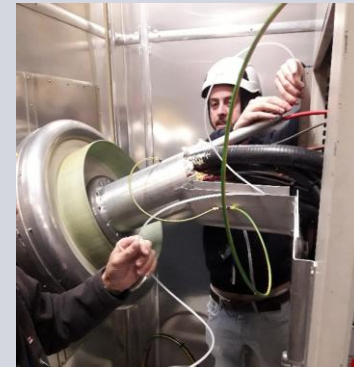
Cables pulled from the HV room (outside the highly radioactive area)

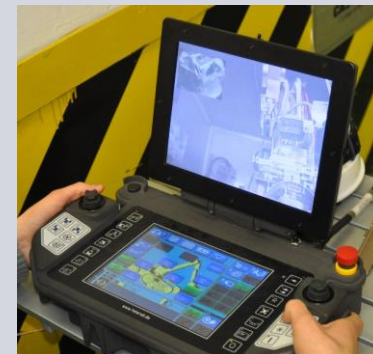
During decoupling of the compressed gas cable from the trolley by the Telemax, involuntary pressing of the trolley's push-button is possible, which can cause the table to fall

**A= - the consequence of the accumulation of errors in several directions should be tested outside the controlled area in September 2018 by EN/SMM/ESA (geometers) and EN/SMM/MRO (telex operator) / Ferran Boix Pamies – EN/STI**

- Alignment measurements can be made by installing a camera at the Telex → No human presence would then be required for the alignment of LIEBE in the target area.

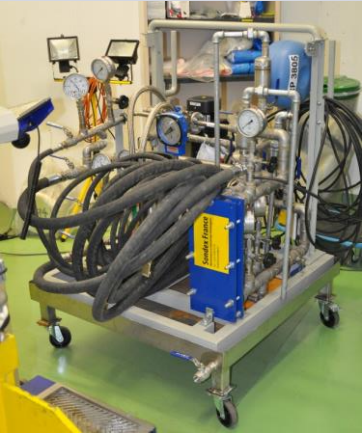
REX : SETUP OF THE SKID	RESULTS / ACTION / PICTURE	
<p>Time to setup the skid ~ 3min45            → Plan to unwind the cables in advance of the skid (loss of time to untangle the pipes)</p>	<p>A= to add in the new version of the WDP / Julien Riegert – EN/STI</p>

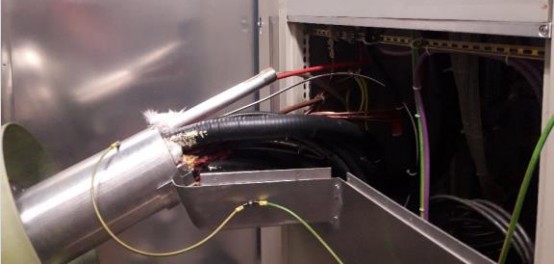
REX : PULLING OF THE CABLE (through the Boris tube from HV room)	RESULTS / ACTION / PICTURE	
<p>A 15m needle was pushed from HV room to GPS front end. The needle was unrolled and inserted straight without twisting.</p>	<p>R= It ensured a good introduction of the needle and avoided blockages inside the Boris tube.</p>

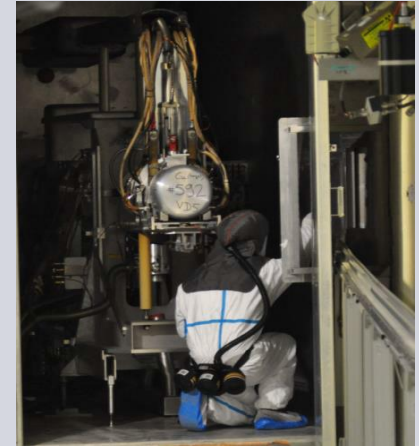
Interventions outside the Faraday Cage performed with Faraday Cage shielding and after 3 months of cooling time

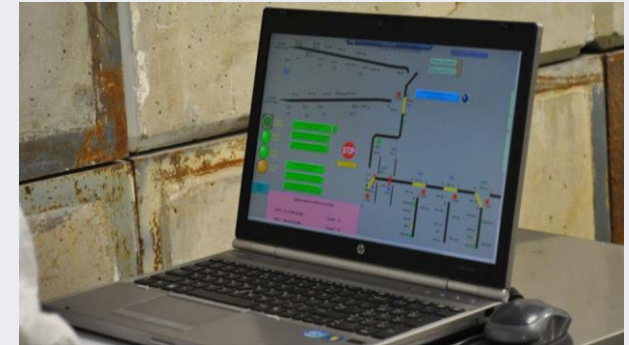
Most of the tests performed outside the high radiation area

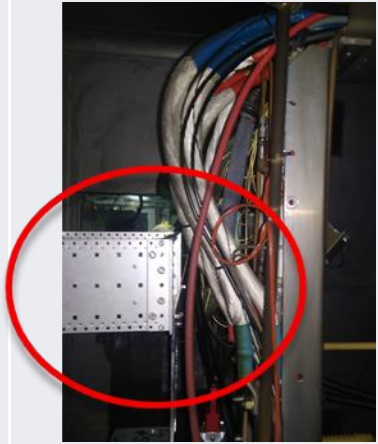
<p>Verification of RF cable was performed from HT room after confirmation of the procedure at offline</p>		
<p>Coupling was tested after this modification and was conclusive</p>		
<p>For the robot test including the transducer box setup on the GPS plug target #593, the clamping of the target was not possible due to presence of cable on the Front-End which collided with the transducer box</p>	<p><b>A=</b> the design was modified (reduction of the height between the support and the transducer box and 90°rotation of the transducer box)</p>
