Fermilab Coil Fabrication Status and Non-Conformity Report

9th HL-LHC Collaboration Meeting at Fermilab – 14-16 October 2019

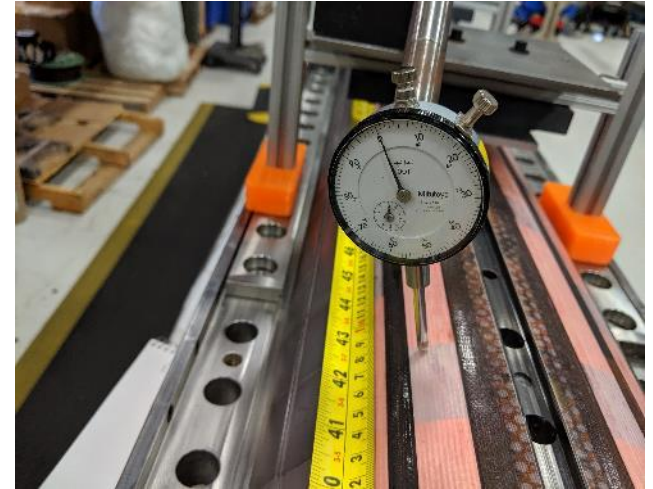
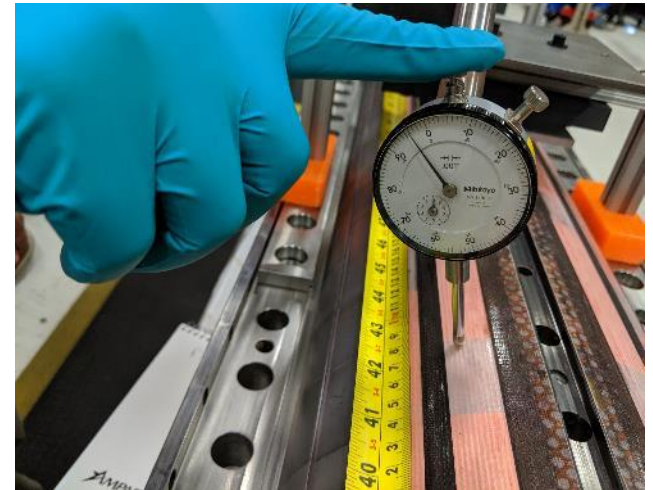
DR-11878, QXFA118 Roped Cable & Strand Damage, **Rejected**

- On August 15, 2019 outer layer cable roped
 - 15th turn on the transition side (2 turns after wedge)
 - Due to hard way bend against the white roller.

- Strand damage likely caused by the strand dragging against top edge of vertical guide roller(s) after the cable collapsed.

- Obtained final disposition of coil QXFA118
 - Reviewed by conductor & cable folks
 - Dispositioned by Giorgio Ambrosio
- Back wound coil to retrieve all parts: wedges, pole pieces, end parts
- Adjusted boom to nominal position
- **Designed & procured taller rollers**, due end of Oct.
 - Mitigate strand damage
- **Boom position checked prior to each coil winding.**
- Coil QXFA119, inner layer completed on Selva.
