Coil fabrication status at CERN

Susana Izquierdo Bermudez

9th HL-LHC Collaboration Meeting

14-16 October 2019

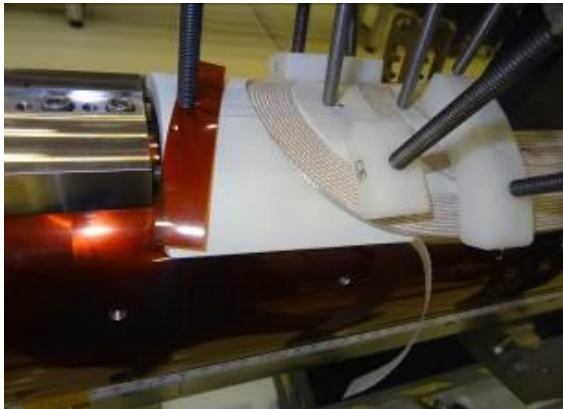
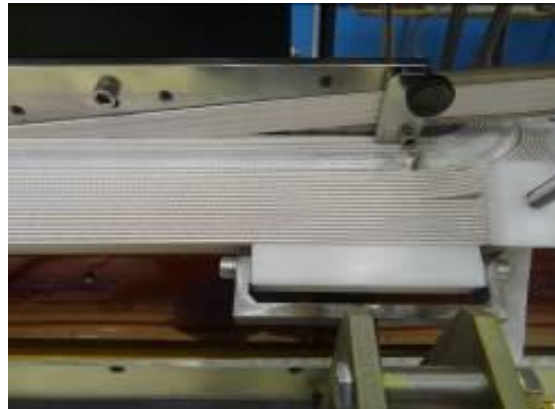
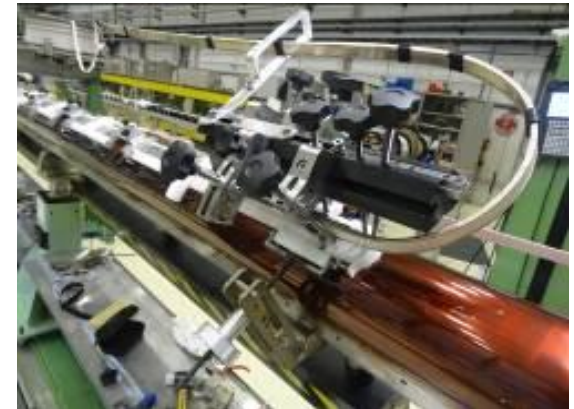
- We went through a in depth review of the procedure during the de-bugging phase, to align the experience short-long coils. The more controversial one where we did not converge:
 - Short coils: Winding tension on short models is kept constant with 25 kg
 - Long coils: 19 kg turned out to be adequate in terms of tension/instability. On the pole ends it is reduced to 7 kg while the manipulator rotates around the pole end, afterwards increased back to 19 kg.

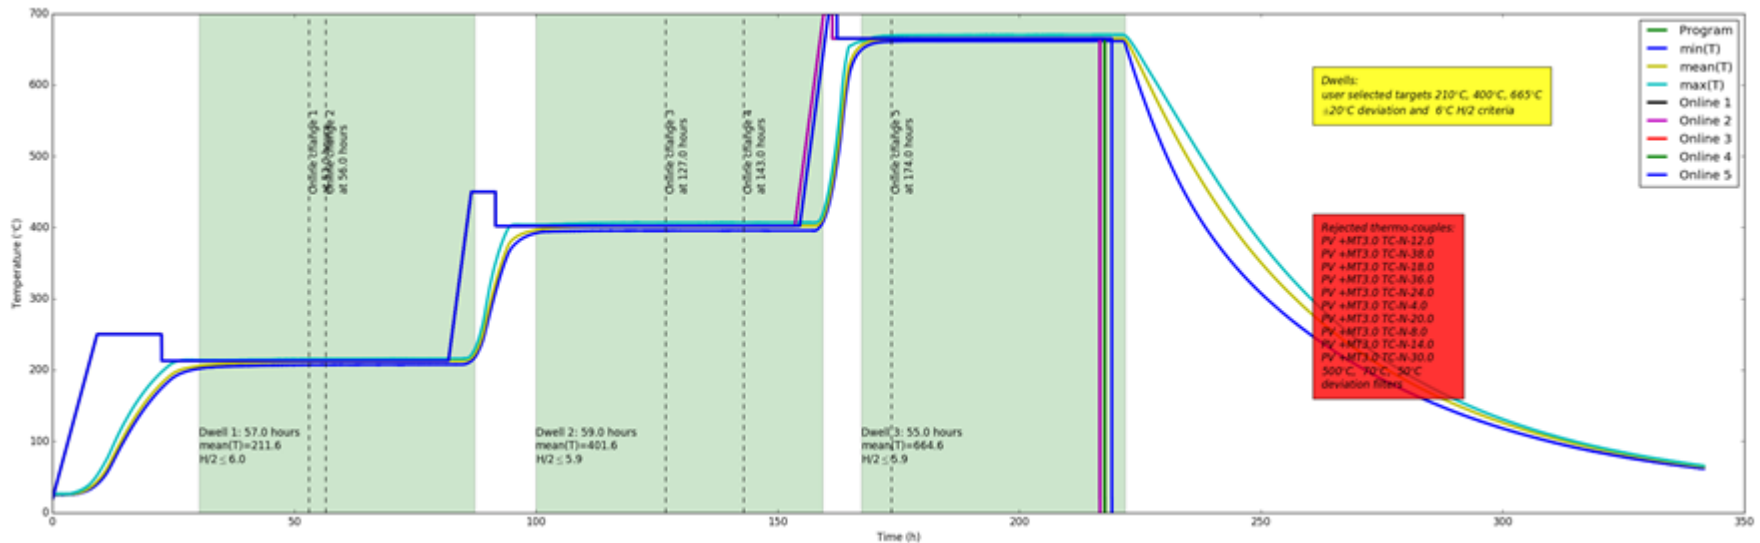
Temperature profile for coil 109

- Fine tuning of the oven parameters requires on-line adjustments of the plateau lengths and temperature, including boosts.
- Practice coil 003 was used to finalize the heat treatment parameters, aiming at react coils (from coil 110) without the need of on-line adjustments.

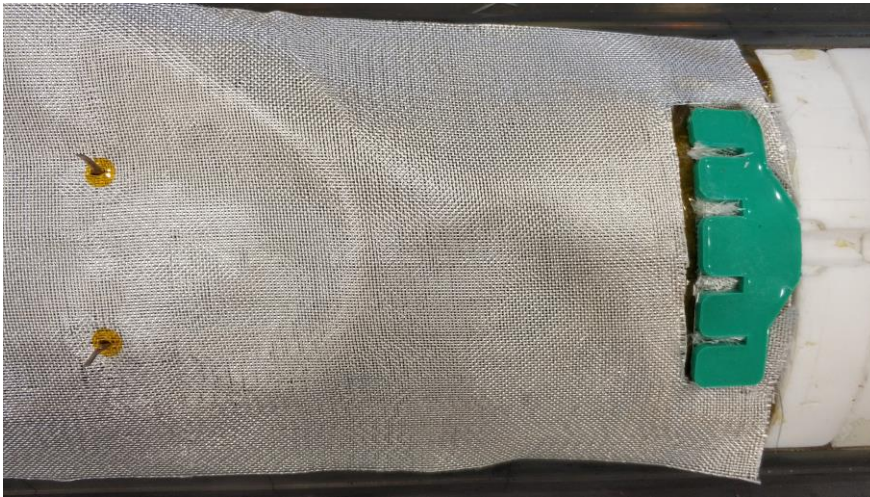
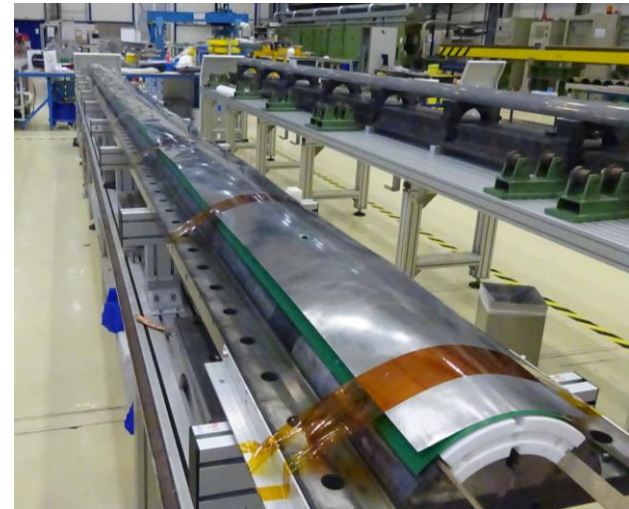
- Coils 204-003: External quench heaters
 - Difference on coil outer diameter compensated by introducing a 0.3 mm thick filler in between the two liners.
