Status of the CM4 repair work

W. Venturini Delsolaro and M. Therasse, on behalf of all the CERN teams involved

ICCC meeting- 1 July 2019

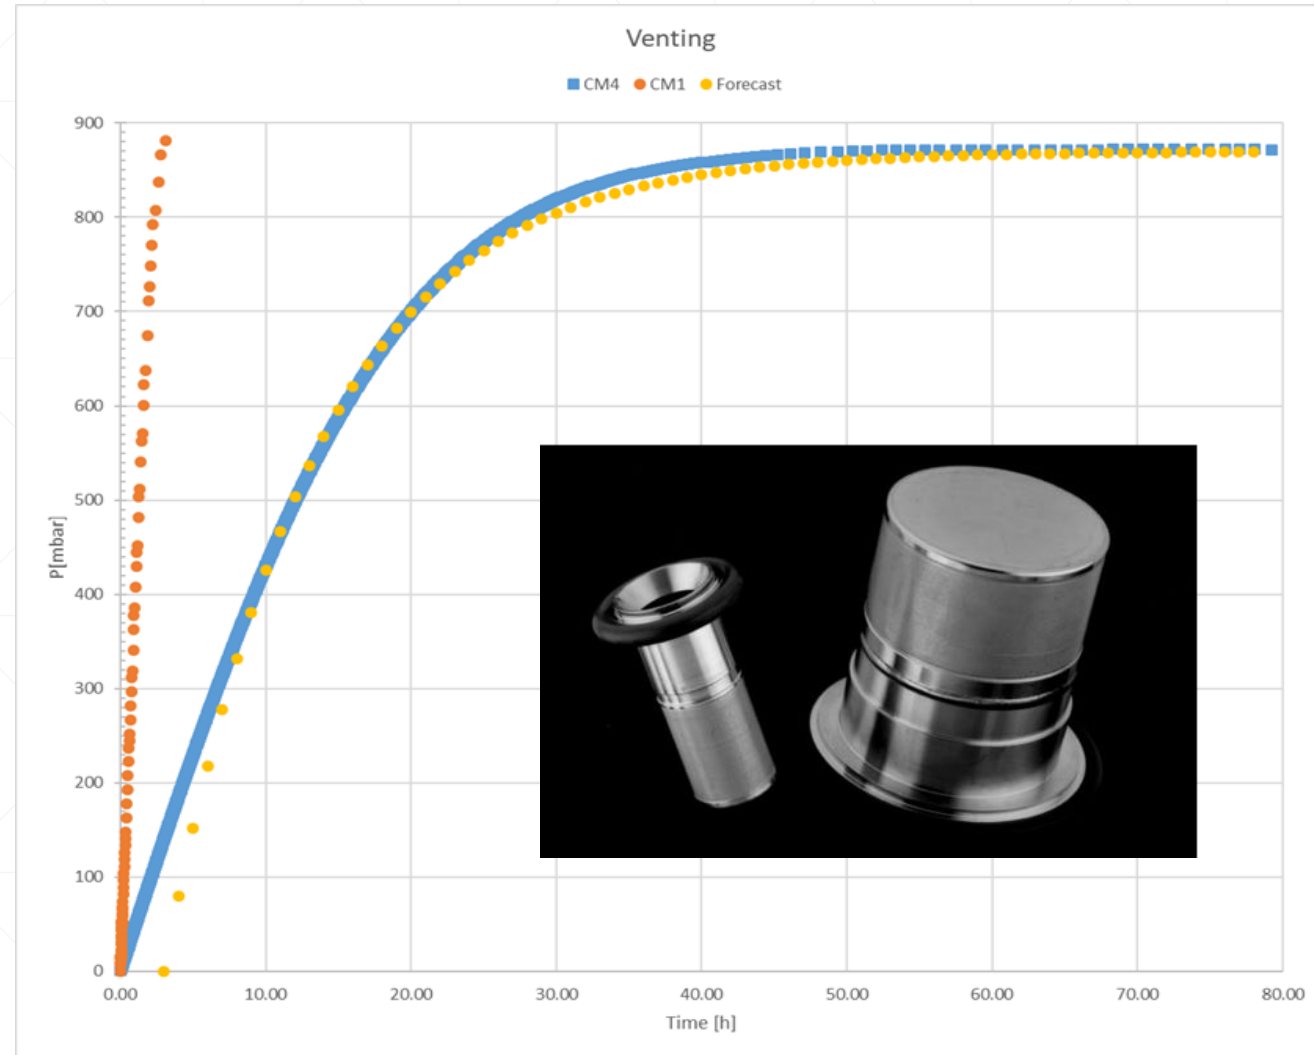
Venting from the top has the advantage the flow goes in same direction as gravity.

A diffuser filtering particles $\geq 0.003 \mu\text{m}$ was installed in the clean room. The space between the filter and the shutoff valve was assembled in clean conditions

Dosing valve to control the flow. This time we have targeted a venting time of maximum 2 mbar/min, final value was set to 0.8 mbar/min.
