# Electronics Lessons Learned from GE1/1

Gilles De Lentdecker    **Laurent Pétré**

October 2, 2019

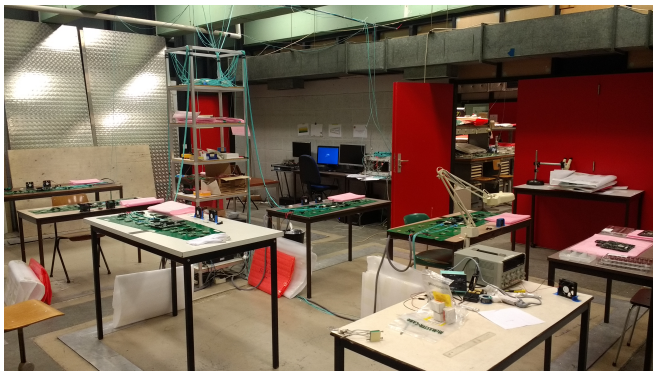
# Plan for failures

- ▶ Allow to test 6 electronics sets "simultaneously"
- ▶ Crucial to increase the throughput
- ▶ Coordination required for access to the CTP7
- ▶ Re-used testings components can also fail:
  - ▶ FEASTs
  - ▶ VFATs

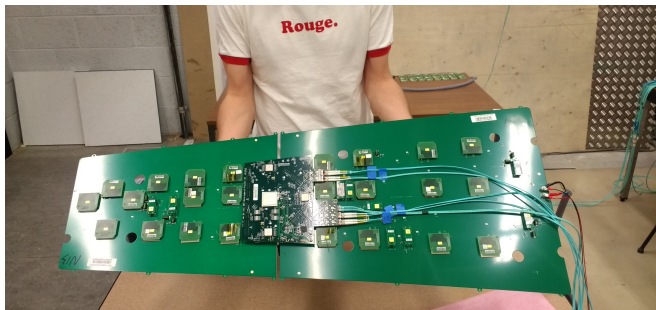
## Two parts design

- ▶ Two pairs of SAMTEC connectors with complex geometry
- ▶ Difficulties to mount the OptoHybrid on the two GEBs
- ▶ Alignment (and cleanliness once again) are crucial
- ▶ Should minimize the mechanical stress on the SAMTEC connectors
- ▶ The 3 components can easily be handled alone once assembled
