KM3NeT Qualification Penetrator Base Module OFP Report of the tests

KM3NeT_QUAL_2019_002

CPPM

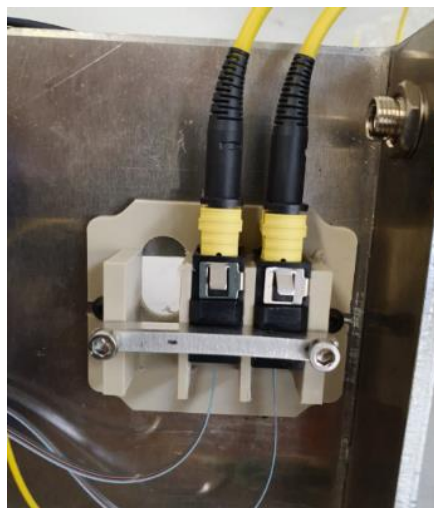
Figure 5: details of the MPO adaptors mounting

The PMO connectors, that were also included in the qualification tests, were mounted on the internal support by using 3D printed piece as shown on the Figure 5. This mechanical configuration, defined for the qualification tests, is not the final one, which will be used for the base module integration.

- The optical components needed to pass from the 12 fibres ribbon to the 12 individuals fibres that come with the MPO connectors to be operated in the base module (MPO/APC -12 LC/APC - as described in the next part) were included in the climatic test but not in the mechanical test)
- The MPO connectors mechanical supports shown in Figure 5 are not the final design that could be used in the ARCA or ORCA base modules

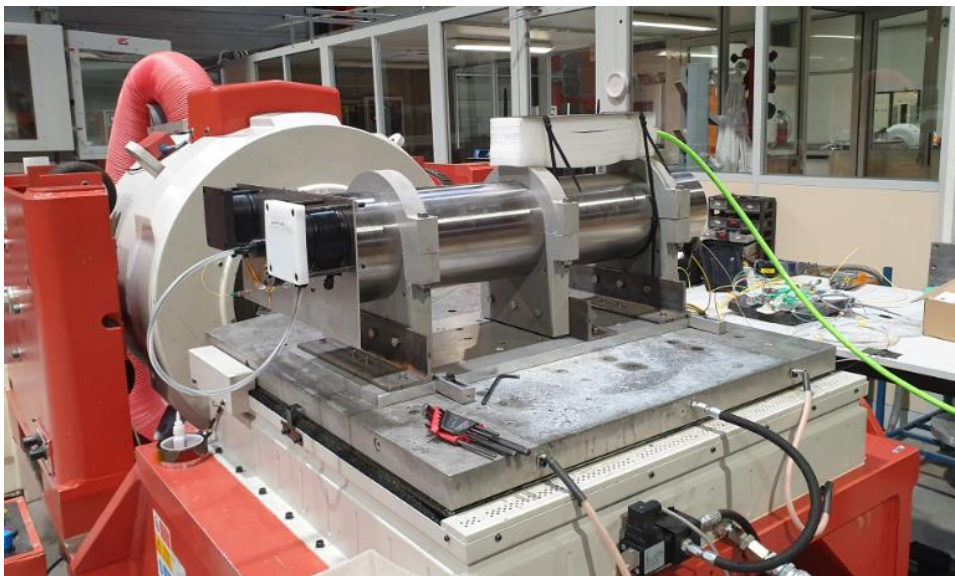
Figure 8: set up in the transversal mode

The vibration test was stopped after 2 minutes due to a mechanical fixation not well tight. The nuts were tightened before to resume the test.

It was noticed that the plate where the two BoBs were mounted oscillated a lot when submitted to the certain frequencies of the vibration excitation. A try have been made to limit the amplitude of these oscillation by the use of plastic collars.

No problem detected after the tests

The visual inspection does not reveal anything suspicious

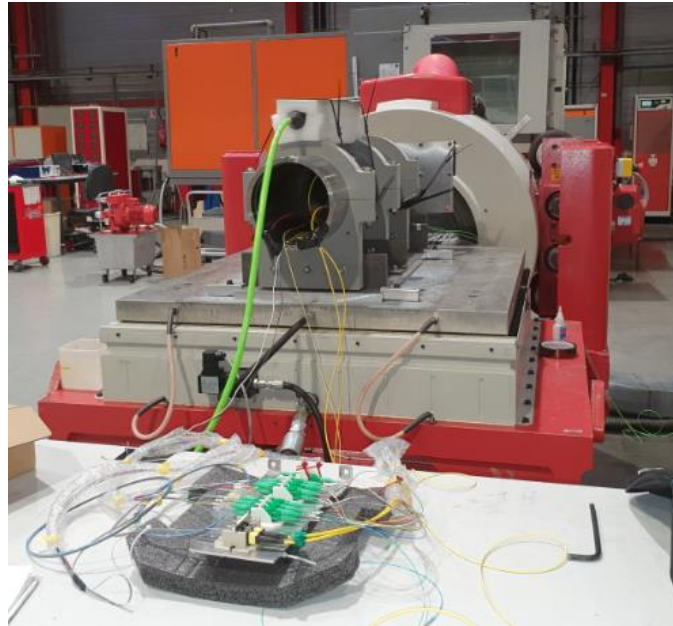
Figure 9: set up in the axial mode

In the middle of the shock sequence, the cylinder started to slide inside its support. So the tests was stopped around 5 minutes in order to put it back in place and tighten the fixing screws

No problem detected after the tests

The visual inspection does not reveal anything suspicious
