Report: #22

Activity: PS complex

17th February 2020

LS2

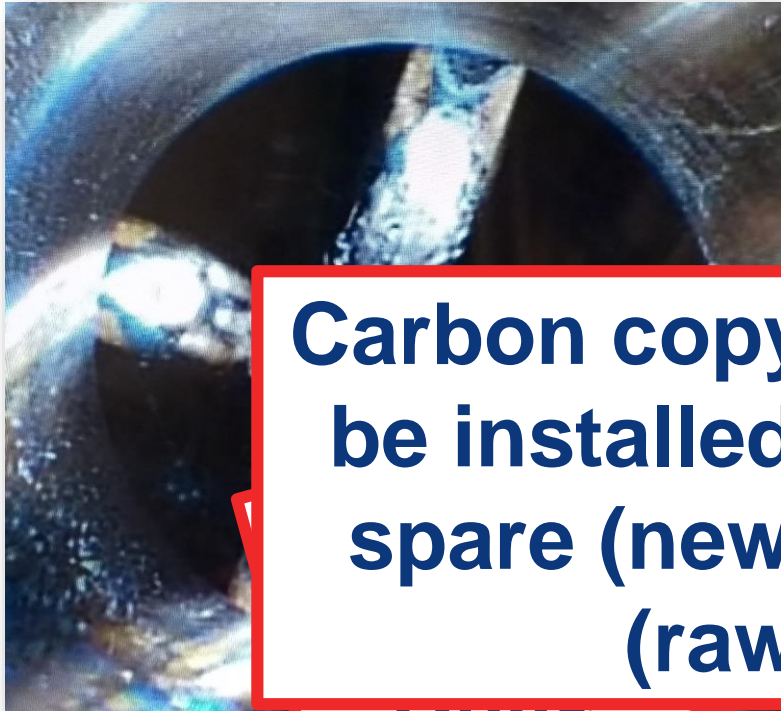
Endoscopy of LINAC4's RFQ:
Damage on the surface of the vanes
Impact on operation
Produced with tolerance 0.02 mm
and Ra 0.8

Carbon copy spare started. To be installed in test stand. 3rd spare (new design) starting (raw material)

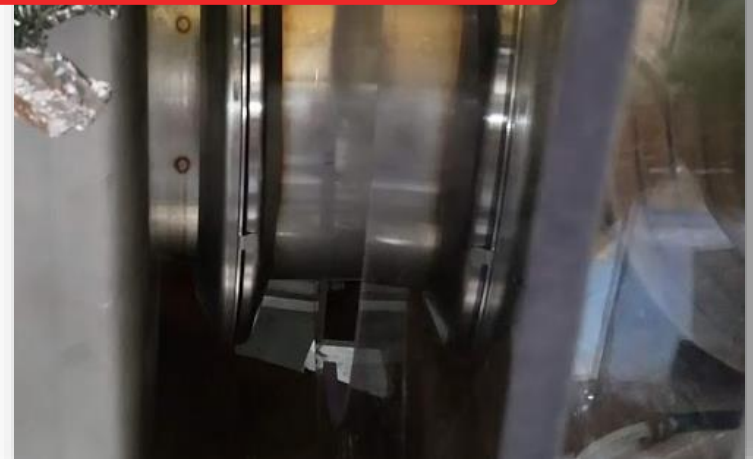
- ❑ Still issues to... bypasses
→ This could have... impact in the progress and ISTs
- ❑ Error during the installation of the first batch
→ Short-circuit through the seal
- ❑ Very poor design → Redesign after LS2
