Update MBHA-001 test results of the first cool down

2019 December 4 – 11T technical meeting

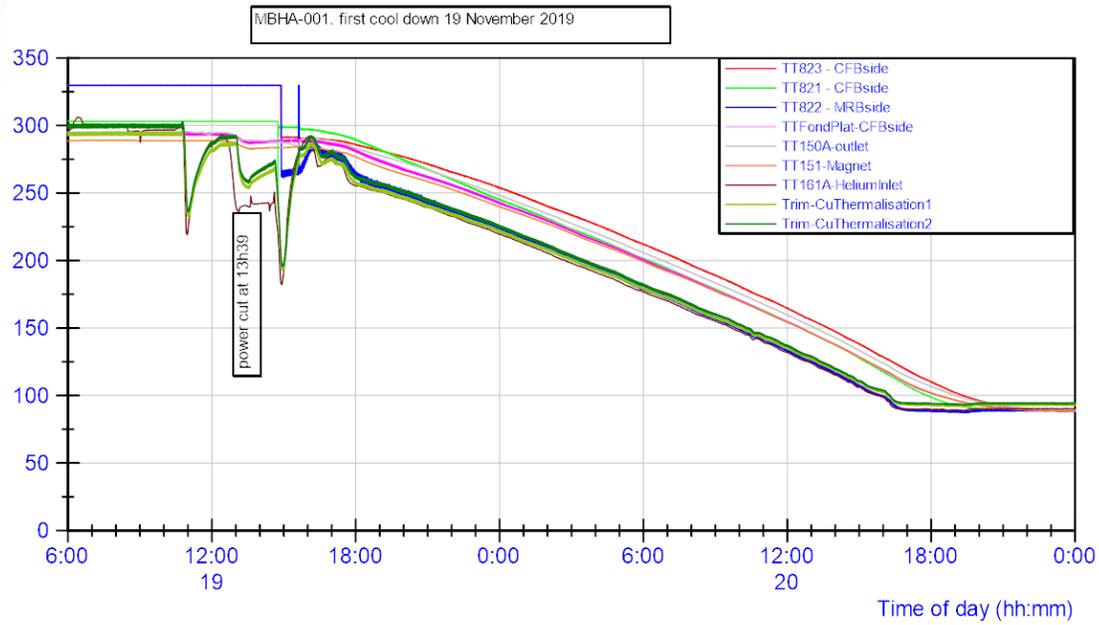
Cool down from 300 to 80 K. Delta T of 30 K.

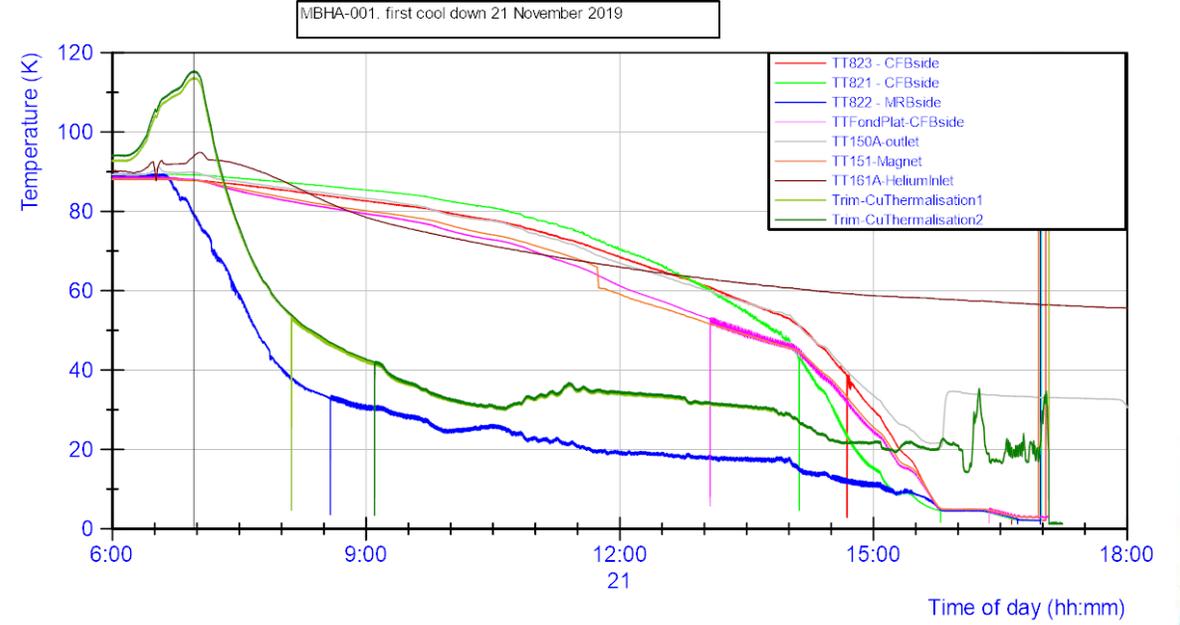
Cool down from 80 K to 1.9 K.

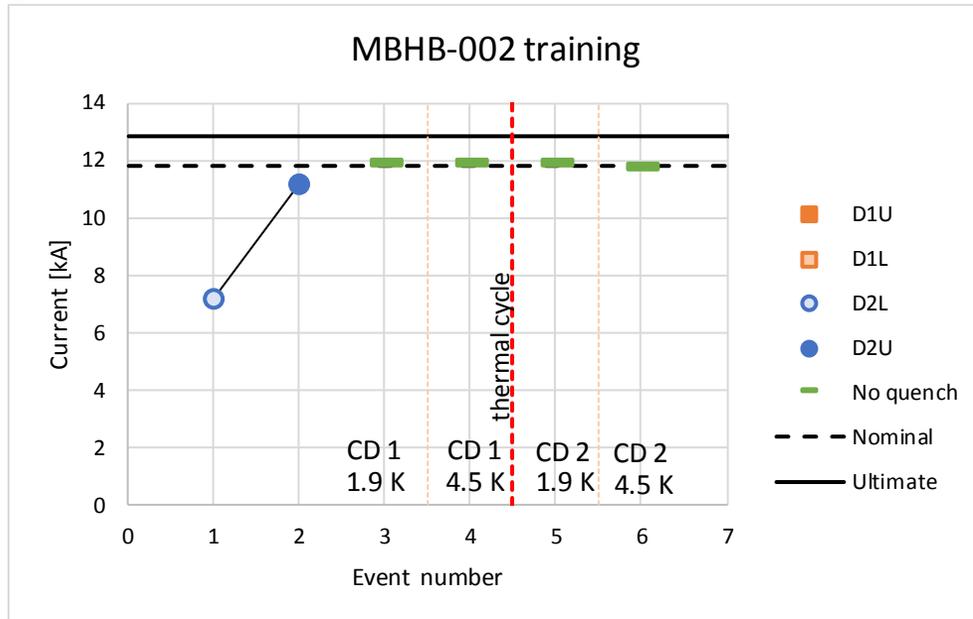
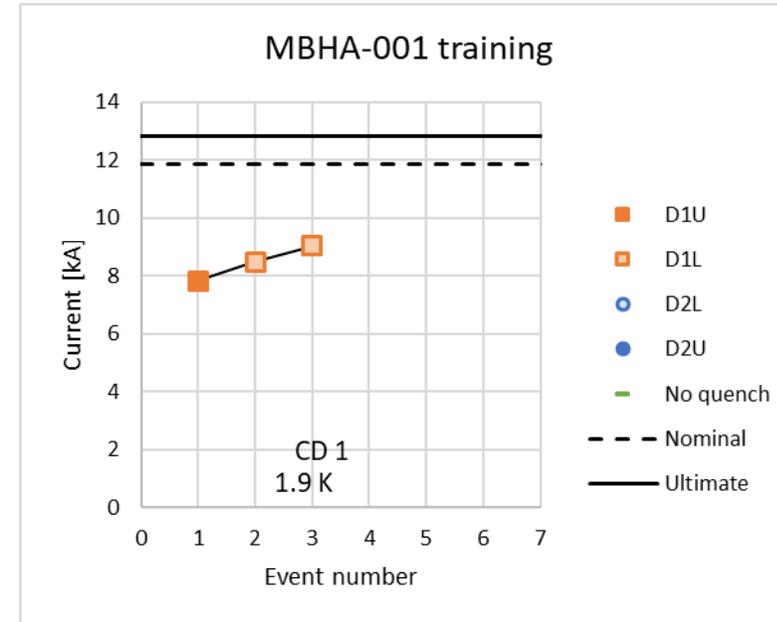
3 training quenches before powering was aborted due to other reasons.

Too few quenches to give any prediction, no show-stopper in training so far.

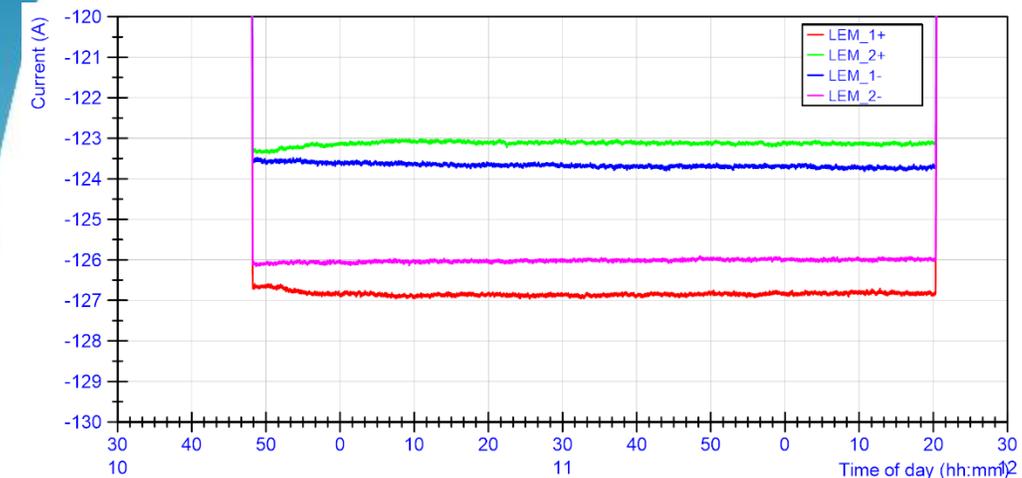
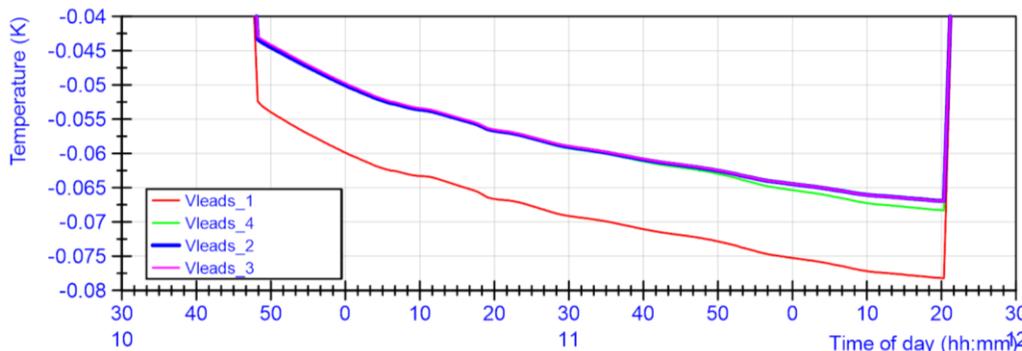
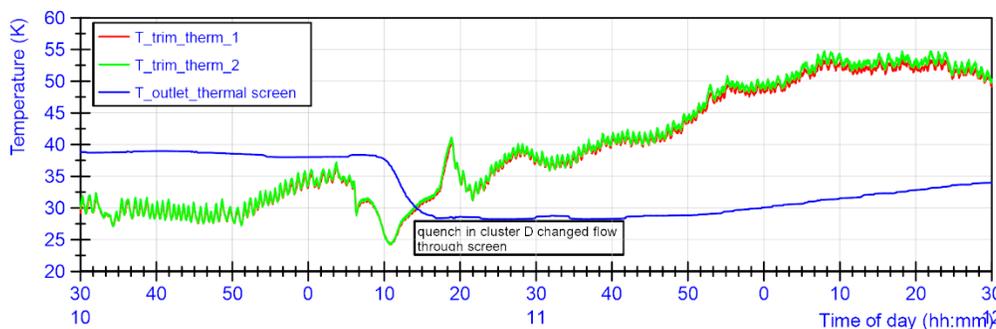
Trim leads

1.5 hours test at 250 A done.

Temperature and voltage still drifting after 1.5 hour.

Helium gas exits the thermal screens (30K-40K depending on pressure of the cryolines in the building) much colder than the trim thermalisation point (up to 53 K). The helium heat capacity is not fully used.

Data not fully analysed.
Two more tests were done.

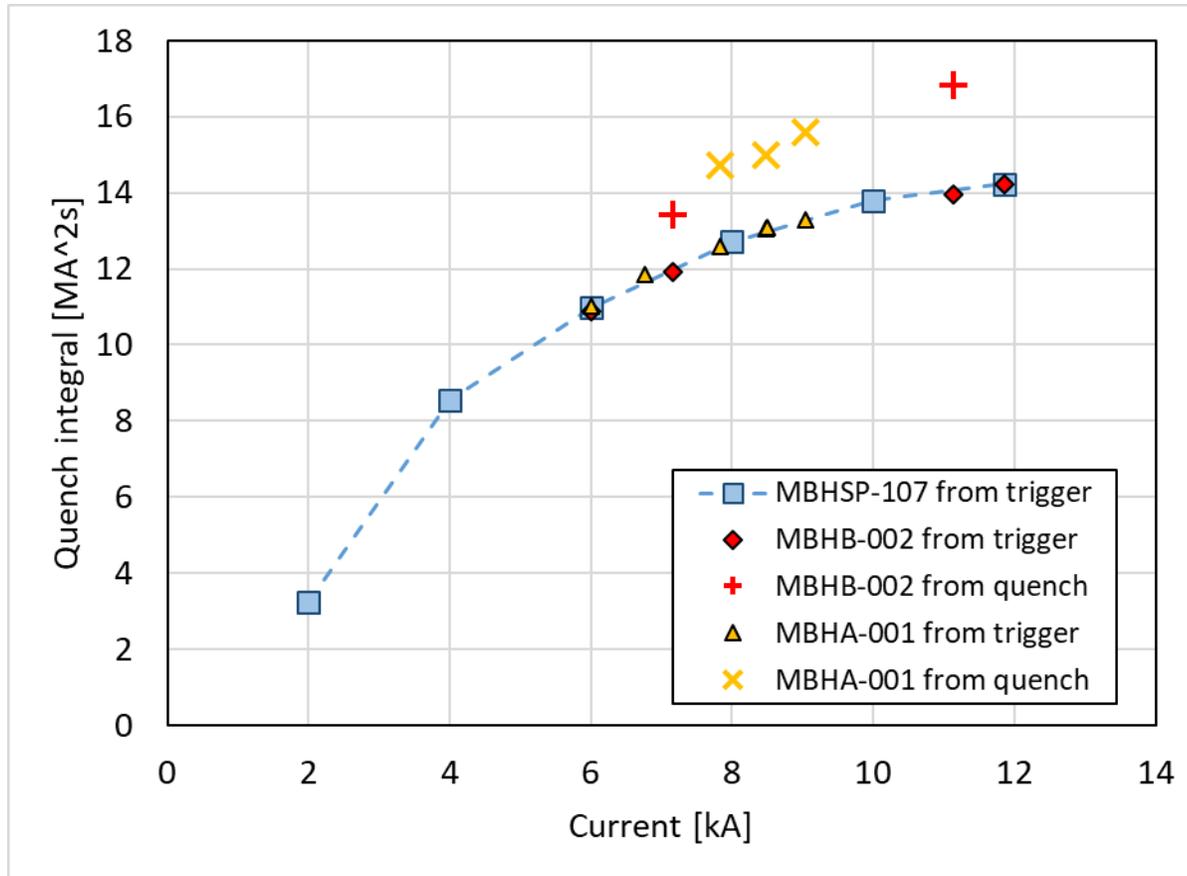
Quench integral from QH firing as expected

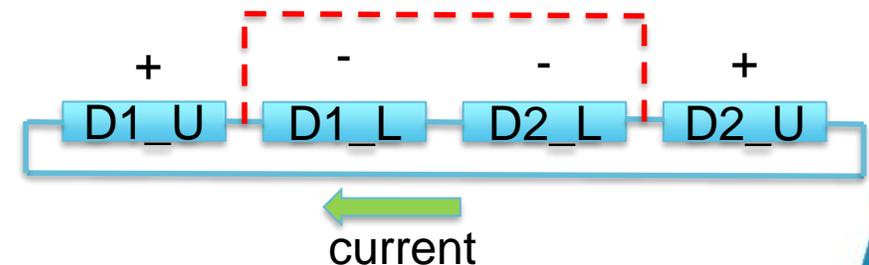
This symmetry, and the spikes appearing and disappearing give immediately the idea of an **intermittent short between the two inter-coil points**

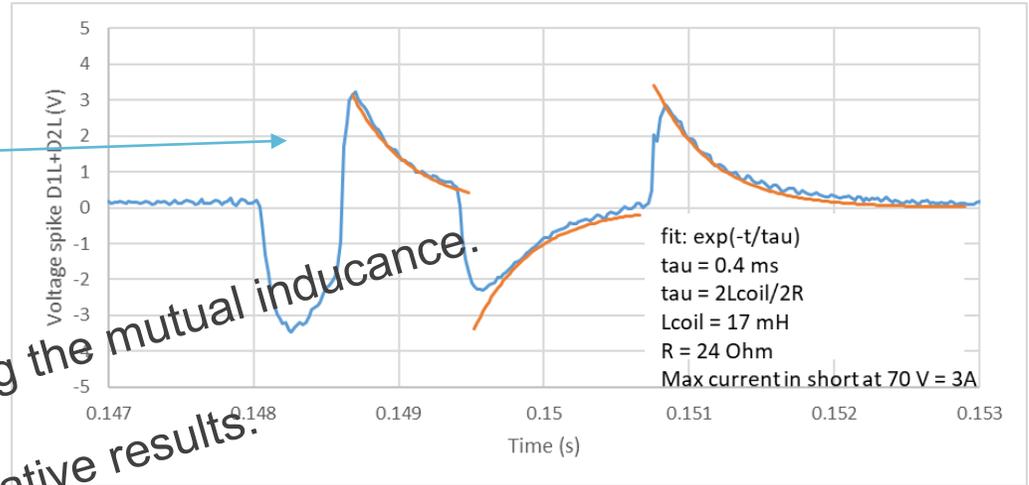
Method 1: time constant and L/R

Simplified approach to model the short, not including the mutual inductance. Qualitatively sufficient. See slides by Emmanuele for more correct quantitative results.
