ELQA tests of 11 T series
magnet

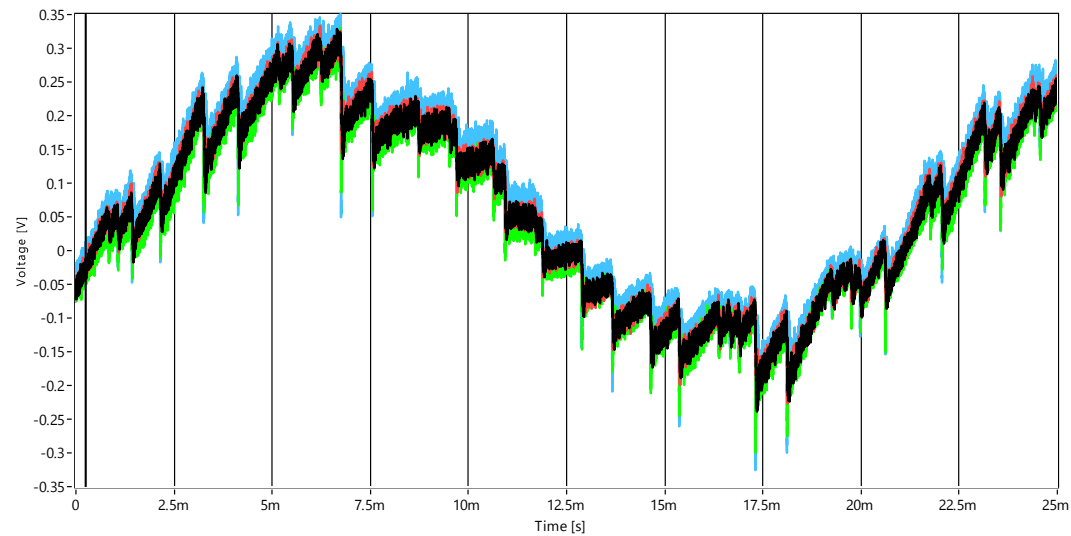
Scope data - 20191203_101642400Wfm

50 Hz noise chopped with fast transients, unknown origin, most likely external to the magnet

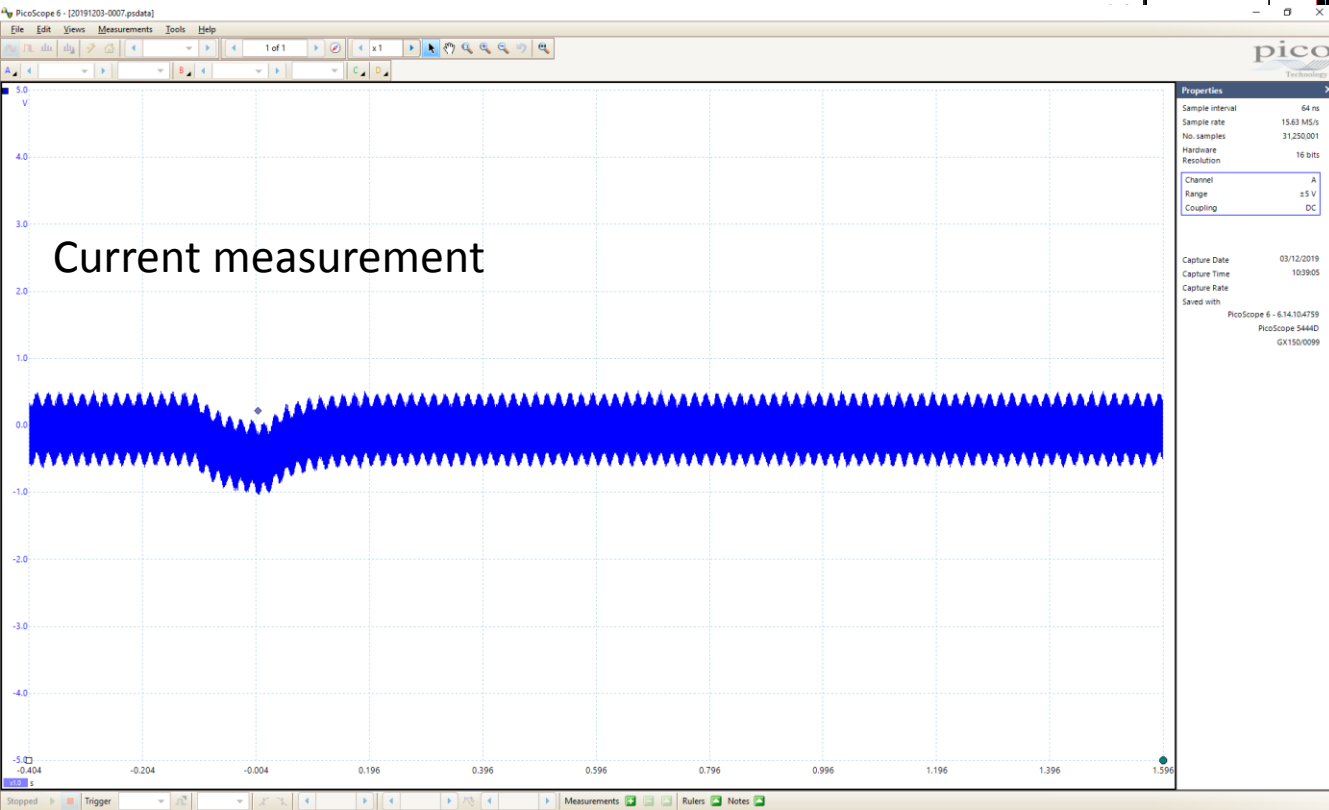
Current measurement

- High leakage current that appears at about 2 kV during the HV test was observed with both instruments (SM18 and ELQA)
- The high leakage current is not acceptable for the installation in the RB magnet chain
- Multiple measurements were performed testing various scenarios
- Very difficult to localise this kind of fault, especially in a superconducting magnet
- The fault location cannot be clearly identified
- If the fault persists at warm, the fault localisation will be much easier
- The capillary has to be kept for future studies
 - Confirming or excluding the fault in the capillary will be very useful for the magnet
 - If the fault is in the capillary, it is a very good study-case
 - The capillary has to be handled with particular care during and after the removal from the magnet
