# Quench Analysis

## MBHA-002

### Quick upate

### 04 Febuary 2020

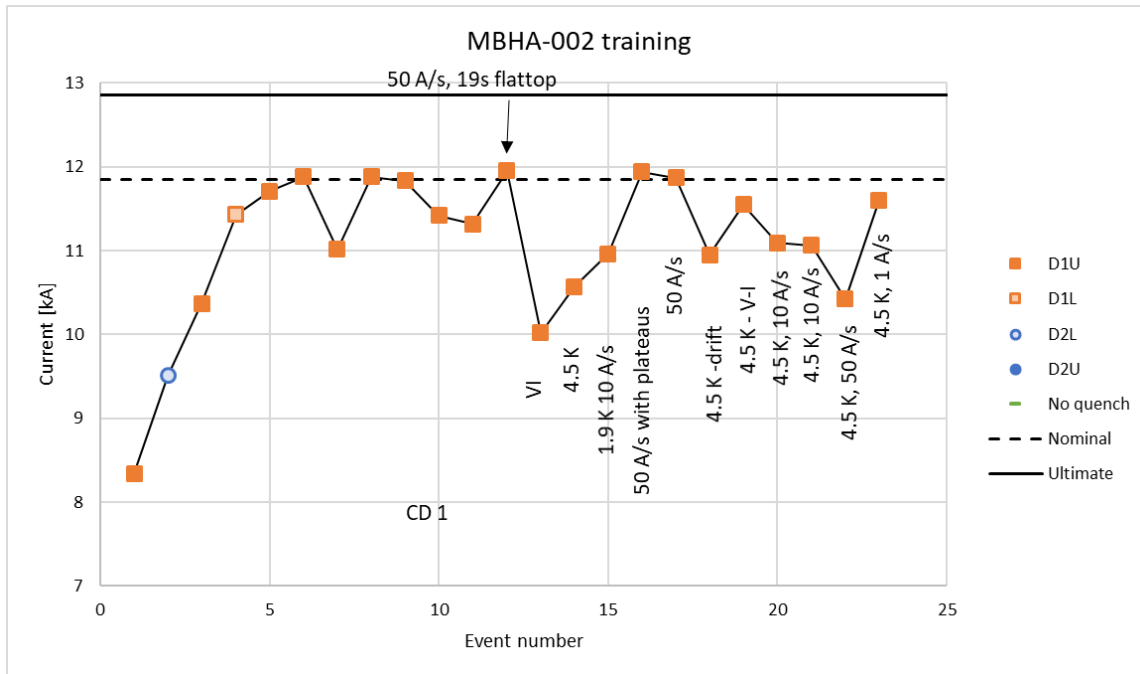
# Quench history

Ramp rate	Temperature	Current	Precursor	Location	Location	QA	LQA
1	10	1.9	8.34	Yes	D1U	CS	head	1 and 2
2	10	1.9	9.51	Yes	D2L	CS	head	1
3	10	1.9	10.37	Yes	D1U	CS	head	1
4	10	1.9	11.43	Yes	D1L	CS	head	1
5	10	1.9	11.71	No	D1U	NCS		5
6	10	1.9	11.88	No	D1U	NCS		5
7	10	1.9	11.015	No	D1U	NCS		5
8	10	1.9	11.88	Yes	D1U	CS	head	1
9	10	1.9	11.83	No	D1U	NCS		5
10	10	1.9	11.42	No	D1U	NCS		5
11	10	1.9	11.32	No	D1U	NCS	head	<1 (shifted)
12	50	1.9	11.95	No	D1U	NCS	head	3
13	VI	1.9	10.02	No	D1U	NCS	head	3
14	10	4.5	10.57	No	D1U	Straight	~40-50 cm from head	>11
15	10	1.9	10.96	No	D1U	NCS	head	3
16	flattops	1.9	11.938	No	D1U	Straight	~40-50 cm from head	
17	50	1.9	11.87	No	D1U	NCS	head	<1
18	10	4.5	10.95	No	D1U	Straight	~40-50 cm from head	>11
19	V-I	4.5	11.55	No	D1U	Straight	~105 to 115 cm from head	>11 (shifted)
20	10	4.5	11.09	No	D1U	NCS	head	<1 (shifted)
21	10	4.5	11.06	No	D1U	NCS	head	<1 (shifted)
22	50	4.5	10.42	No	D1U	NCS	head	<1 (shifted)

23	1	4.5	11.6	No	D1U	Straight	~105 to 115 cm from head	>11
24	10	1.9	ongoing

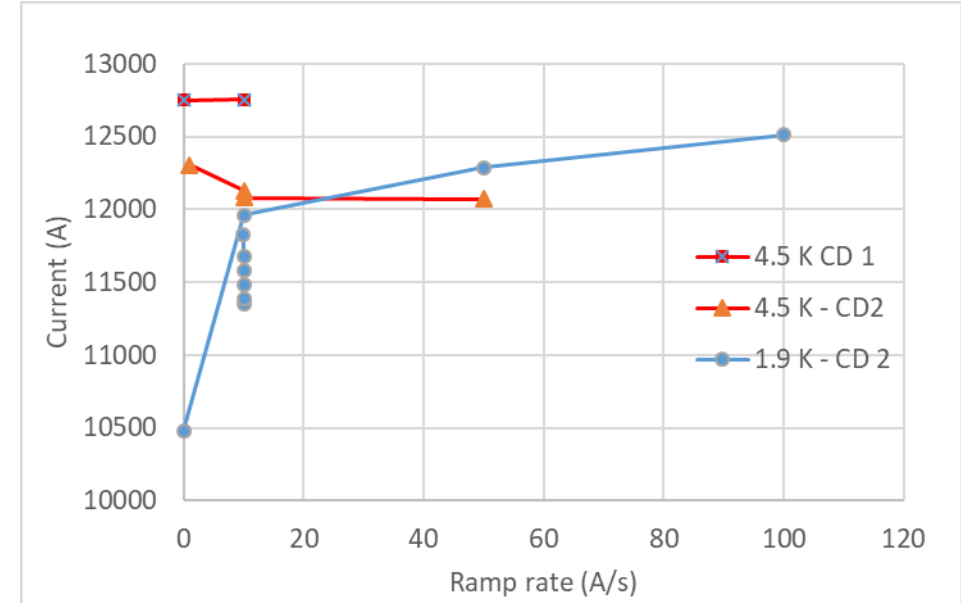
For comparison MBHB-001 hybrid

Instability at 1.9 K at 10 A/s.

Reproducibility at 4.5 K at 10 A/s.

4.5 K higher ramp prate gives lower quench current

4.5 K highest quench current with very low ramp rates

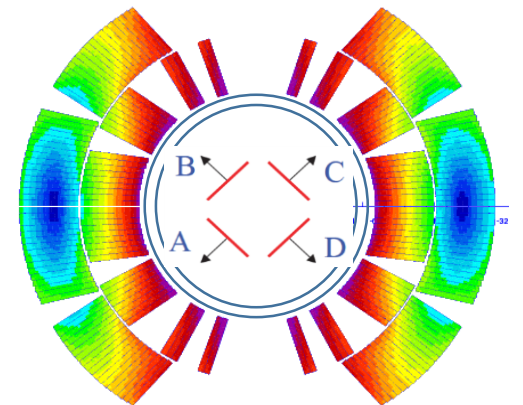
# Conclusion

- Coil D1U has a clear damage
  - Decay in V-I curves indicate current redistribution -> Local defect
  - Voltage buildup starts at very low current -> severe damage to some of the conductor
  - 3 quench locations:
    - We believe that the 50 A/s ramp at 4.5 K forces the current through the defect the most and may indicate the location of the defect. The defect is therefore most likely in the head.
    - At 1.9 K the large variation in quench current indicates self-field instabilities
    - Quenches in the straight segment are assumed to result from current redistribution effects caused by the defect.
  - The pickup coils give propagation signals on the straight part inconsistent with any earlier proposed model.
- There are no good models for localizing quenches in the head.  
Difficult to pinpoint the defect to a single turn.
