MBHA-002 results

Quick update

05 February 2020

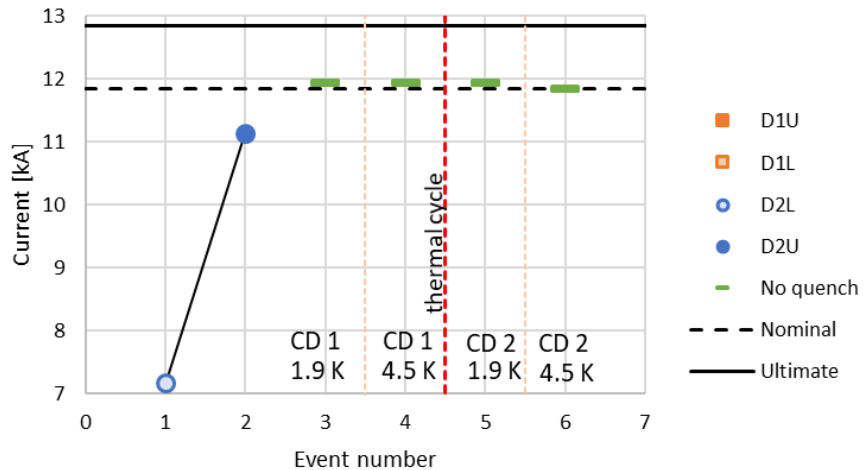
MBHB-002 training

Only 2 quenches
No retraining after thermal cycle
4.5 K no quench, showing conductor margin.

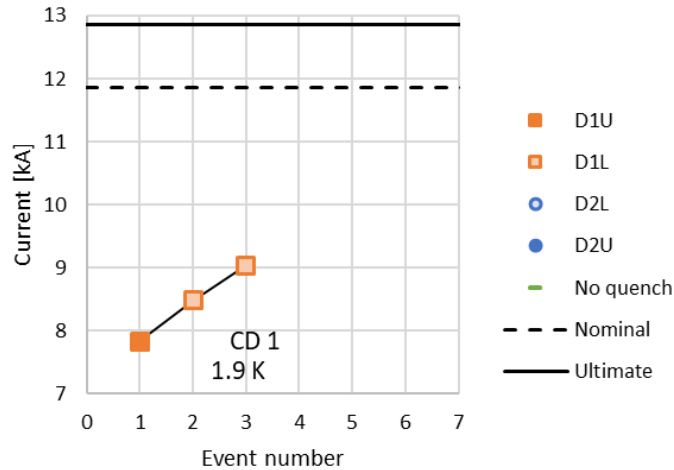
MBHA-001 training

3 training quenches
Issue identified (wiring, see next slides) and training was stopped.

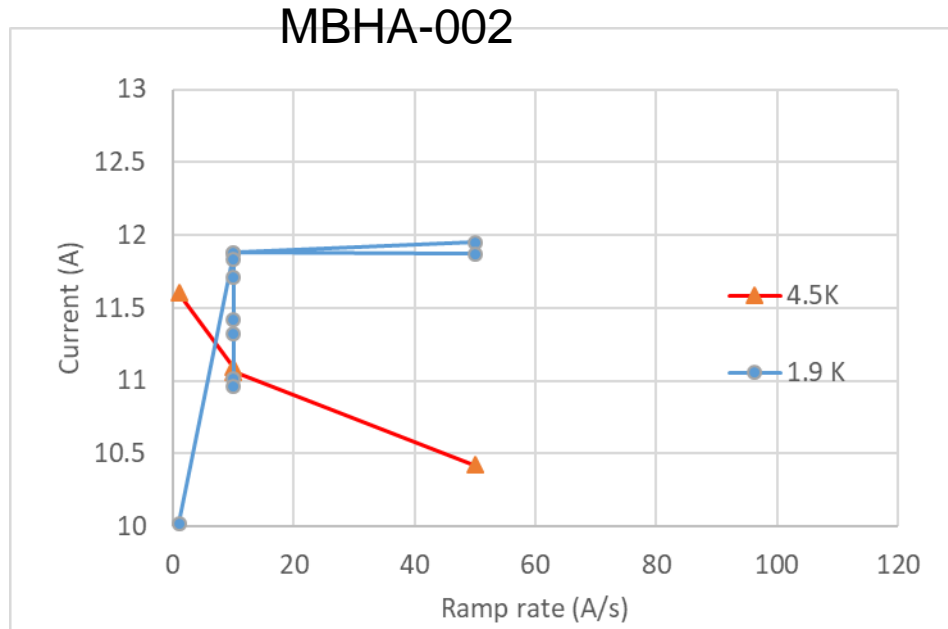
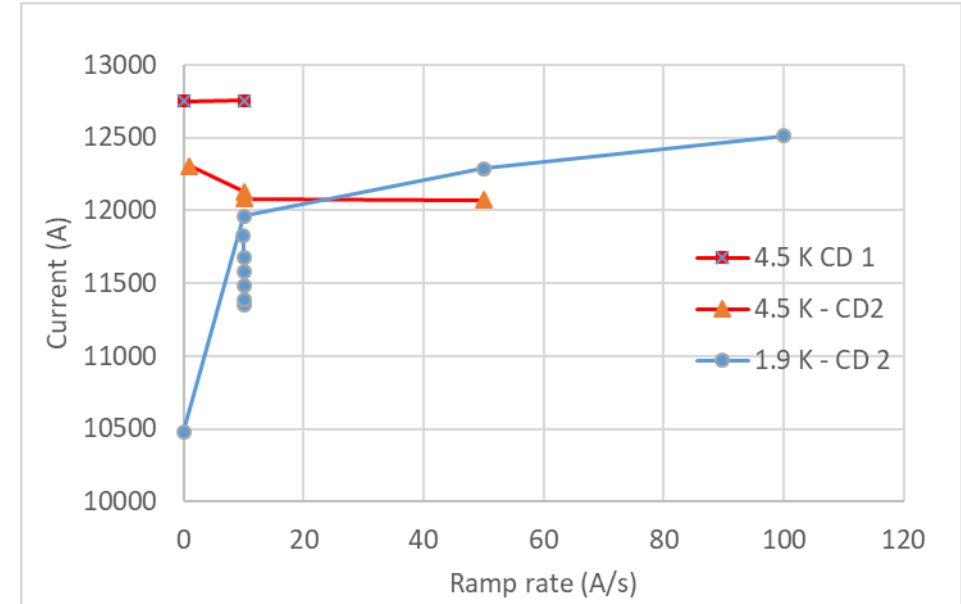
Ramp rate and temperature dependency

Instability at 1.9 K at 10 A/s.
Reproducibility at 4.5 K at 10 A/s.

4.5 K higher ramp rate gives lower quench current
4.5 K highest quench current with very low ramp rates

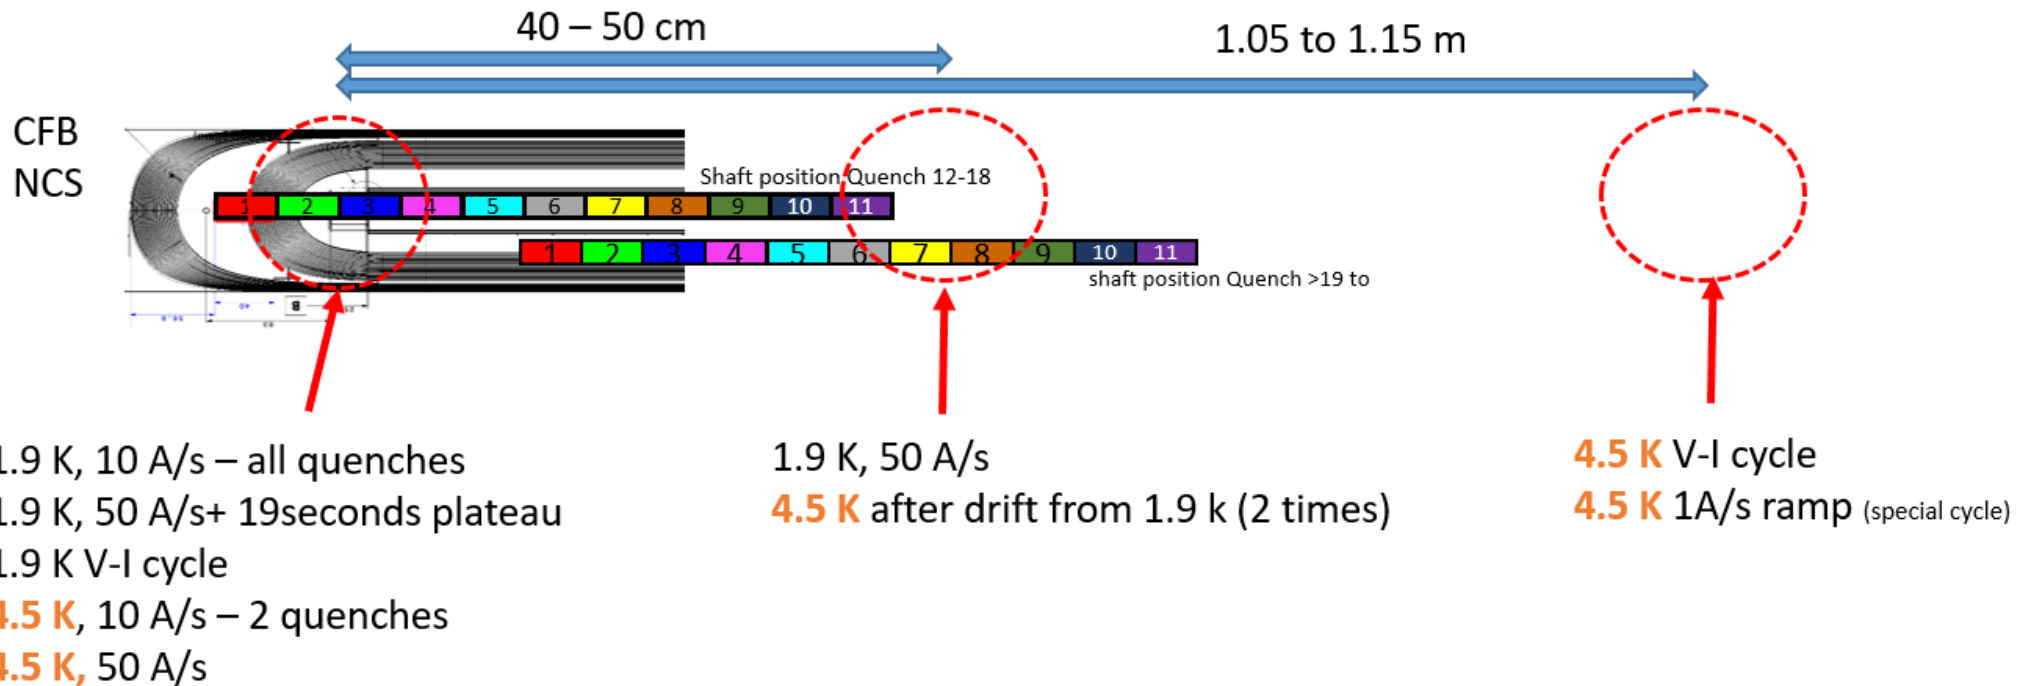
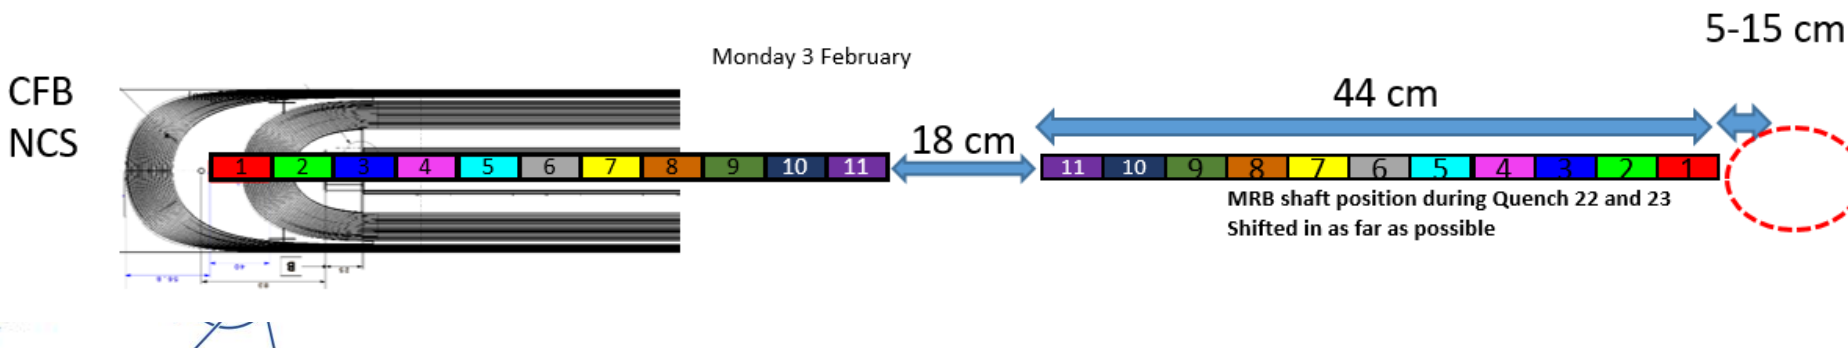
Quench Location

Some issues appeared with erratic quench patterns.
Coil D1U does not show stable performance.

23	1	4.5	11.6	No	D1U	Straight	~105 to 115 cm from head	>11

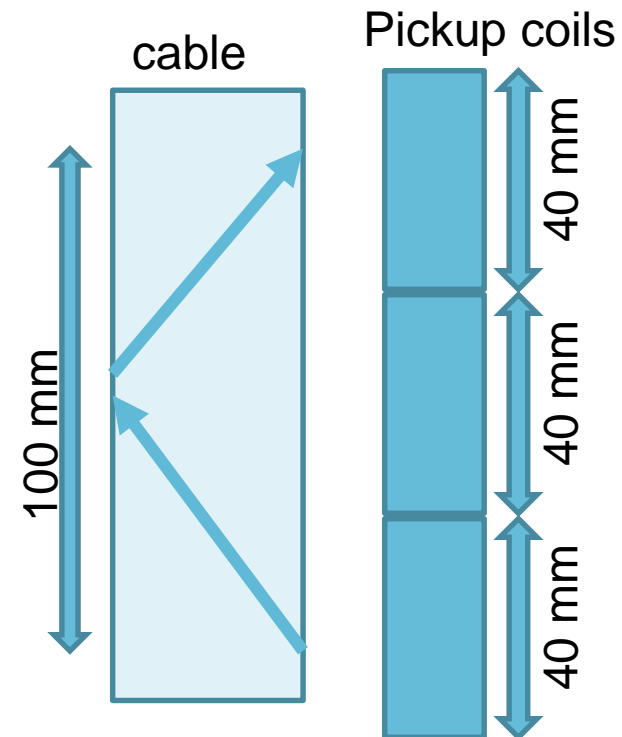
Can a quench propagate through a single strand (or a few strands)

To check
Quench signal should repeat each 5 segments.

If always the same strand has propagating quench, repeatably between quench.

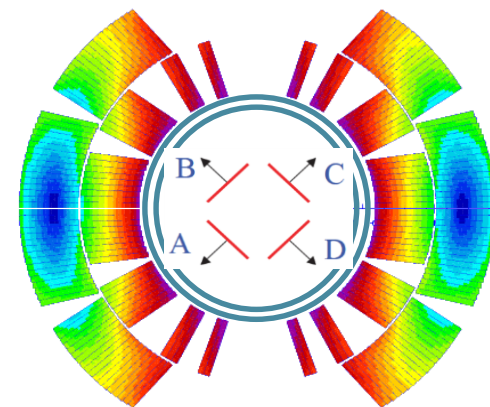
- Coil D1U has a clear damage
- Decay in V-I curves indicate current redistribution -> Local defect
- Voltage buildup starts at very low current -> severe damage to some of the conductor
- 3 quench locations:
 - We believe that the 50 A/s ramp at 4.5 K forces the current through the defect the most and may indicate the location of the defect. The defect is therefore most likely in the head.
 - At 1.9 K the large variation in quench current indicates self-field instabilities
 - Quenches in the straight segment are assumed to result from current redistribution effects caused by the defect.
- The pickup coils give propagation signals on the straight part inconsistent with any earlier proposed model. There are no good models for localizing quenches in the head. Difficult to pinpoint the defect to a single turn.

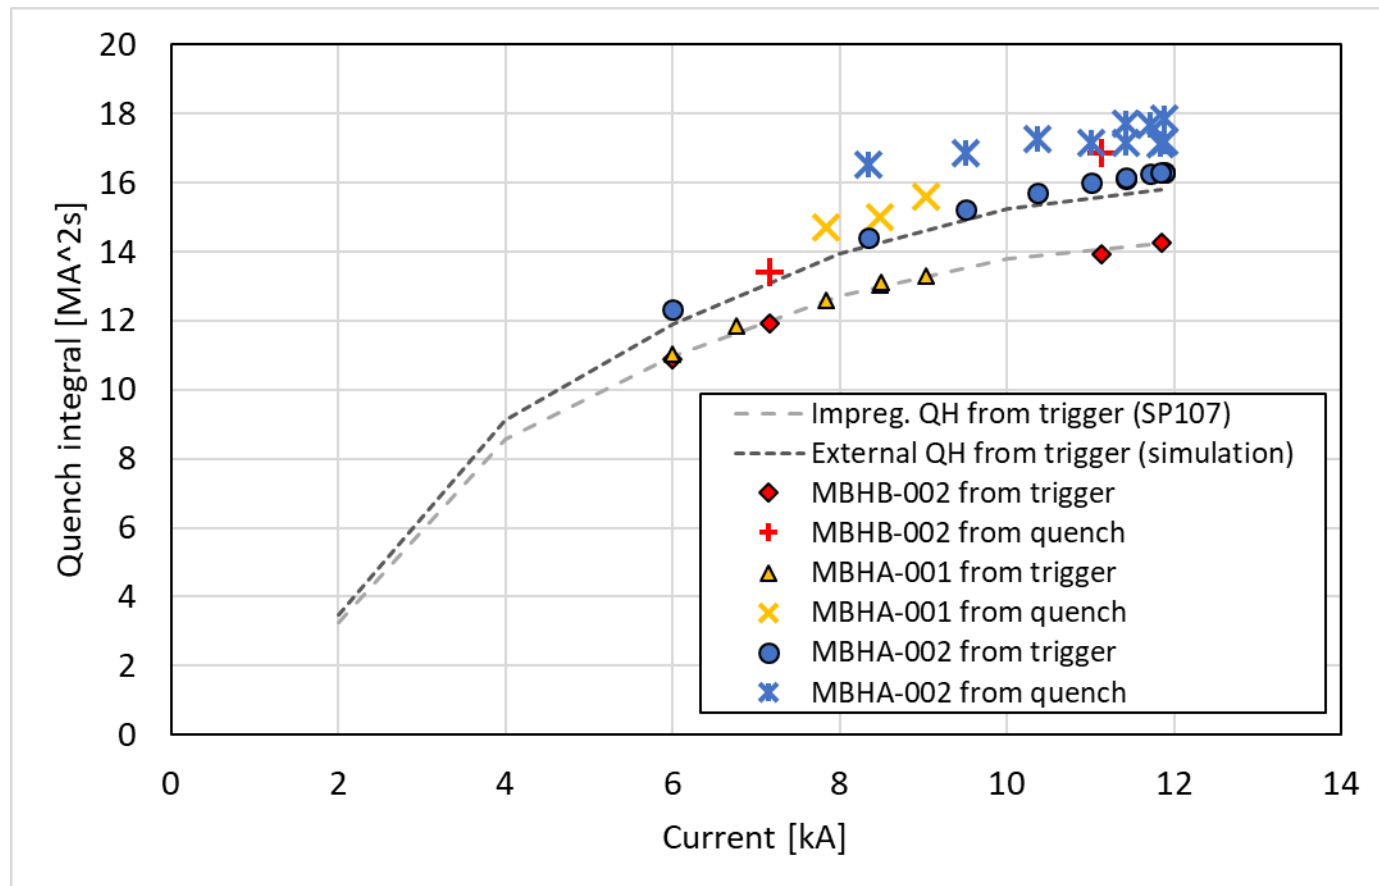
Quench Integral

With the quench heaters outside of the impregnation, the QI is higher as predicted.

For MBHA-002 the values are with 7 out of 8 quench heaters.

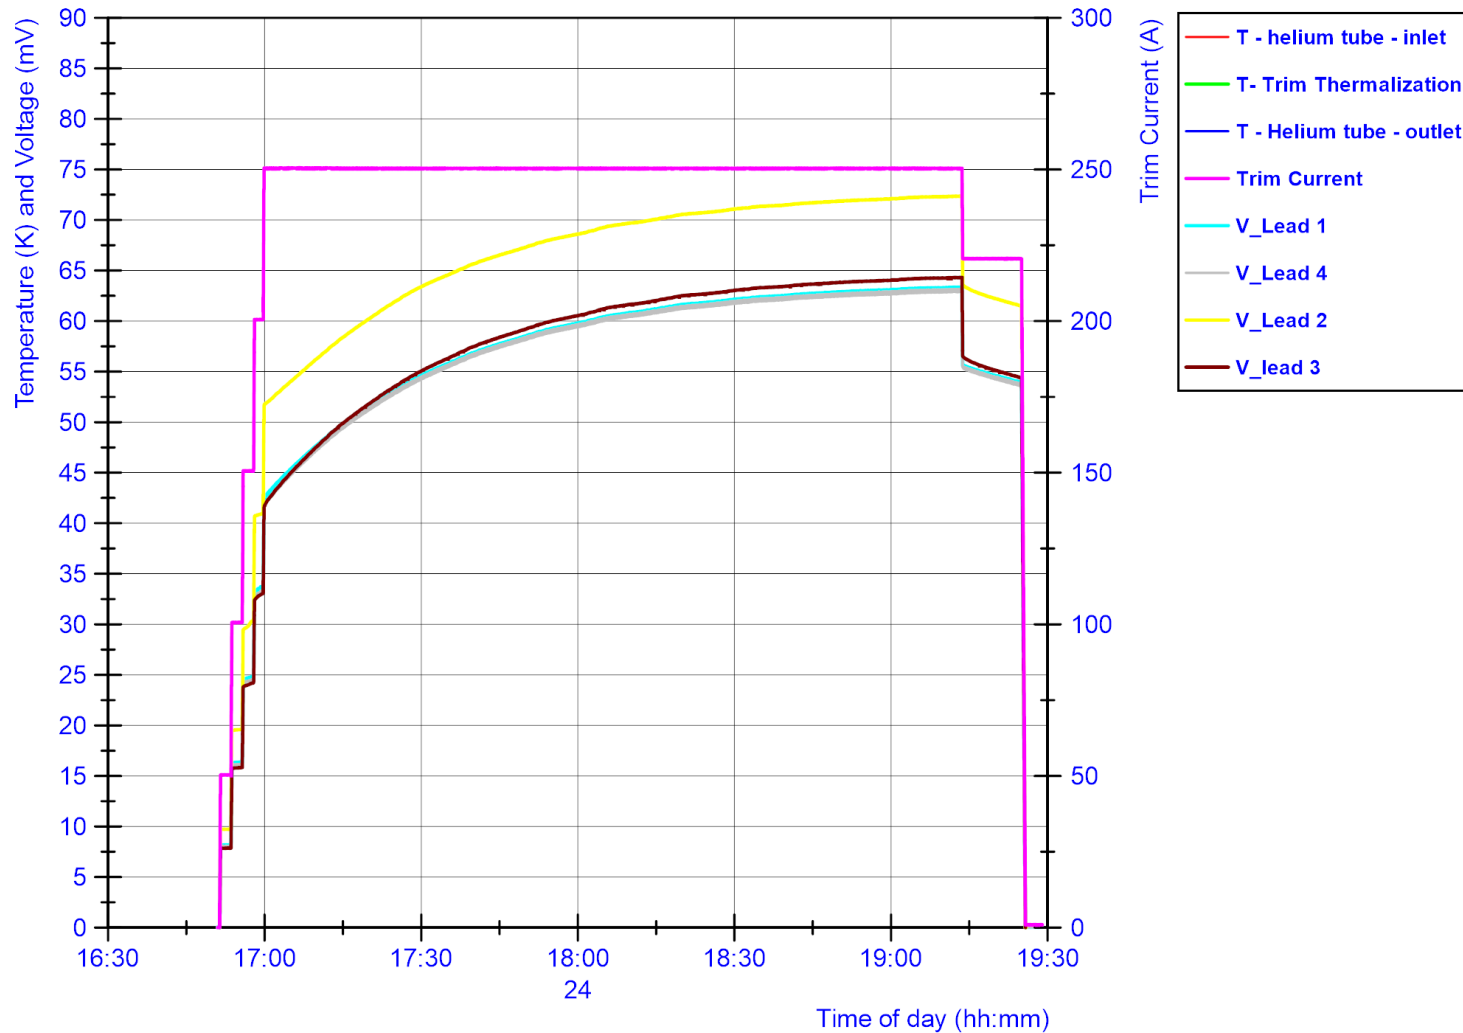
MBHA-002 Trim endurance test result

At 0.9 g/s, nominal helium flow
Stable trim thermalization of 32 K
Voltage stabilizing at 65 mV (threshold is 150 mV)

Reducing current to 220 A -> Voltage stabilizing below 55 mV....

Very good result!

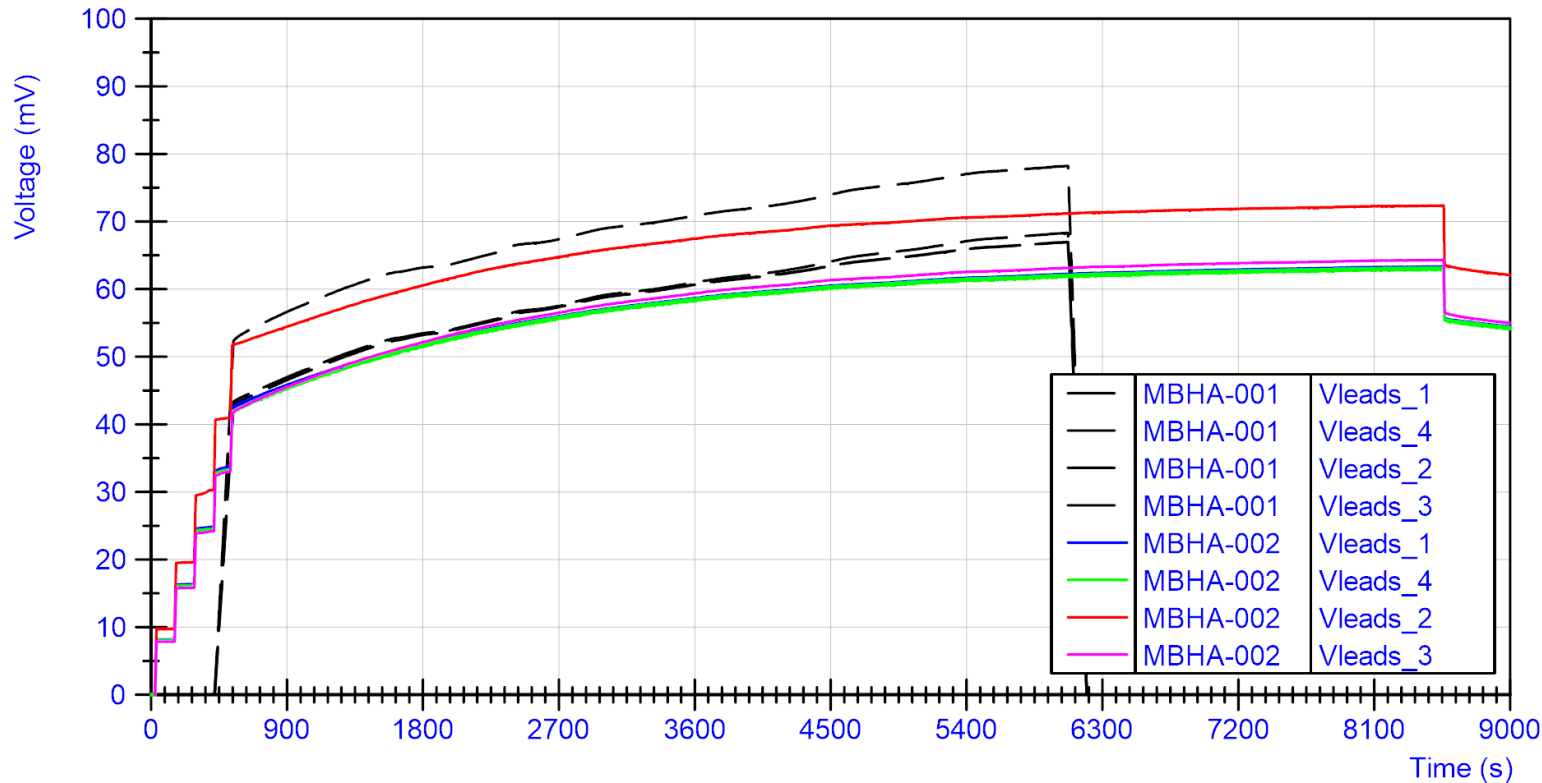
Trim MBHA-001 vs MBHA-002

In MBHA-001 the start temperature of the thermalization block was higher. Stabilization took longer and to a higher temperature.

Trim thermalization at about 32 K.

In hindsight: likely the He-flow was lower than the nominal 0.9 g/s.

Trim thermalization > 50 K.

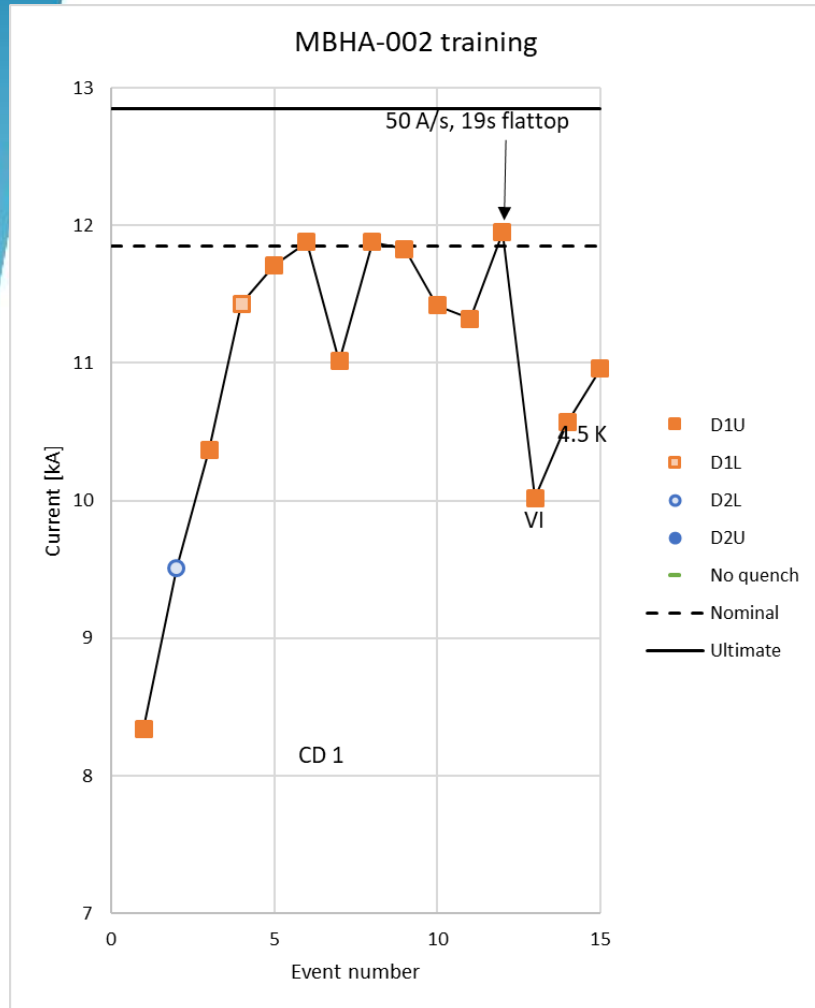
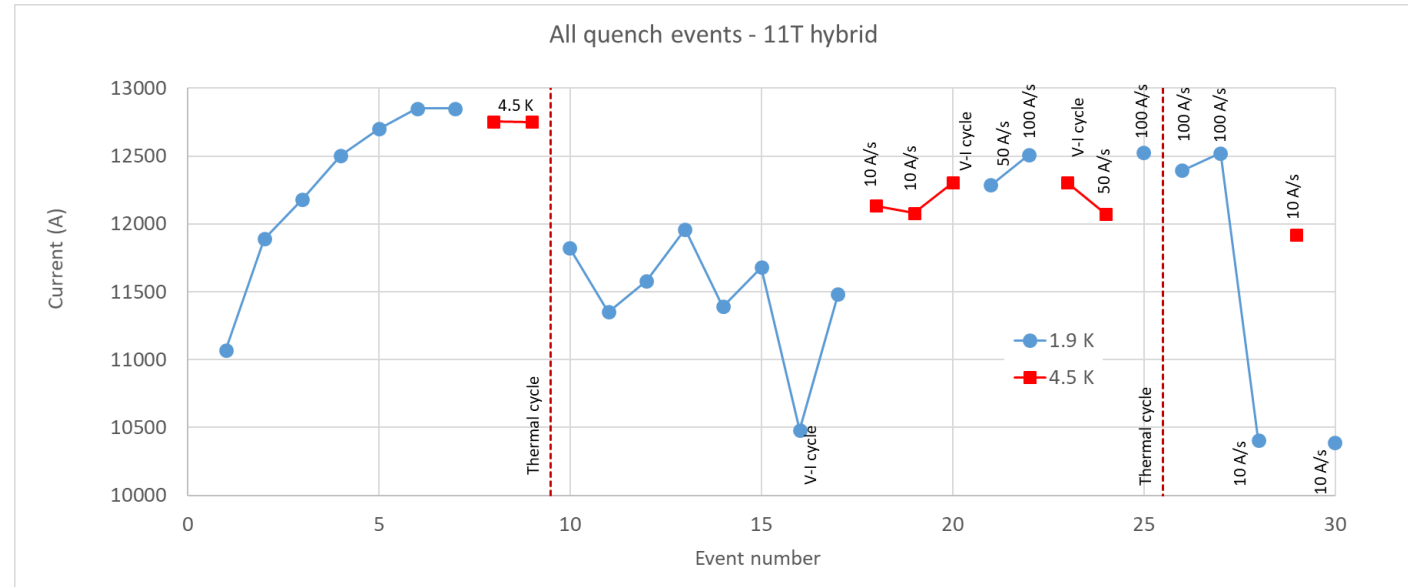
MBHA-002 and MBH-hybrid (after TC)

- Erratic behavior at 1.9 K, 10 A/s between 11 and 12 kA.
- V-I cycle gives the lowest quench current
- Higher ramp rates give higher quench current
