CBM GEM Muon detector assembly and discussion on the opto-coupler based HV system

Anand Kumar Dubey

VECC, Kolkata

Opto Coupler Scheme for biasing triple GEMs in the trapezoidal module

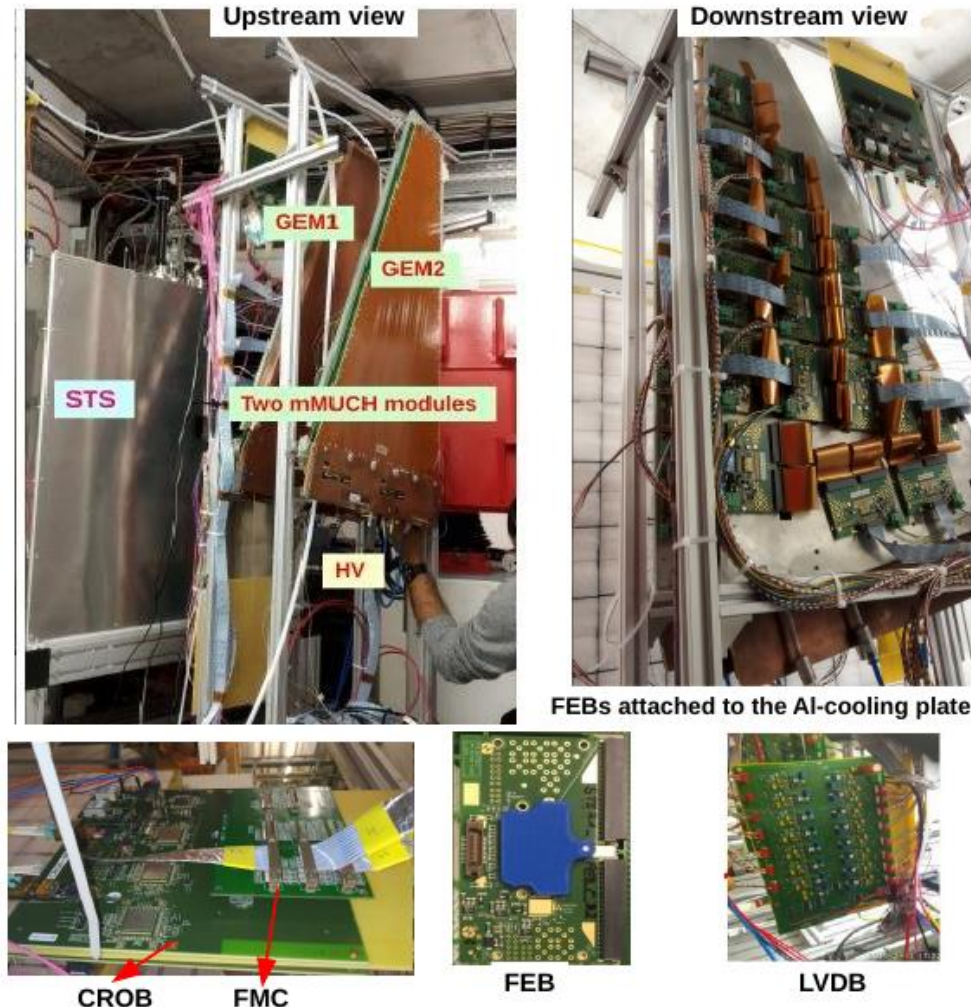
GEM chambers at mCBM
-- detectors of Station1 type

- The modules took good data for the entire run period.
- However, one observation :
- There was occasional **elink-loss at high GEM voltages – also called as link-break problem.** (4600 or higher)
- It was attributed to some spikes coming from the detector.
- The situation worsened with high intensity beams, the system could not remain stable for more than few minutes.
-
- But there were several occasions where the detector handled 4900 V upto one hour without any link-break

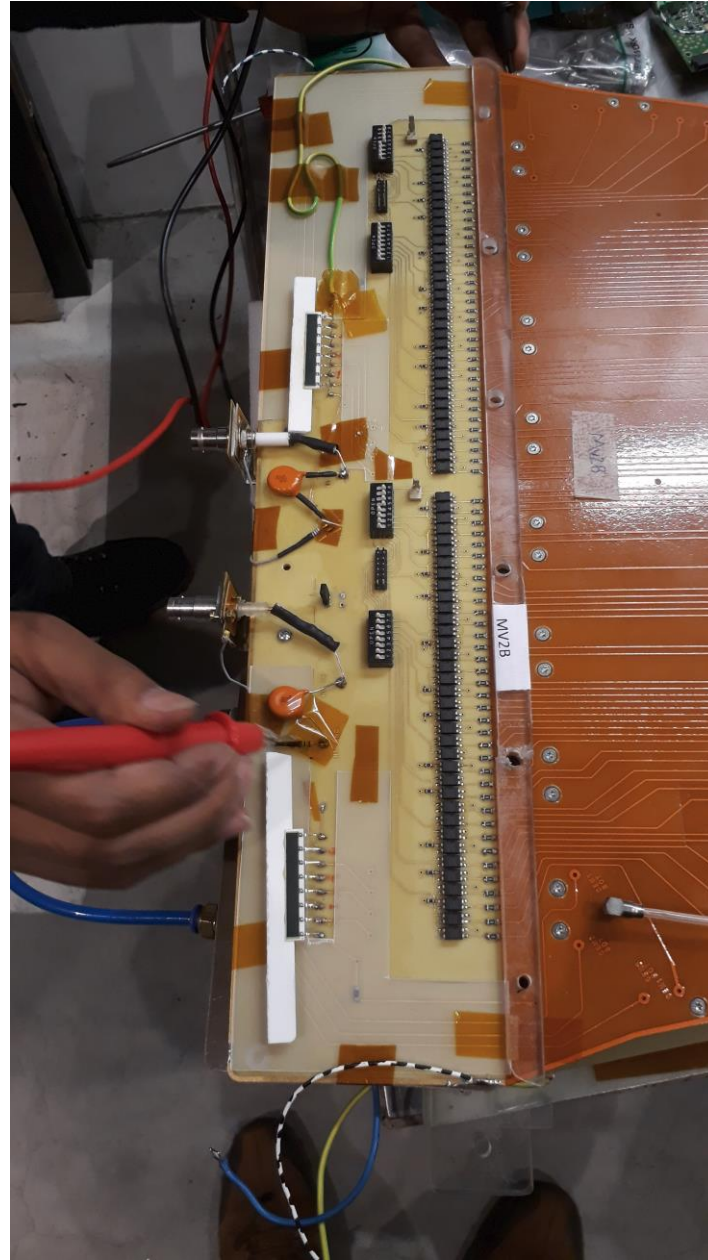
**Picture of the The HV
Portion of the detector**

The Optocouplers as soldered on the drift PCB

Test Setup at GSI,
---> outside the cave

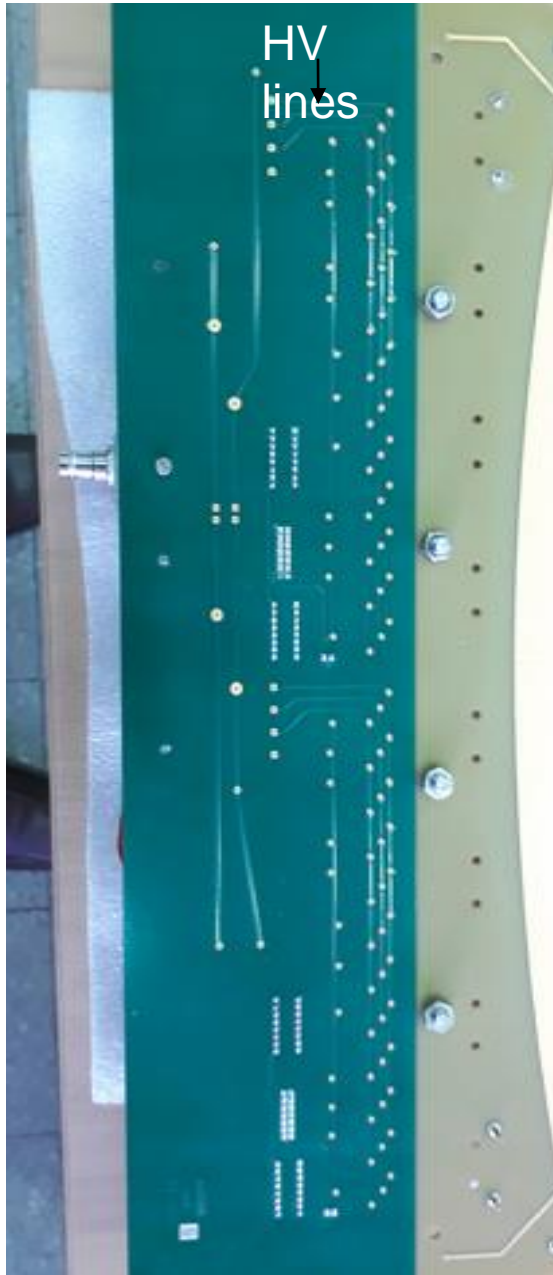
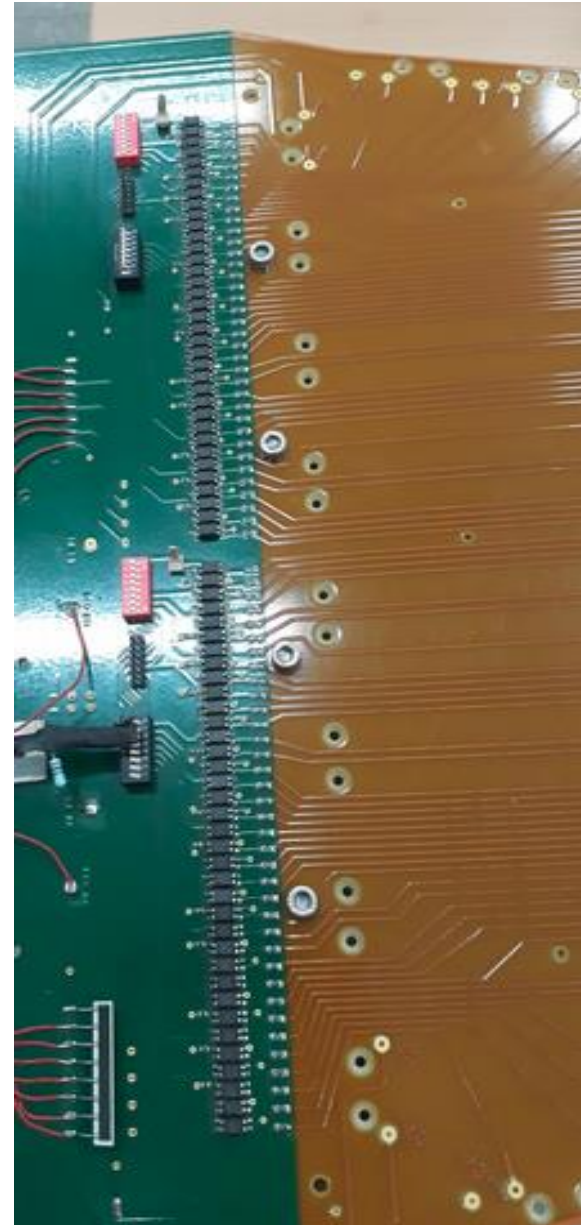
Investigation into the layout to identify any leaky path

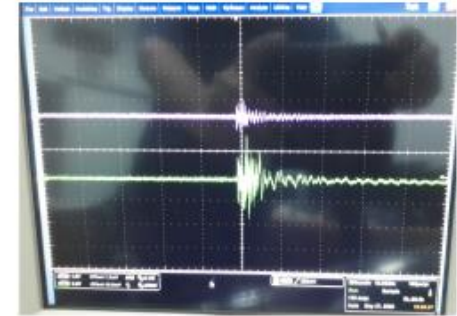
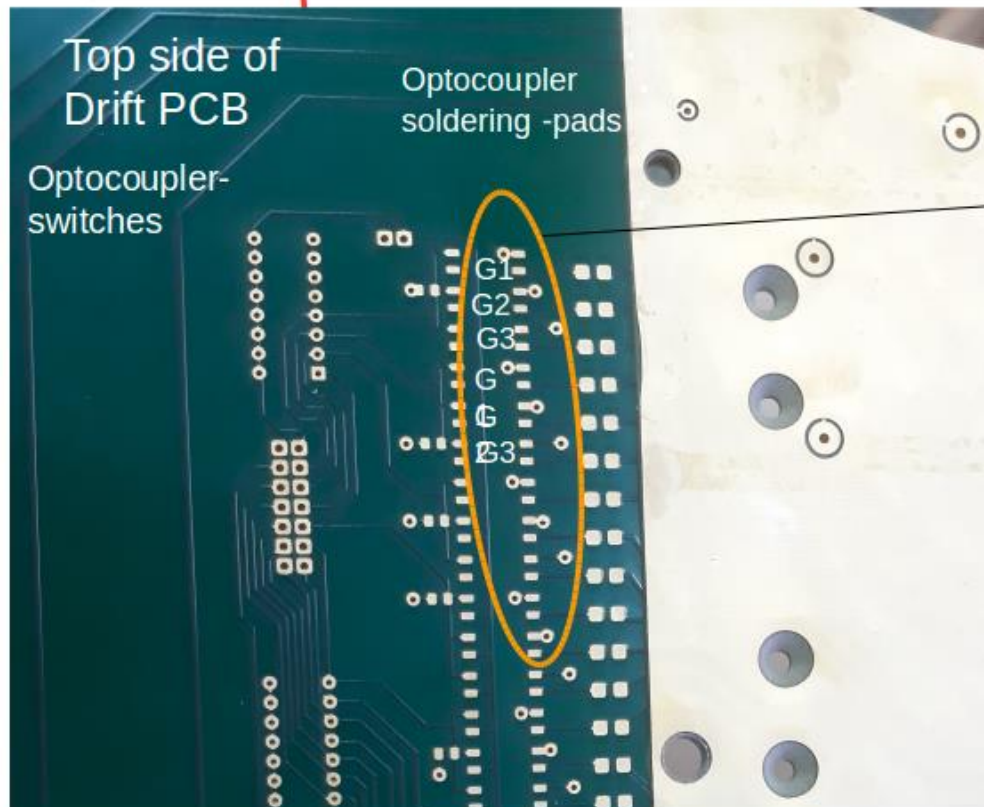
Investigation of Link-break using a detector assembly without GEM foils

Occasional to Frequent spikes seen on the scope

-- frequent at higher humidities.

On replacing the opto-couplers with simple SMD resistors, the system ran smoothly without any link break for several hours at 4900V.

One reason could be :

too close proximity of the optocouplers of GEM1, GEM2 and GEM3.

Can we increase the separation ?
-- we make use of three separate planes, where the optocouplers will be mounted.

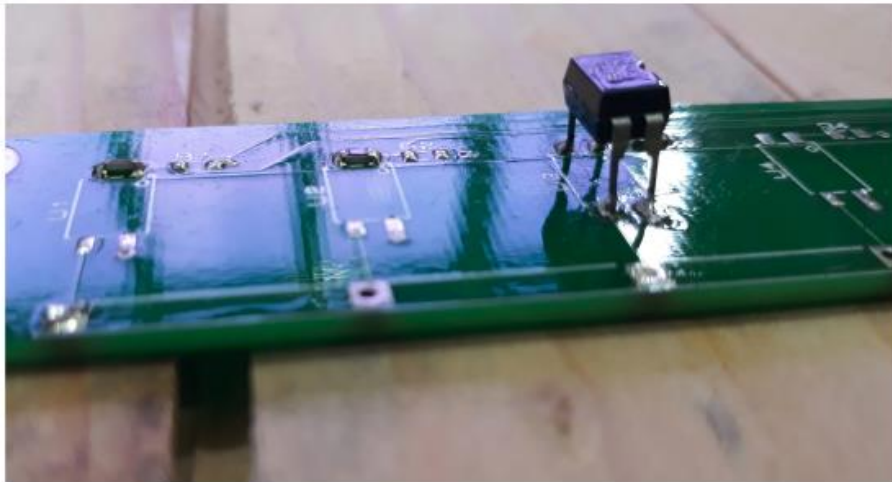
Optocouplers enveloped with glue

Optocouplers fixed on IC sockets,

Those fixed on IC-sockets were found to be relatively more stable under HV
