CMS Pixel

New Layer 1 and other Upgrades to the current Tracker during LS 2

Klaas Padeken

On Behalf of the CMS Collaboration

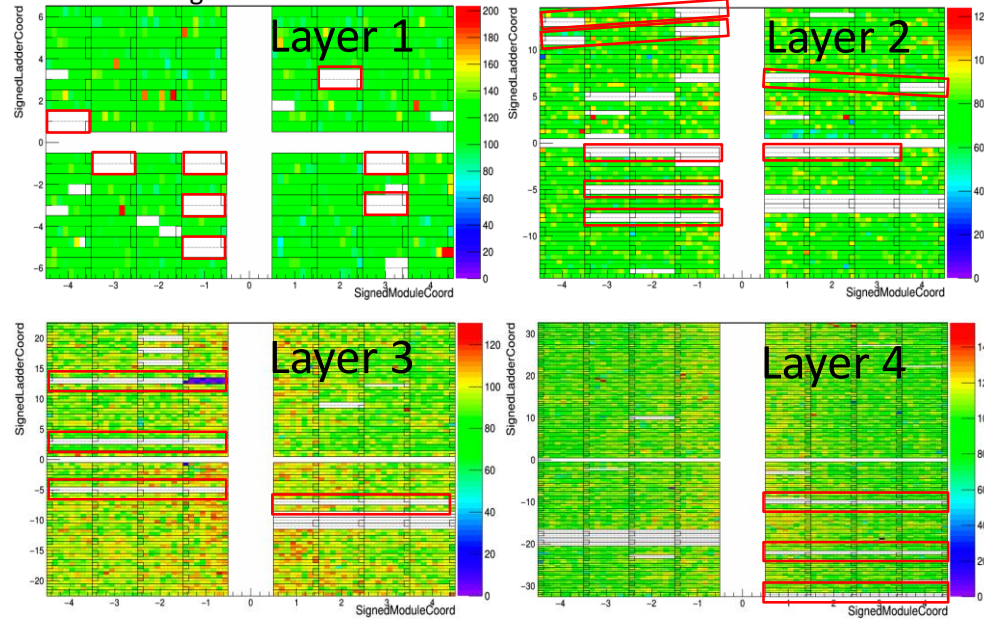
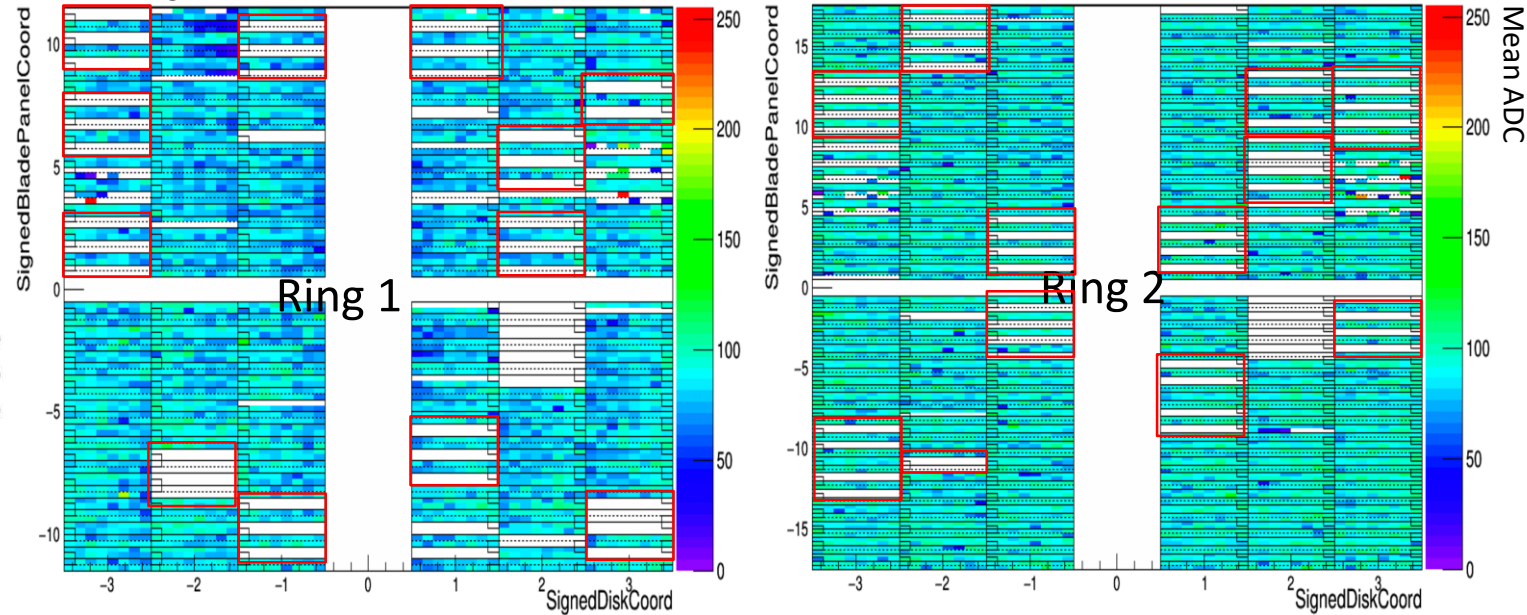
Broken
DCDC
Converter

The sudden and most unexpected
death of the DCDC converters.

If the DCDC is **irradiated** and **disabled** -> a **current** can be **amplified** and **break** the DCDC

5% converters
not working,
11% detector not active

Detector Extracted, Replaced all DCDC
with bigger fuse, problem not
yet understood

Problem reproduced in
the lab (IRAD,X-ray),
reason understood

- We ran 2018 without using the DCDC converters to cut the power to the modules
- Powercycling needed for the stuck TMBs
- Reduced the supply voltage to 9V
- Use powersupplies to powercycle between beam
- The turn on current of the modules is very high
 - We did have to disable a few DCDCs in order to turn on the detector/powercycle the powersupplies --> **none broke in 2018**

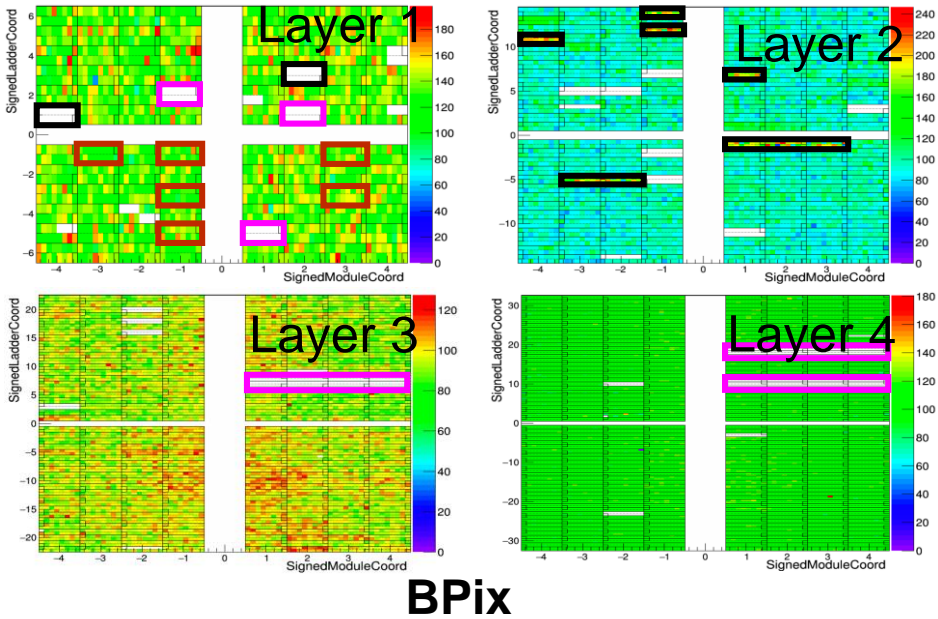
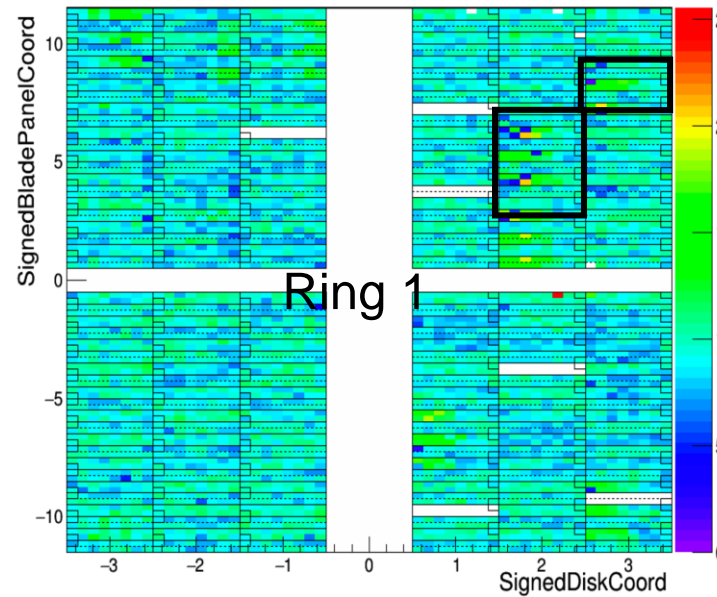
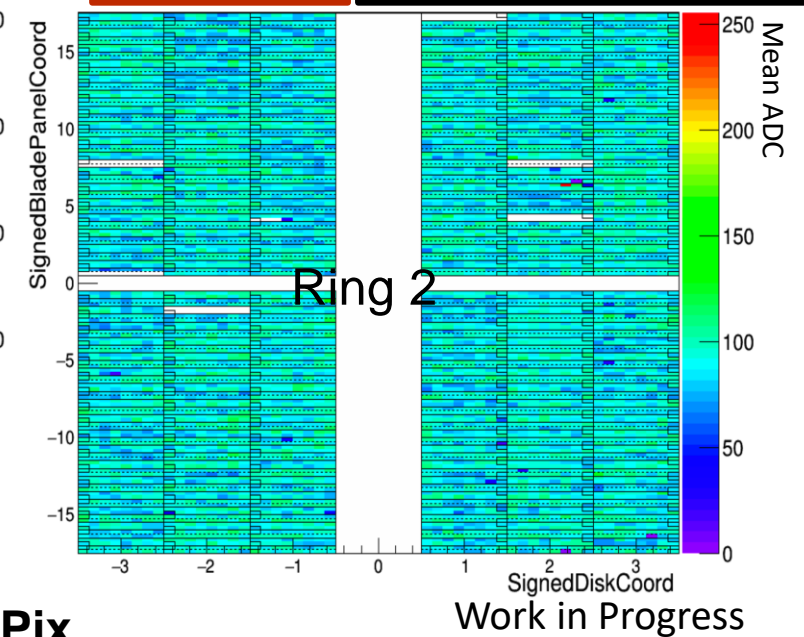
New modules

Damaged modules from 2017

- Reason for DCDC failure discovered in May/June
- Active channel fraction at end of 2018 : 94.5%
- Layer 1 HV breakdown of 2 modules at >400V
- Layer 3/4 connection LV problems
- No modules lost in FPix

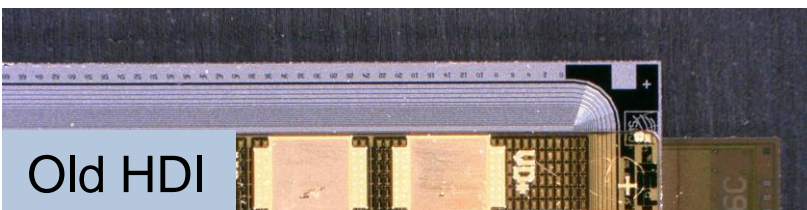
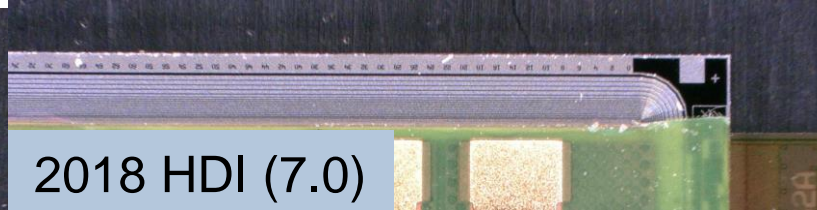
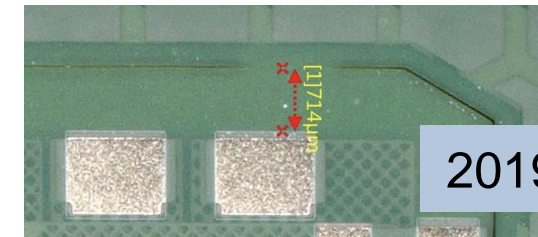
Problem:

The edge of the L1 HDI was not covering the sensor enough, so a HV spark to pad ground could damage the module.

Solution:

For the new L1 the HDI boarder was **increased** to cover the guard rings completely.

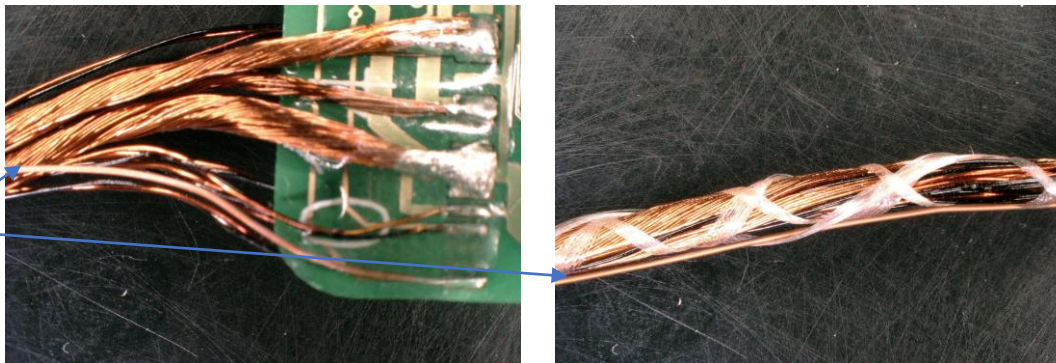
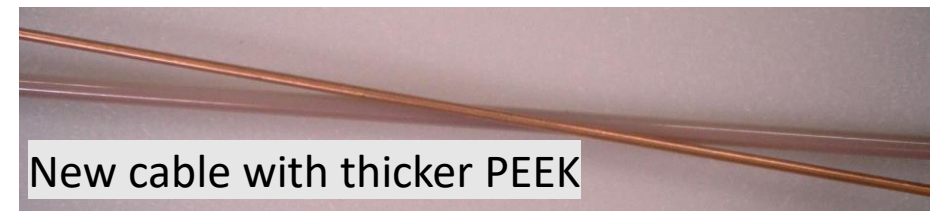
New Cable

- New module cables showed HV problems:
 - Insulator was stripped to far back
 - PEEK insulation was too susceptible for mechanical damage
- New thicker PEEK insulation solved both issues

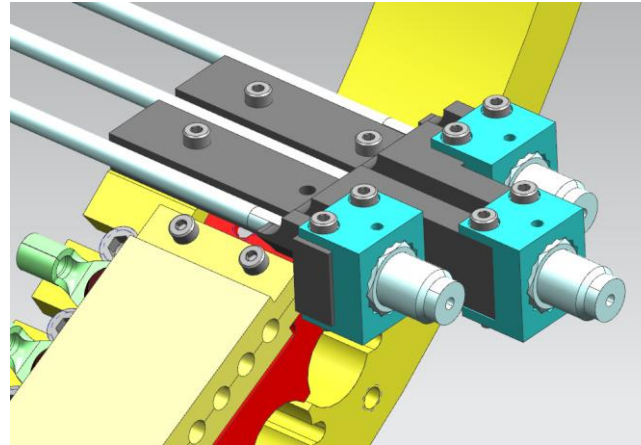
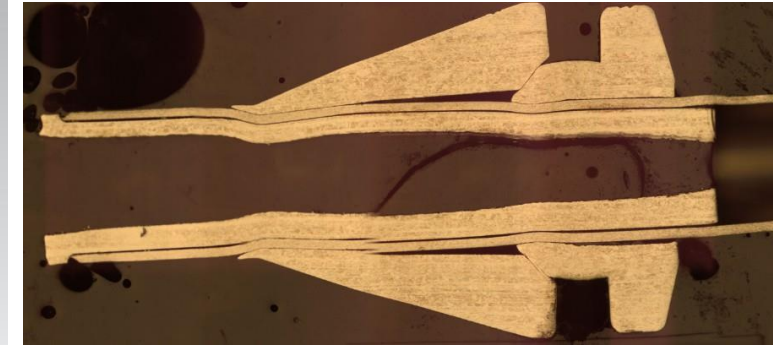
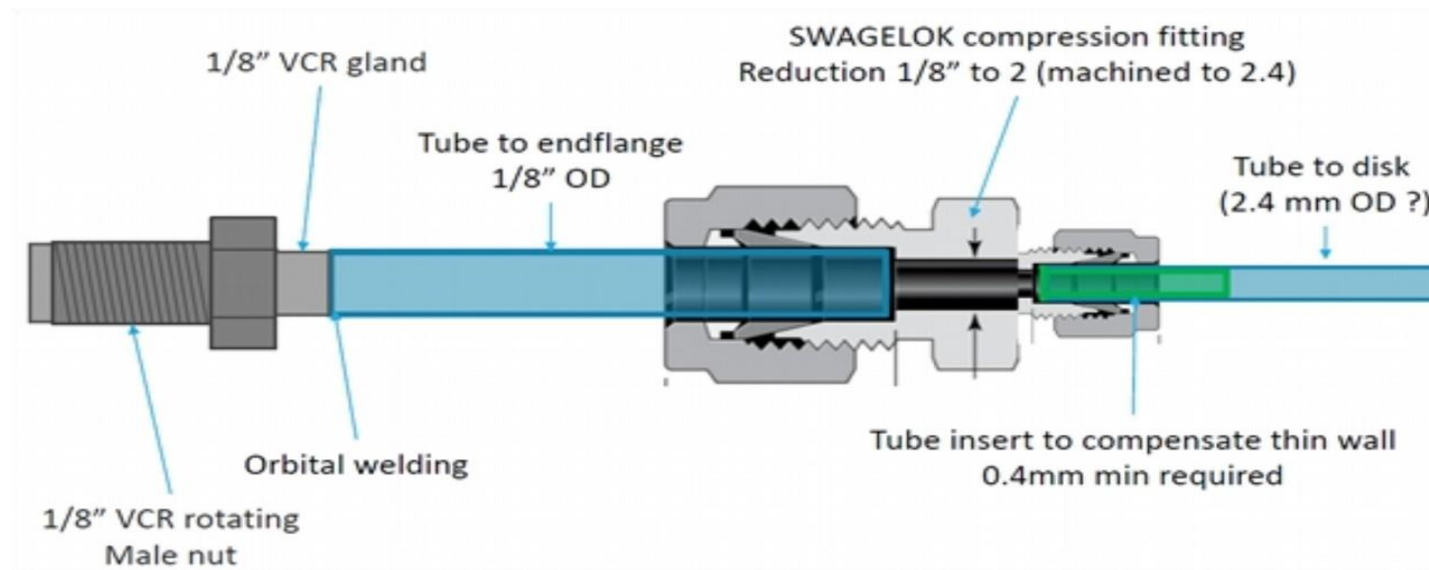
FPix Cooling

- Fixed nut directly welded to 120 μm thick pipe
- Minimal mechanical torque needed to break off the nut
- Glue was meant to reduce the mechanical stress.

- Add a strain relieve to the end flange (for non broken pipes)

OR

- Add a larger 1/8" (3.18mm) tube to the 2.4mm tube
- Connection done with a (custom) VCR fitting
- Which solution will be used on how many pipes will be decided during the repair works

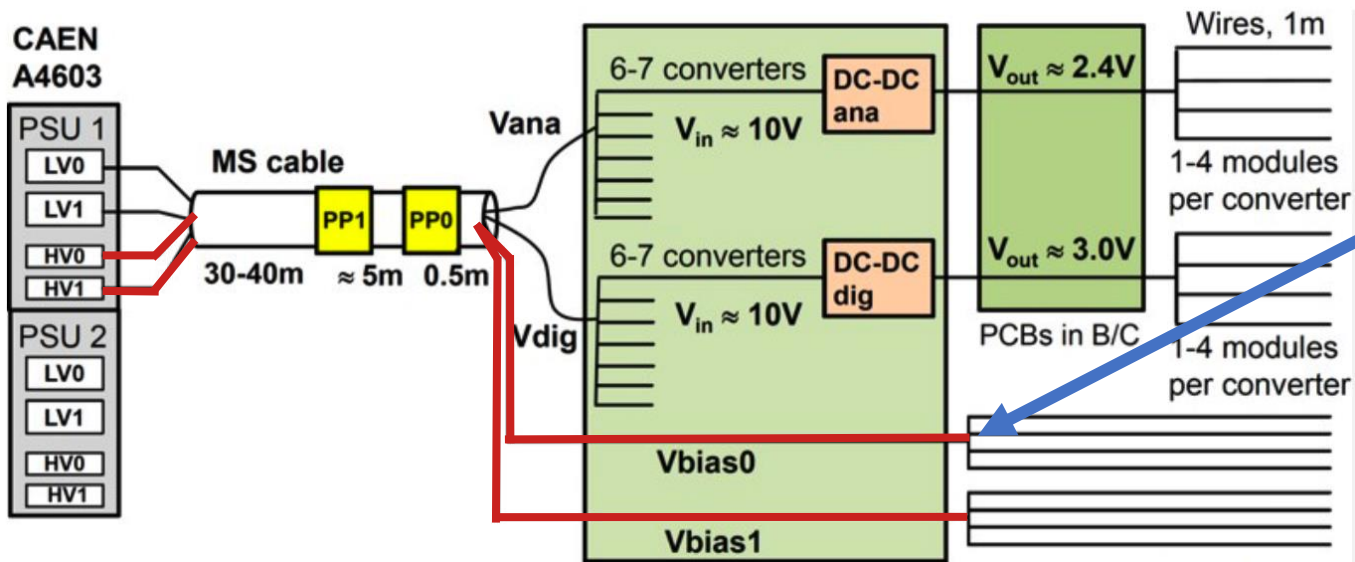
FPix HV granularity

- We know that HV without LV damages the ASIC preamplifier (leakage current)
- HV granularity is one powergroup at the moment

- We have 8 HV lines per cable, that can be switched with jumpers in the power supplies.
- Need to connect the unused cables
