# Linac4 RFQ issues

Suitbert Ramberger

10 June 2020

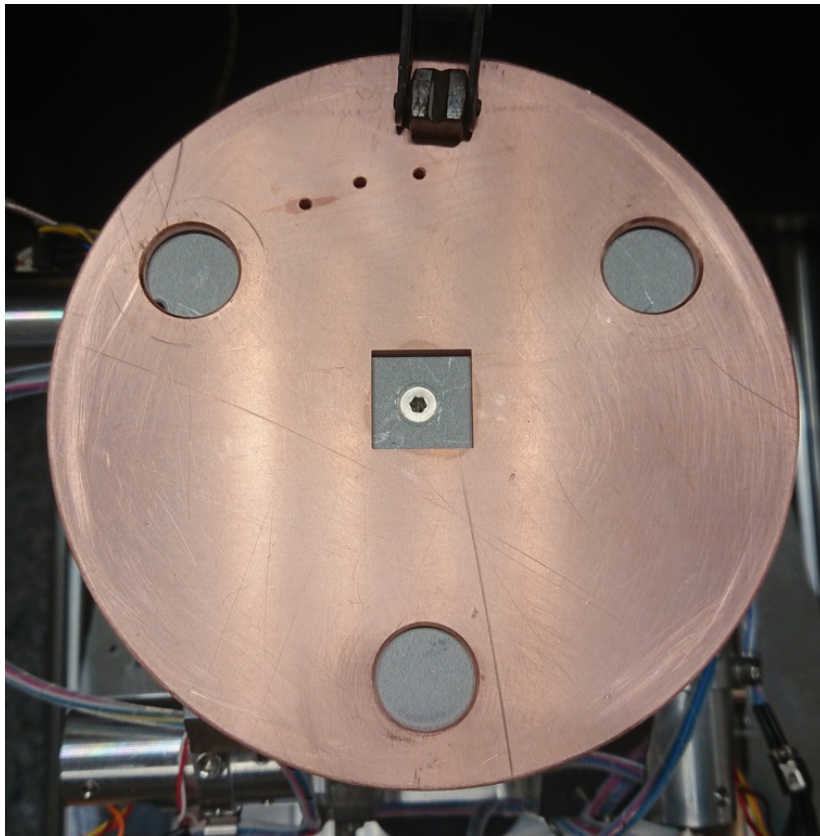
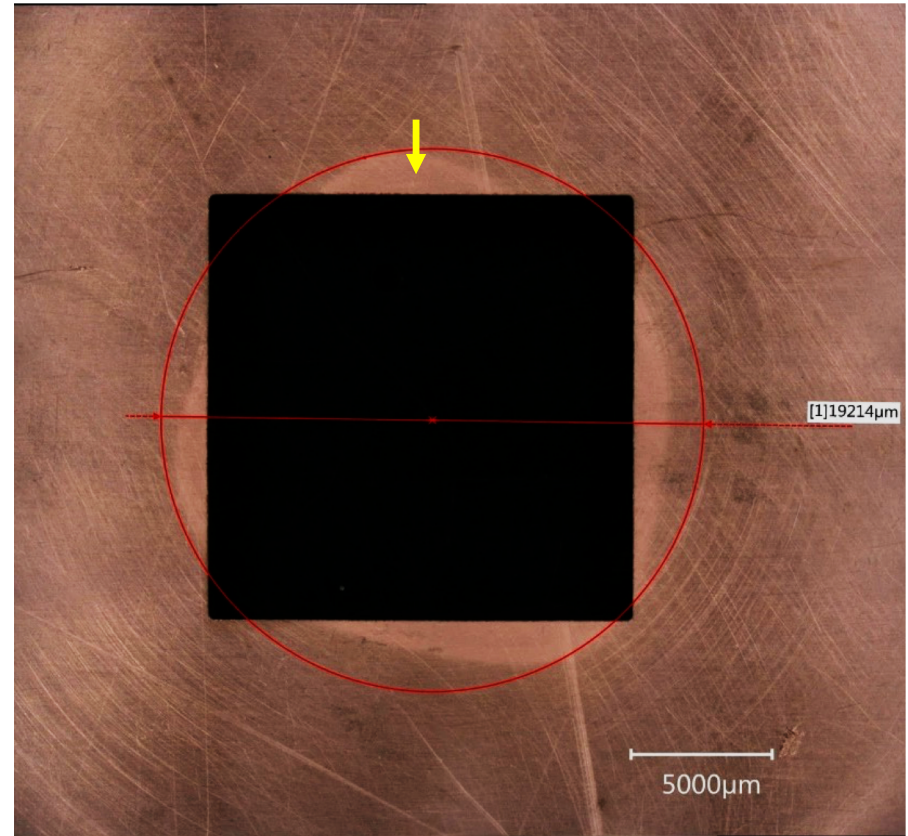
Top view

Material received beam on the L4 source test stand exactly in place of an RFQ

What appears as a change in coloration are:

- Changes in surface roughness with micron-sized features
- Little hydrogen cavities under every bump in the surface
- Spongy material areas going 400nm into the surface
- The Bragg peak at the proton implantation energies is expected at 200nm
- Areas w/o coloration have 400nm of perturbed non-spongy structure
  - Probably due to material production
- The material is not representative for the RFQ – more beam tests required
- More care will need to be taken to reproduce the situation on the RFQ
