Leak in TT2

Jose A. Ferreira (TE-VSC)

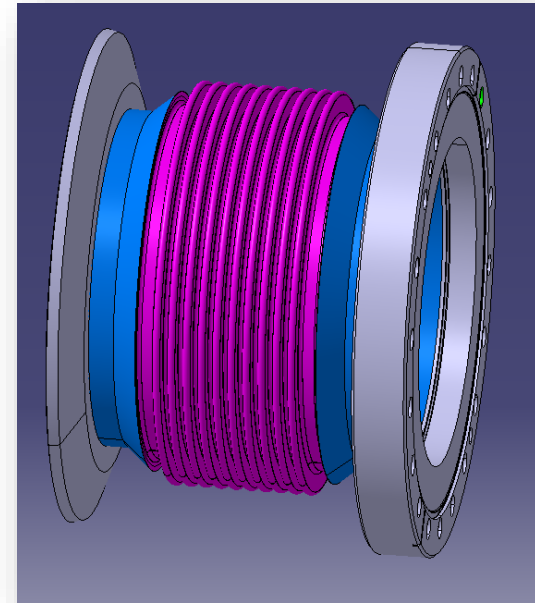
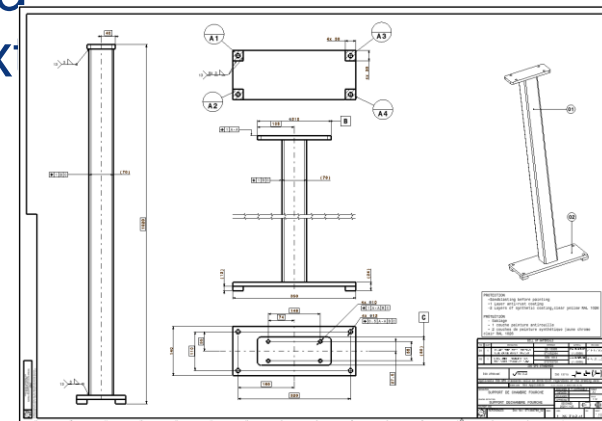
- Failure of support between BHZ.377 and BHZ378
- The fall of the support created a sudden movement on the other side of the chamber
- 3 bellows affected by the movement
- Very poor welding of the support to the plate.

- ❑ Replace the 3 damaged bellows
- ❑ Spare bellows localized and tested. Fixed DN160CF flanges available, 2x rotatable DN160CF also available
- ❑ Some chambers undocumented → Drawing production started
- ❑ Discussions with workshop to be started on Monday (chambers beginning of next week t.b.c.)
- ❑ No major issue for Hardware Commissioning.
