G. Lenoir, K. Puthran, C. Barth, F. Wolf, J. Fleiter, A. Ballarino
European Organization for Nuclear Research (CERN), Geneva, Switzerland

The accelerator magnets for the High Luminosity upgrade of the Large Hadron Collider (HL-LHC) use Nb₃Sn conductor to achieve in-field performance exceeding Nb-Ti based technologies. To sustain Lorentz forces during operation, a pre-compression is applied to the conductor during the fabrication of the magnet. This can lead to an irreversible degradation due to the mechanical sensitivity of the Nb₃Sn material.

The impact of the pre-compression is investigated using a reacted double-stack of Rutherford cables.

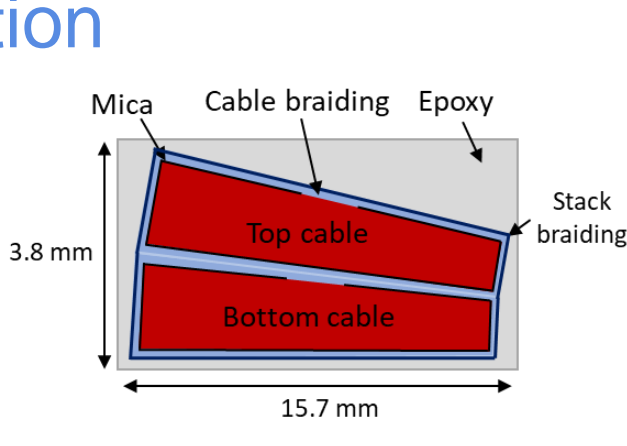
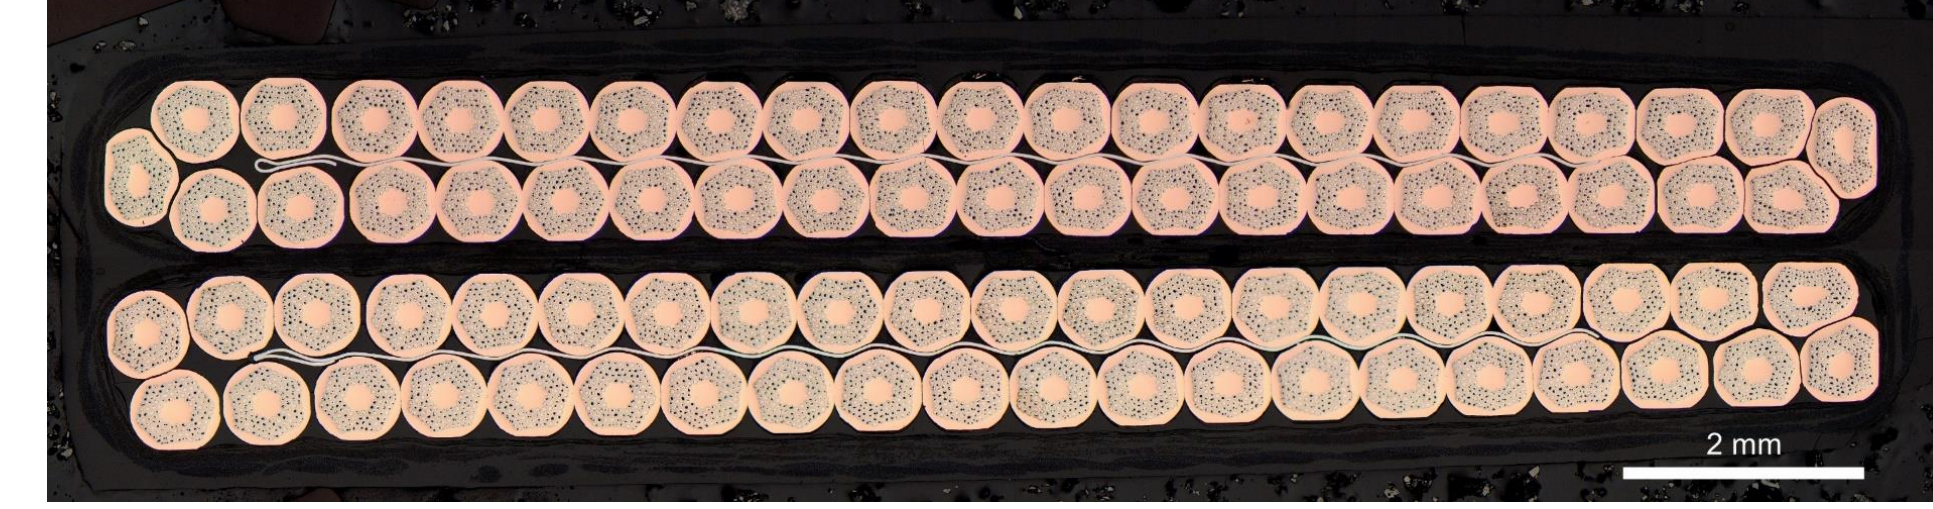
Architecture of the 11T cable specimen

- Latest strand and cable configuration for the 11T magnet
 - RRP 108 / 127 strand
 - "small mica gap" (gap: 0.9 mm)
- Double stack configuration
- Not inverted
 - Evaluation of the impact of inhomogeneous resin distribution
 - Impregnation layer around the stack not uniform → can represent impregnation inhomogeneities
 - Top and bottom surfaces are flat → homogeneous distribution of pressure on the surfaces of the specimen

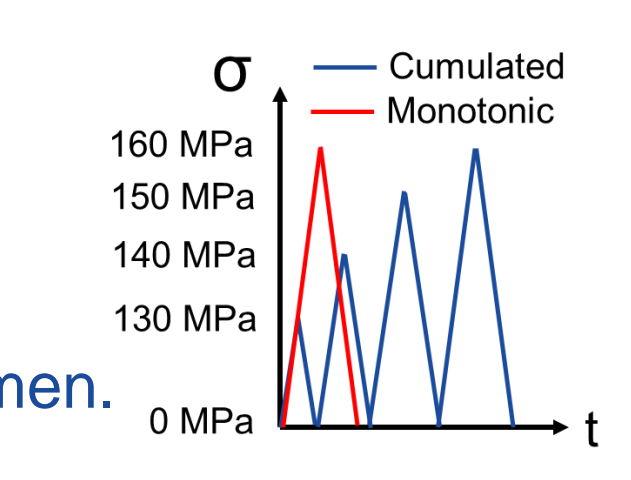
- Specimens → 60 mm lengths w/o Vtaps:
 - 160 MPa Monotonic, 160 MPa Cumulated, 170 MPa Monotonic, 170 MPa Cumulated, 180 MPa Monotonic, 180 MPa Cumulated, 190 MPa Cycled area cut from FRESCA specimen.

- Preparation
 - Reference sample (not cracked) prepared together with the analyzed samples to guarantee the preparation procedure didn't induce damage,
 - Grinding and polishing with decreasing particle size (SiC papers and water-based diamond pastes) - Vibro-polishing final step.
- Analysis procedure
 - Optical microscope for global analysis and small cracks under SEM.
 - Quantification of cracks by B&W stack pictures with color scheme assigned to cracked filaments:
 - yellow-1crack, orange-2, red-3 and dark red-4 & more.
 - Doesn't represent the size of the crack!
 - One yellow coded sub-element may have a 3 μm long crack or a 10 μm long one.

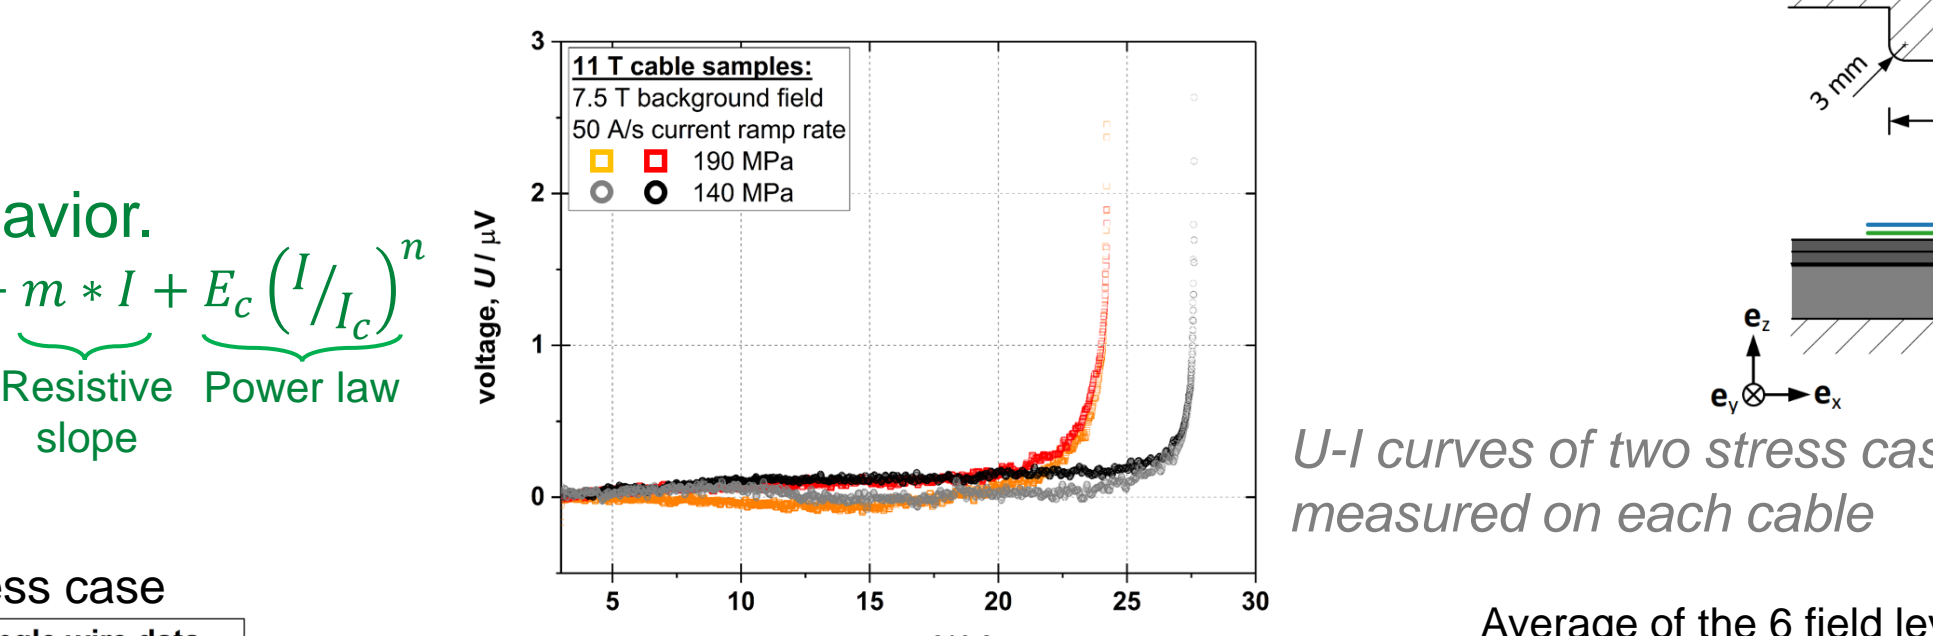
- Test Procedure
 - Measurement at virgin state → baseline,
 - Warming up and application of pressure @ RT,
 - Cool down and measurement in FRESCA, → The sample is submitted to a cumulated loading.
 - After the 190 MPa step, specimen loaded to 20 cycles at 190 MPa and measured in FRESCA,
 - Then, 6 thermal cycles were performed.

From I_c-B_{total} results and expected single wire data
 ↳ Baseline: I_c just within expected range,
 ↳ ≤170 MPa: within expectations,
 ↳ ≥180 MPa: below expectations,
 ↳ Mechanical cycles - 20x190 MPa ~16.5% < baseline,
 ↳ Thermal cycles: 5x 77 K & 1x 4.2 K: no effect BUT performed after severe degradation.

From n-value results:
 ↳ 160 MPa-170 MPa: reduction ⇒ degradation,
 ↳ From 170 MPa: cable irreversibly damaged.
