Canted-Cosine-Theta (CCT) magnets

Optical examination

Manual polishing of 4 slices from CCT magnet

All original high definition pictures are set out in annexes in **EDMS 2453524**

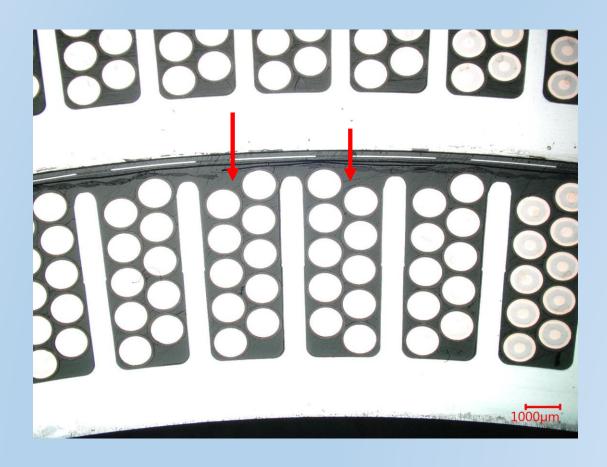
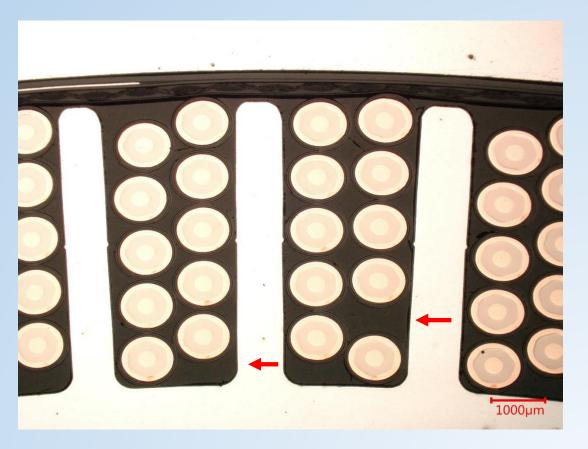
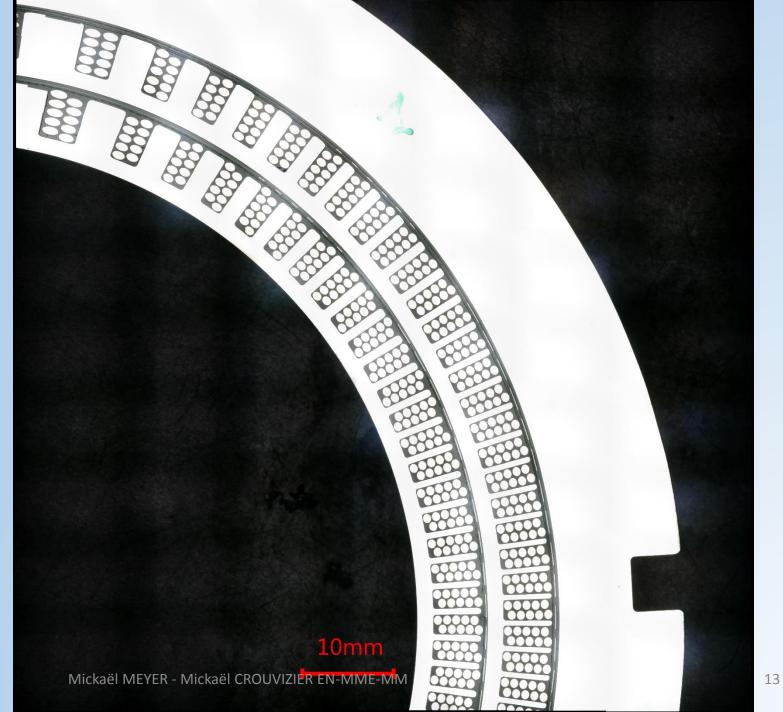
Stacking positions of the superconductive wires

Systematic stacking position errors are observed at all examined slices. Only rare channels exhibit good alignment.

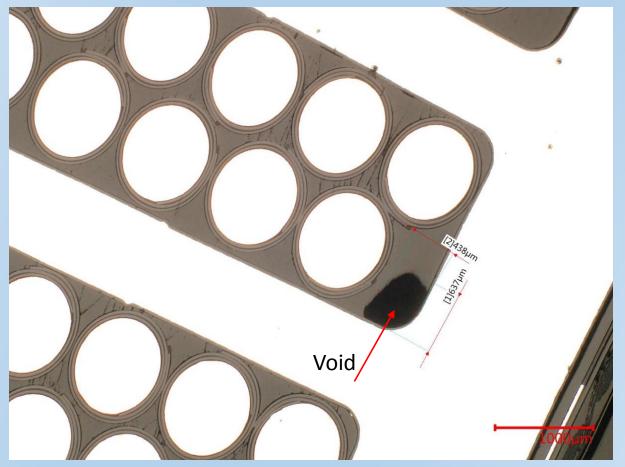
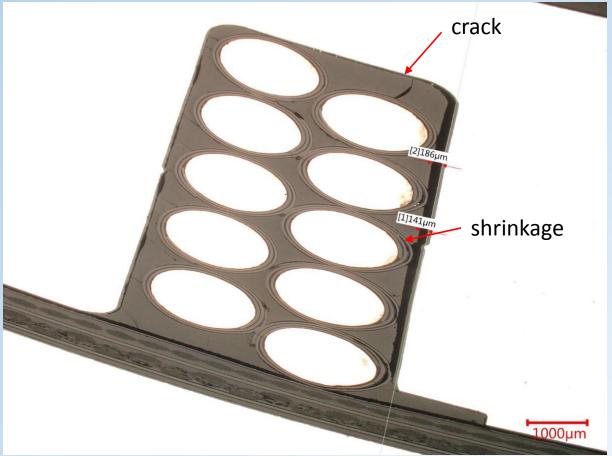
Void, shrinkage or crack at the resin

Shrinkage: up to approx. 0.5 mm

Lack: up to approx. $1.0 \text{ mm} \times 0.3 \text{ mm}$

Cracks: total length up to approx.

0.5 mm

Only few examples of worst/largest resin imperfections are illustrated here. The latter are commonly observed at all prepared slices (see stitched pictures in annexes)

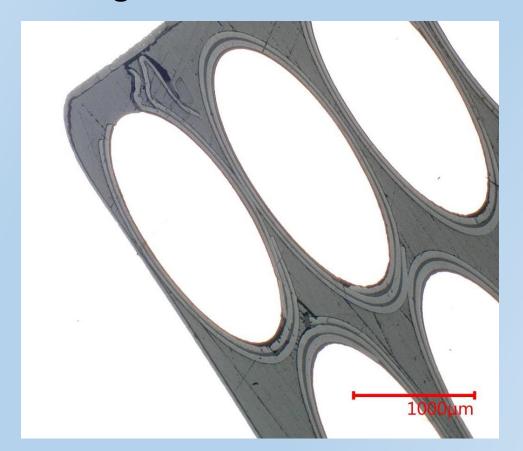
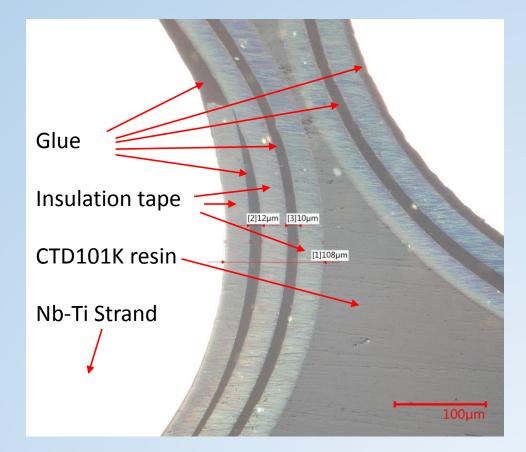
Damaged wire insulation

Damaged wire insulation / lack induced by insulation glue

To the extent of present examinations, the only case that has been observed

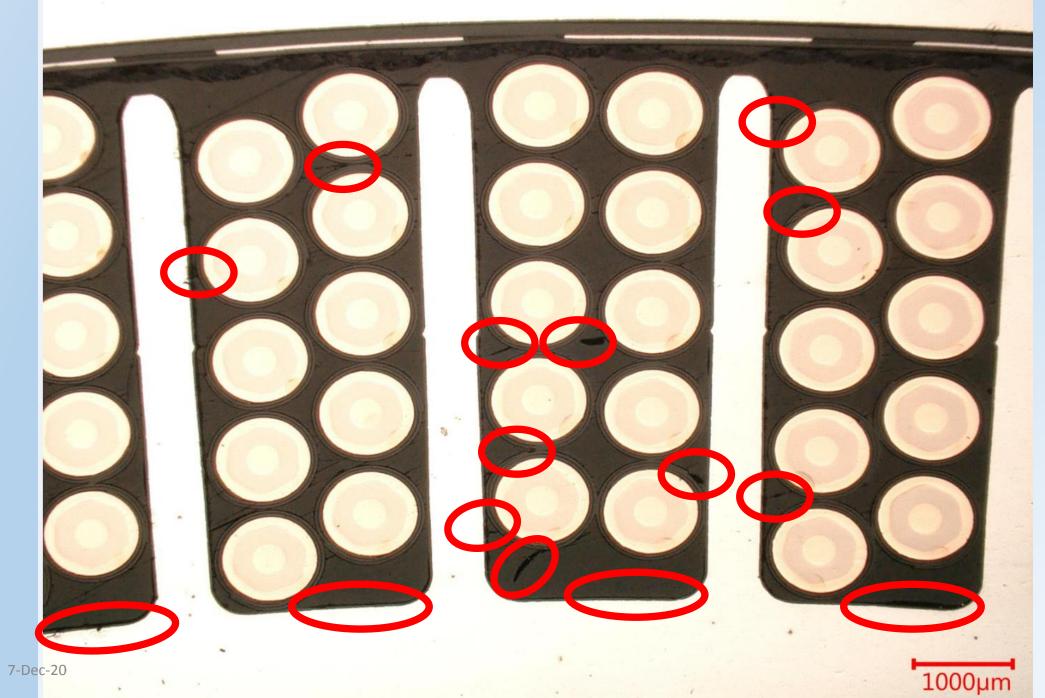
CTD v MY750 we should study the resins!
