P-ONE Virtual Meeting

STRAW-b status update

STRAW-b – 2nd P-ONE pathfinder

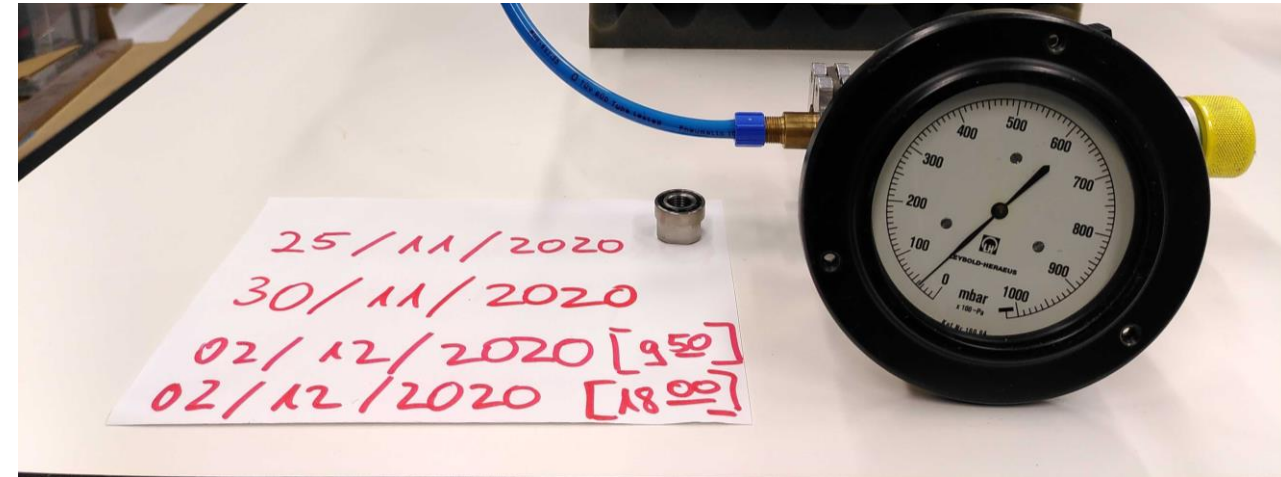
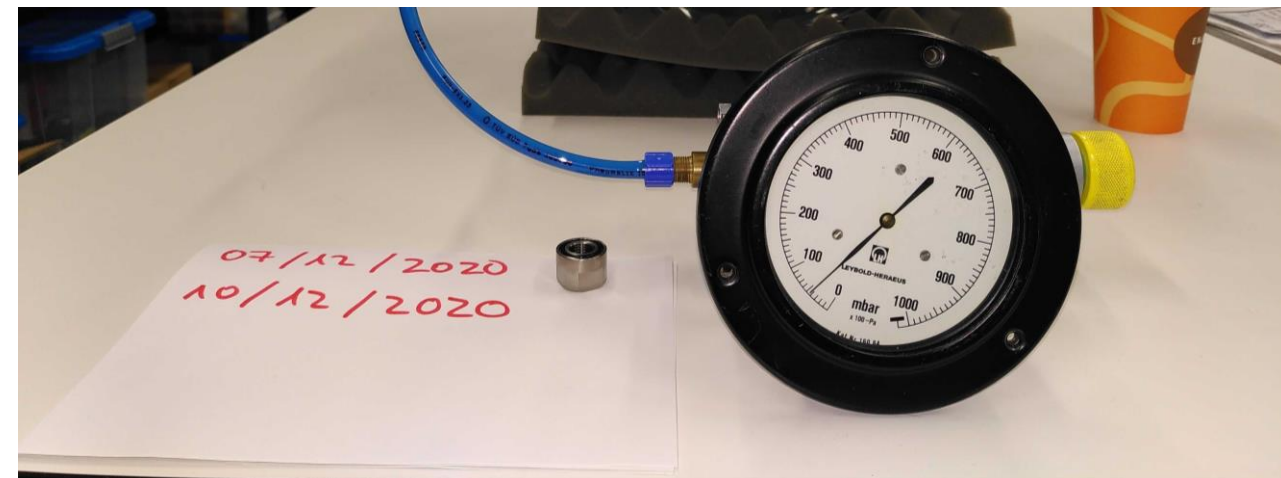
SM2 – conclusion & next steps

- Long term test shows no leak
- Failure origins most probably from penetrator
 - Vacuum port cannot be excluded – but tight if cap is closed correctly (must have happened several times)
 - Teroson can be excluded as fault location
 - Also loose contact of penetrator adapter as fault possible
- Long term monitoring with removed sealing compound
- Additional leakage search with coloured water (tank test)

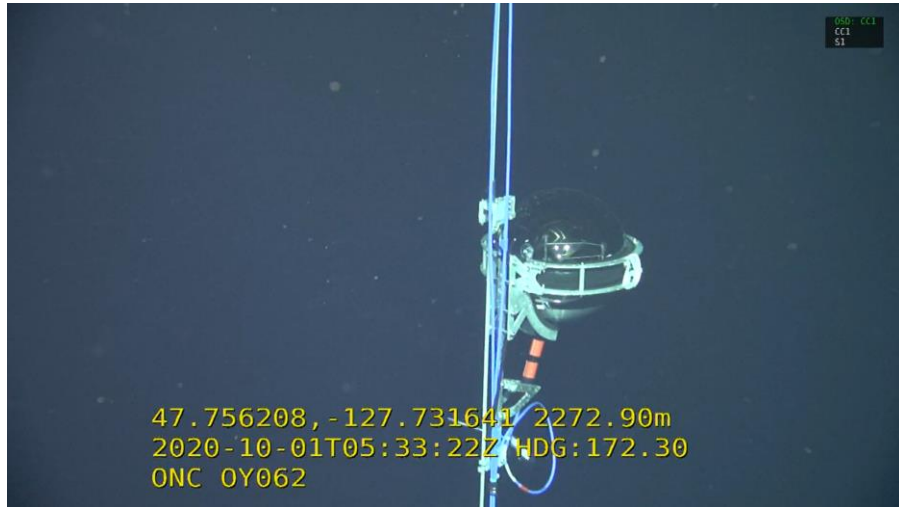
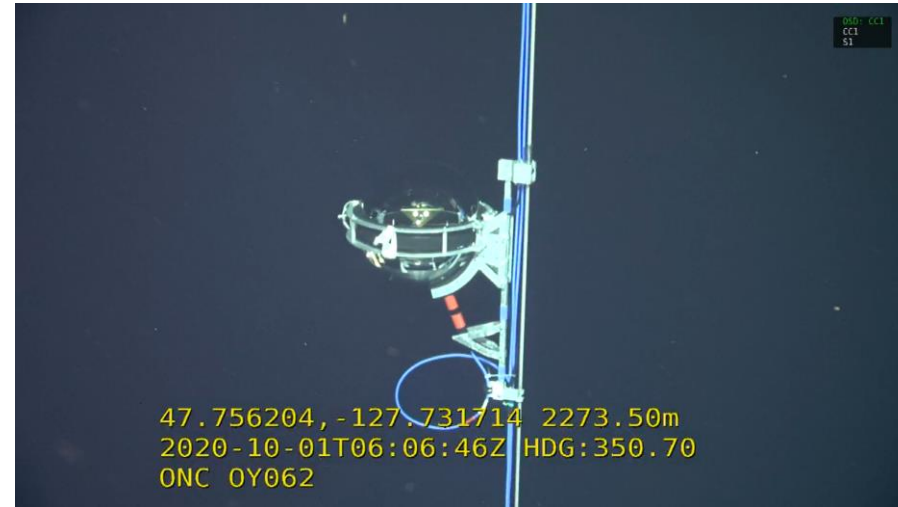
SM3 – failure/timeline recap

26/09 – Last connection prior to deployment – SM3 responds; p/T/H normal (354.46mbar/22.88°/30.31%)

- Voltage drops to 12.5 to 15V (fluctuating)
- Current rises to 1.25A
- Corresponds to a resistance of around 10-12 Ohm
 - VEOC at the SM3 has a length of 384m (with 39.3 Ohm one way)
 - Short at the SM3 is unlikely (voltage would be around 96V)
 - Low resistance indicates that the failure originates from the connector at the MJB
 - Probably caused by water in the connector – could explain voltage fluctuation due to changing resistance
