COMPASS TB: W45 has purity

Carlos Azevedo
(cdazevedo@ua.pt)

28th September 2021

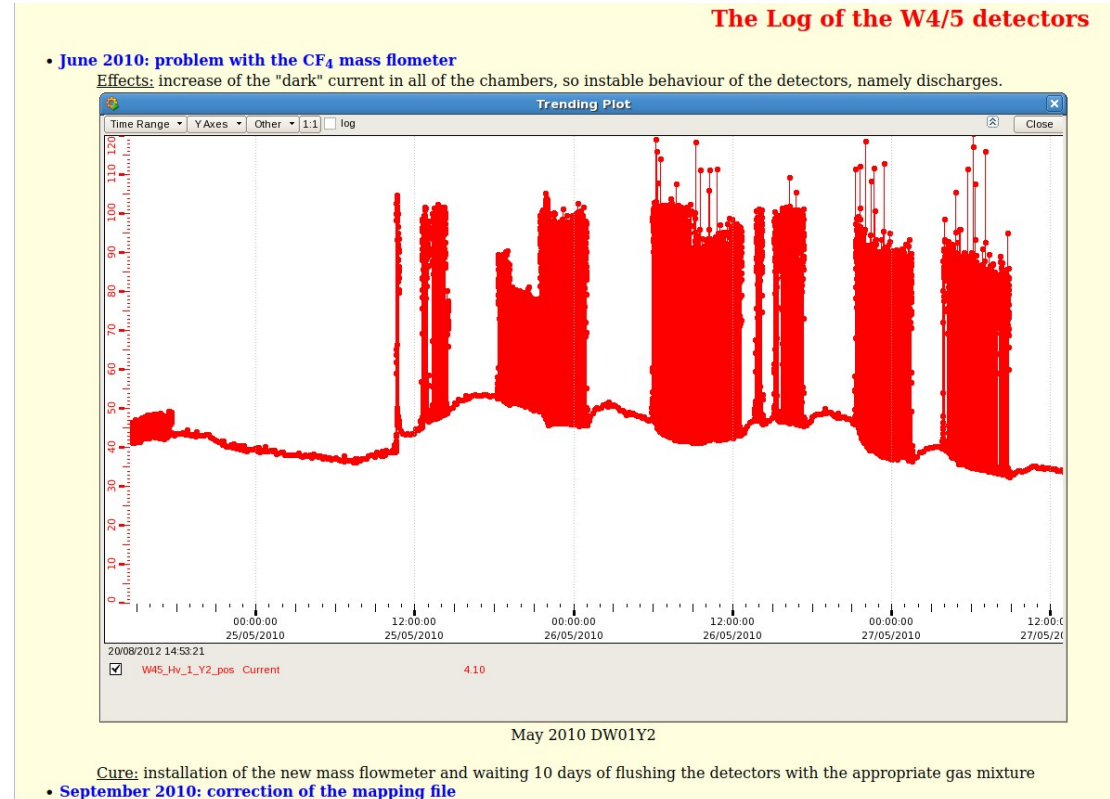
Possible explanation?

- Google pointed me an old W45 page
 - Link not in COMPASS webpage
 - https://wwwcompass.cern.ch/compass/detector/w45/new_page/log/log.html
