# COMPASS Silicon Status and Planning 2021/2022

COMPASS/AMBER Joint Technical Board Meeting

November 16<sup>th</sup> 2021

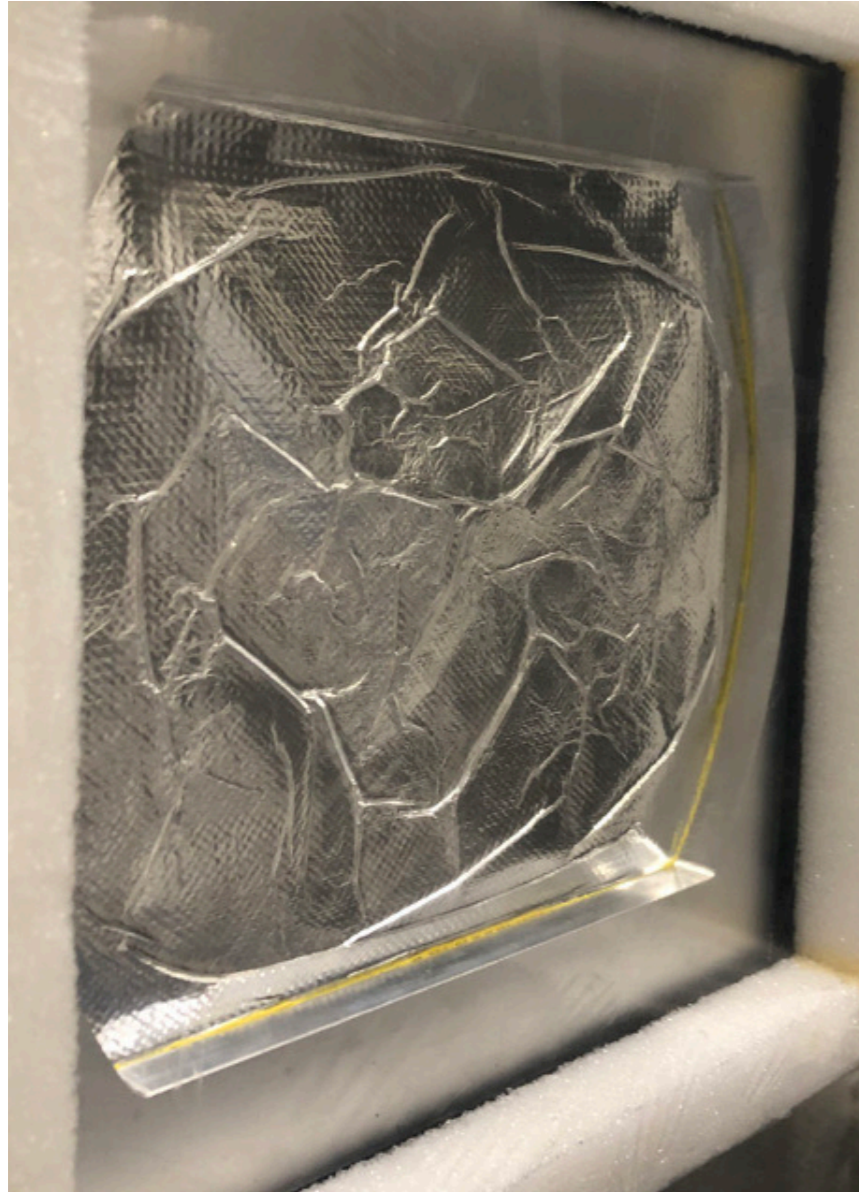
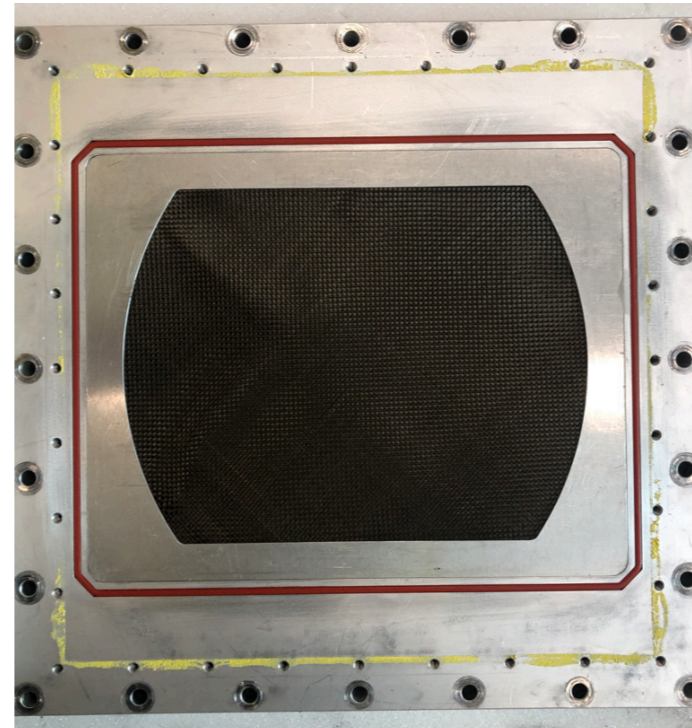
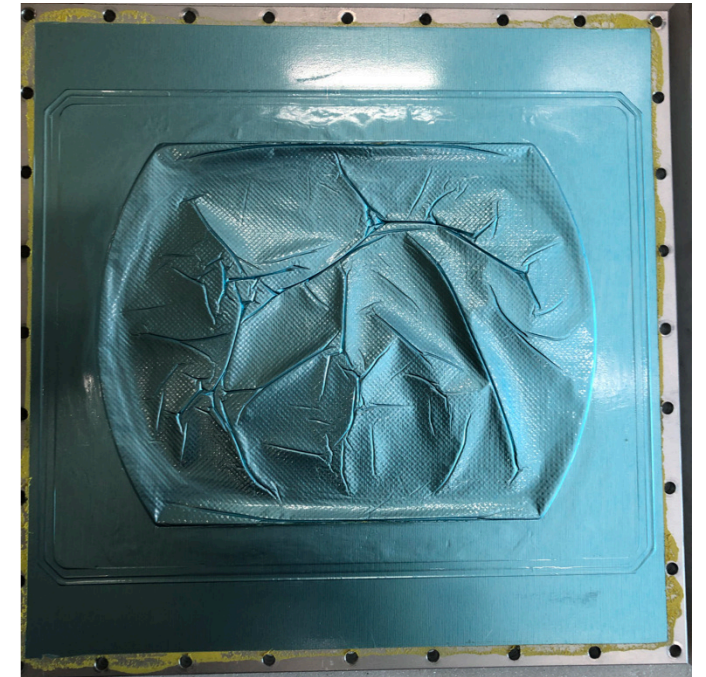
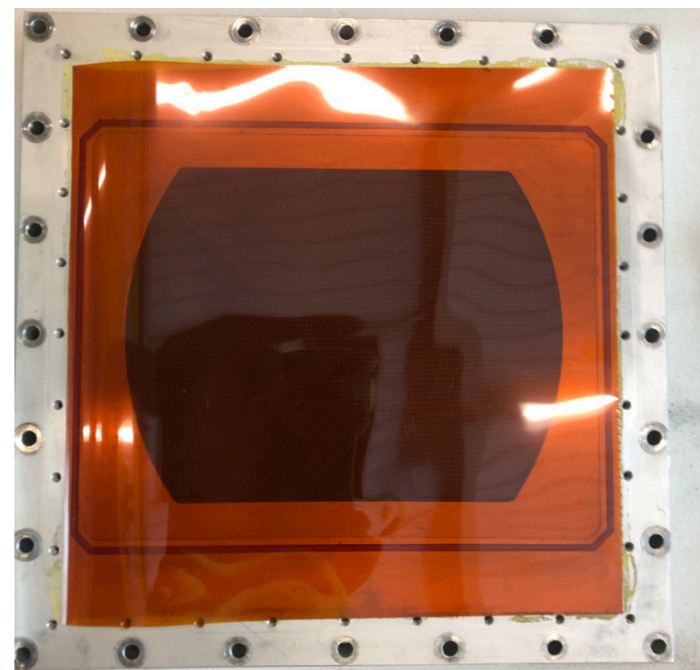
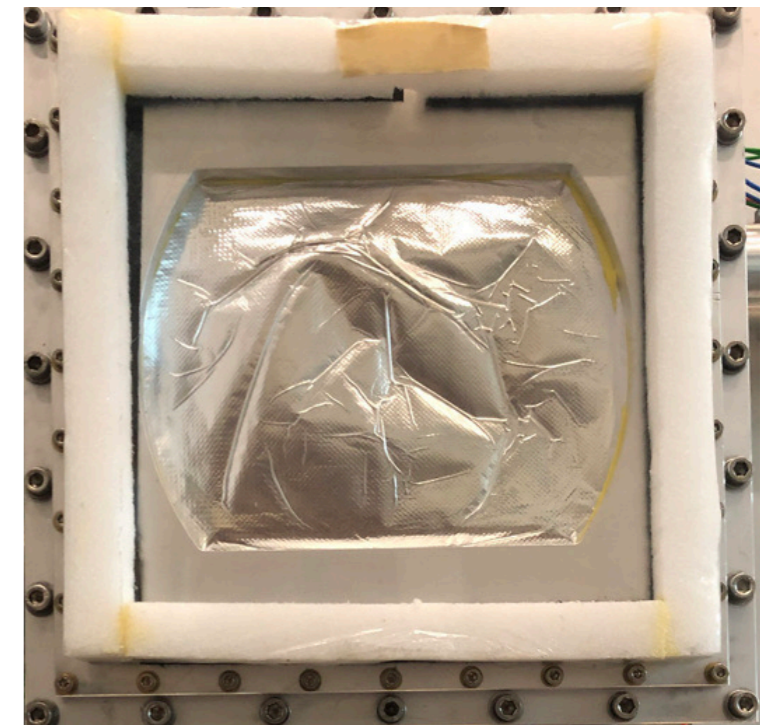
# Report from 2021 COMPASS Run

- Full test of the system
- First test of cooling system after refurbishment - some issues fixed:
  - Open/Closed valve status of inlet valves (“normally open”)
  - Heater for LN<sub>2</sub> reservoir not connected
  - Sealing for one station transfer line missing - LN<sub>2</sub> leak
- High voltage trips for SI02U - probably shortcut if repeater card is fixed with screws
- Incident: station windows blown up
  - All tested - all tight and stable after repair
