# DC5 repair plans

## COMPASS Technical Board Meeting 2021-11-16

Caroline Riedl (UIUC)

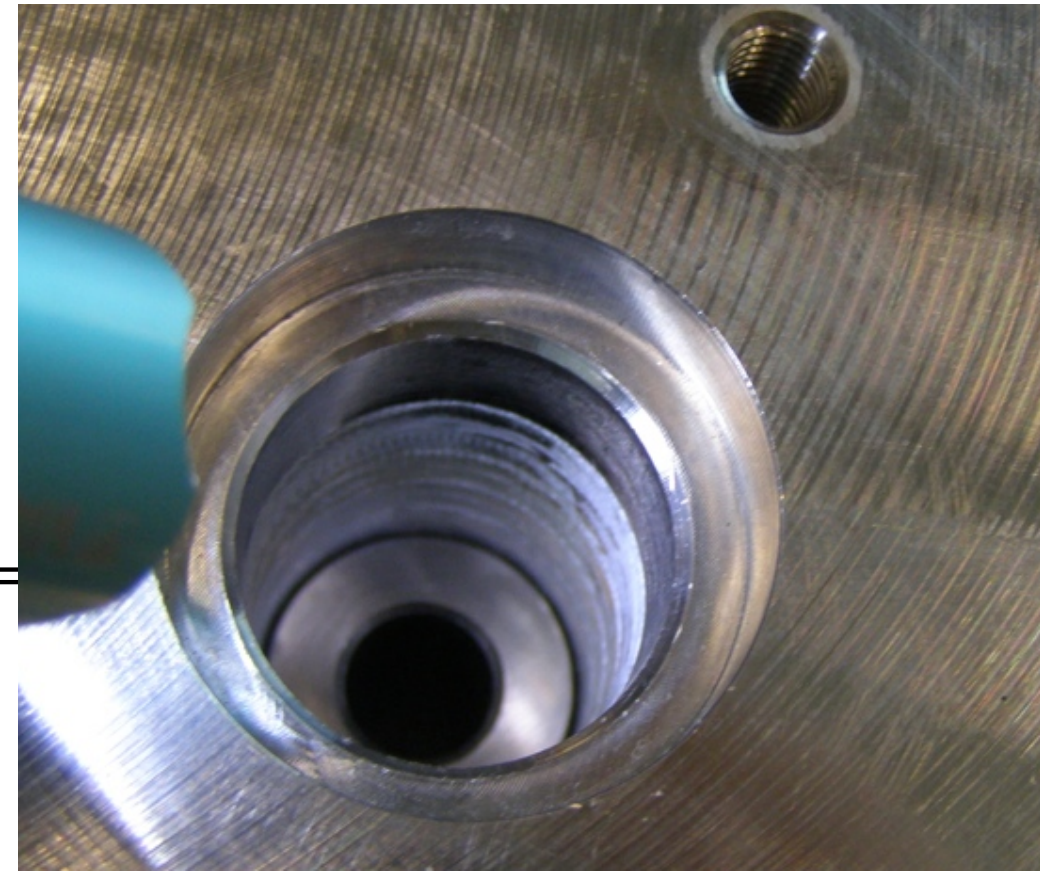
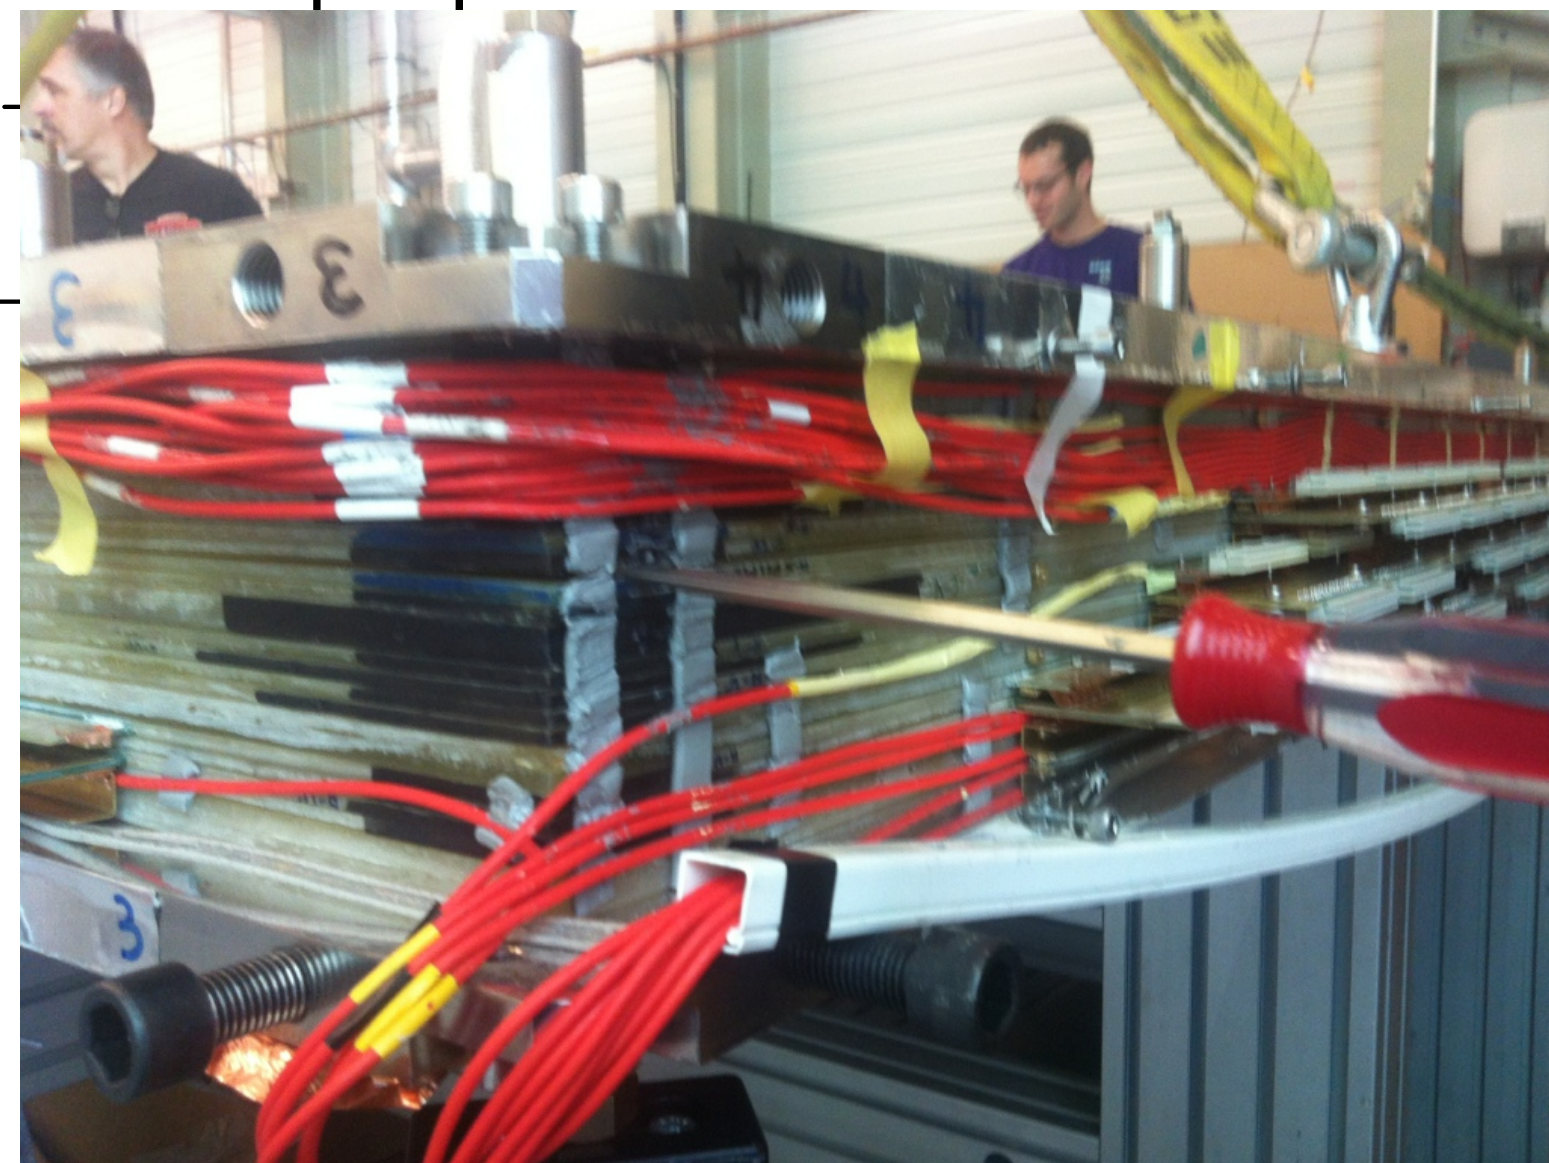
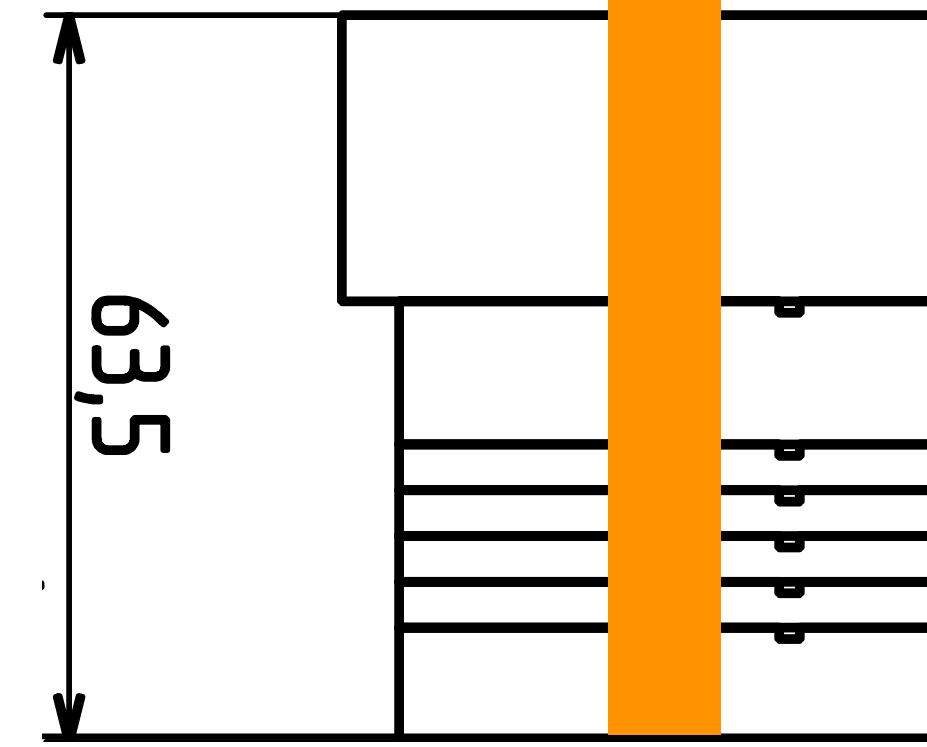
DC5 assembly pin (40x)

20x: every 2nd pin

X-anode is now topmost frame

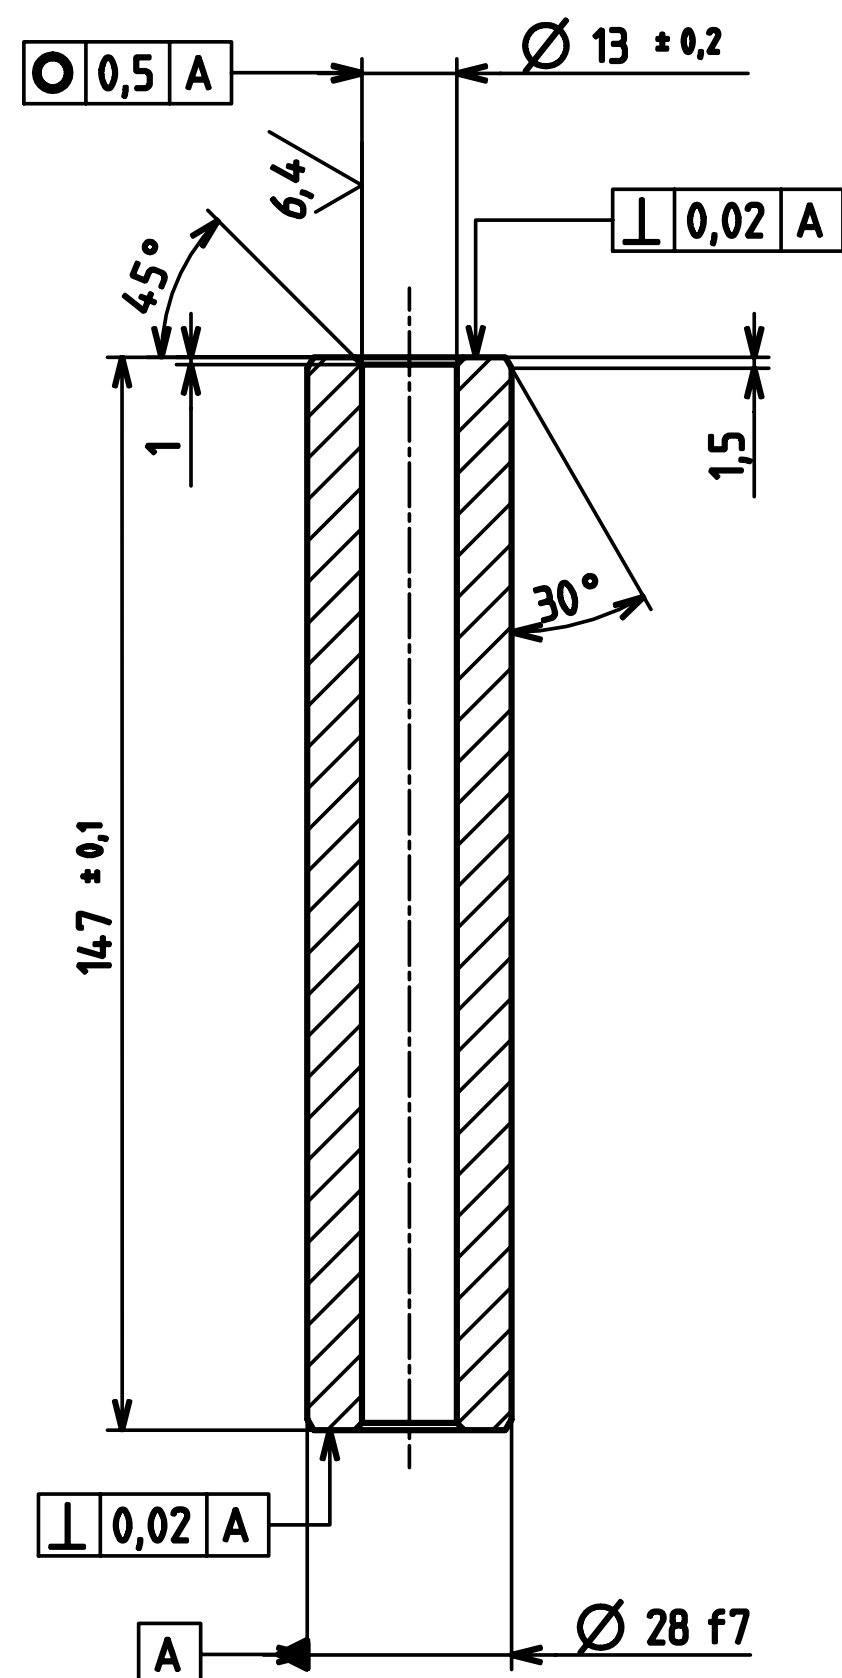
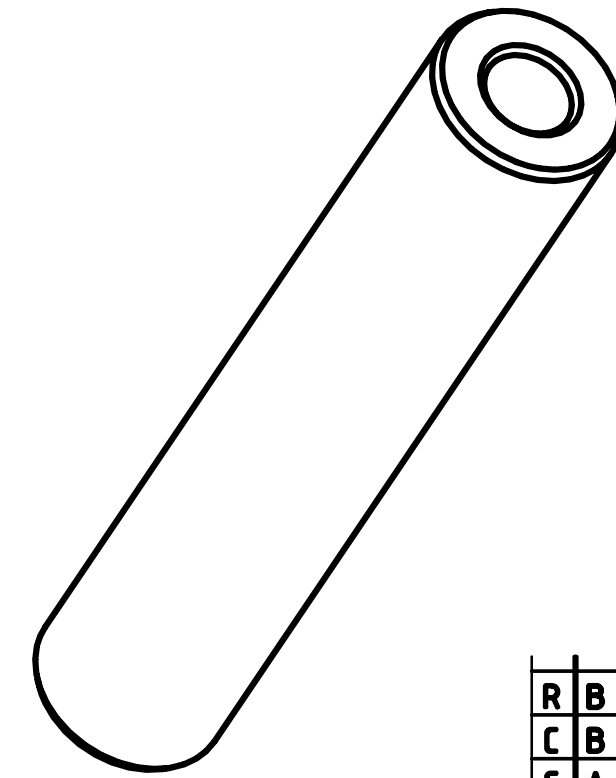
- 20 new steel pins from Atlas Tool Works, Inc. (Chicago, IL) have arrived at UIUC
- Nominal design (dia 28 mm)
- At UIUC Nuclear Physics Lab: will knurl 10 of them

**Knurling** is a finishing process in metalworking where grooves or patterns are formed on the surface of a finished part. This process displaces the material and *increases the diameter* of the workpiece.

- First repair the broken wire
- Then replace too loose pins...
- One at a time, while nearby pins are fully engaged
  - ... with knurled pins (if holes got wider), or
  - ... with new nominal-design pins (if old pins show wear)
- Decide on case-by-case basis.
  - 5-6 are really bad.
  - Corners are probably fine.
- If needed, knurl more at CERN using knurling tools (?) in COMPASS workshop (French knurl = moleter?)
