Xboxes Update

15/09/2020

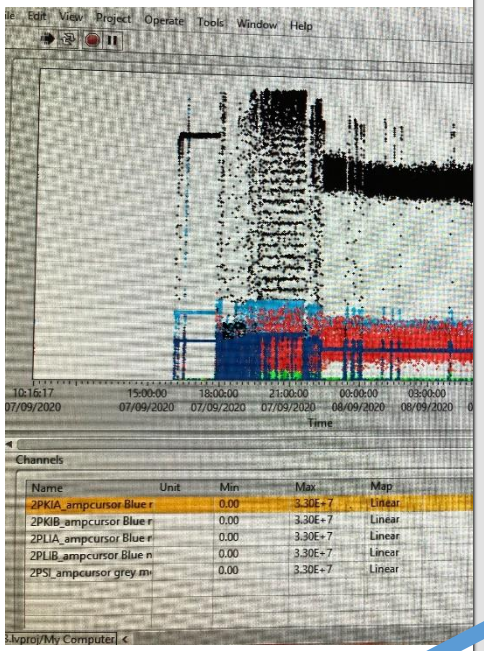
- XBOX1: Waiting for new PC
- XBOX2: Off due to computer problem
- XBOX3AB: T42 Structures
  - Restarted yesterday afternoon
  - Currently OFF due to CRAZY behavior of PKI_B

This is really large!

e.g. for 10MW setpoint the klystron pulses (PKI A&B) are usually ~6000

This disappeared after restarting main (not rt)

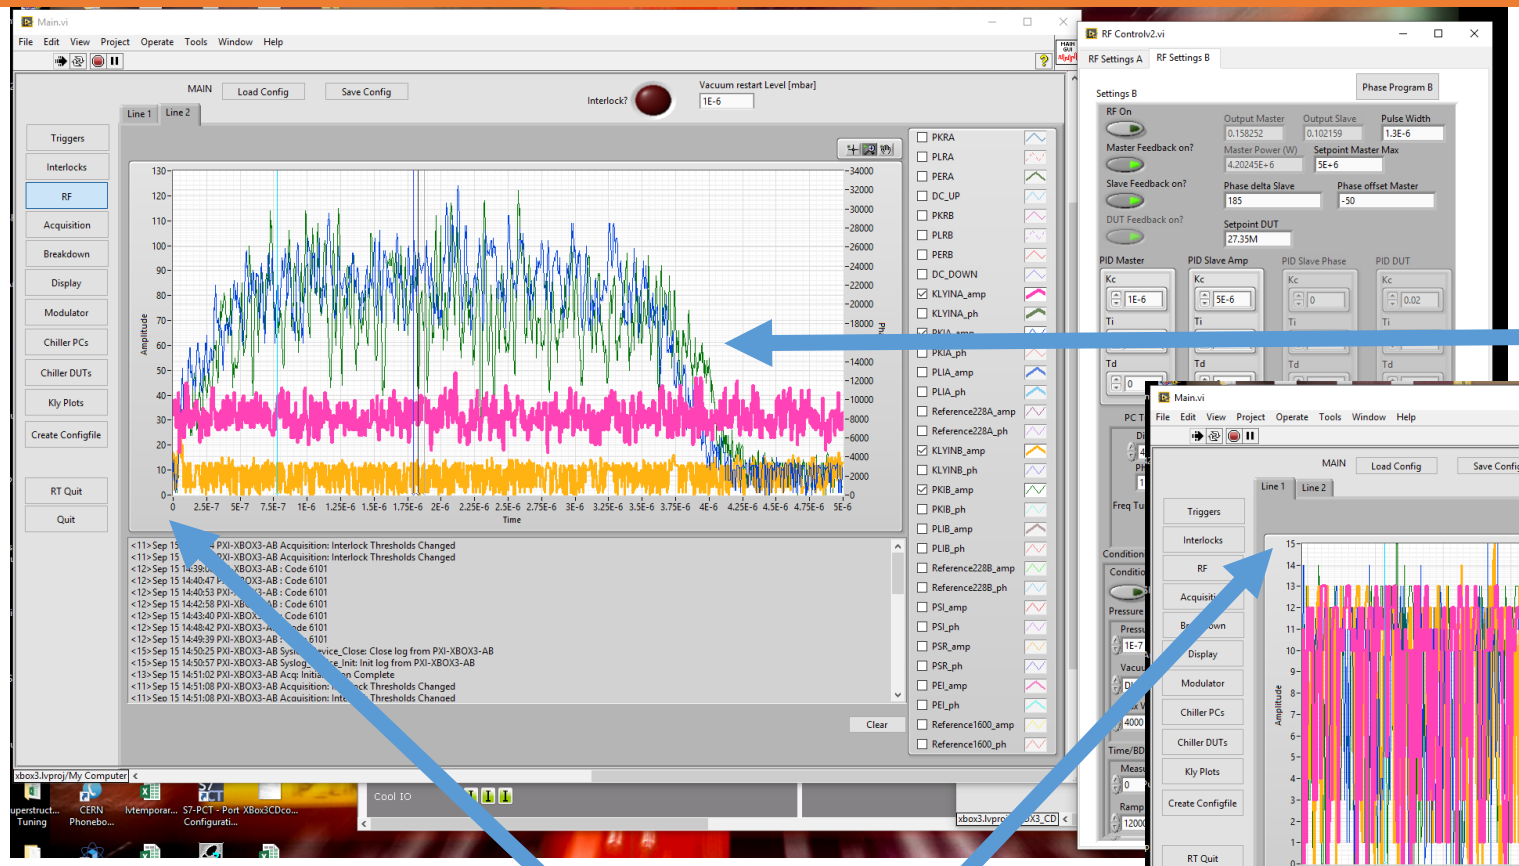
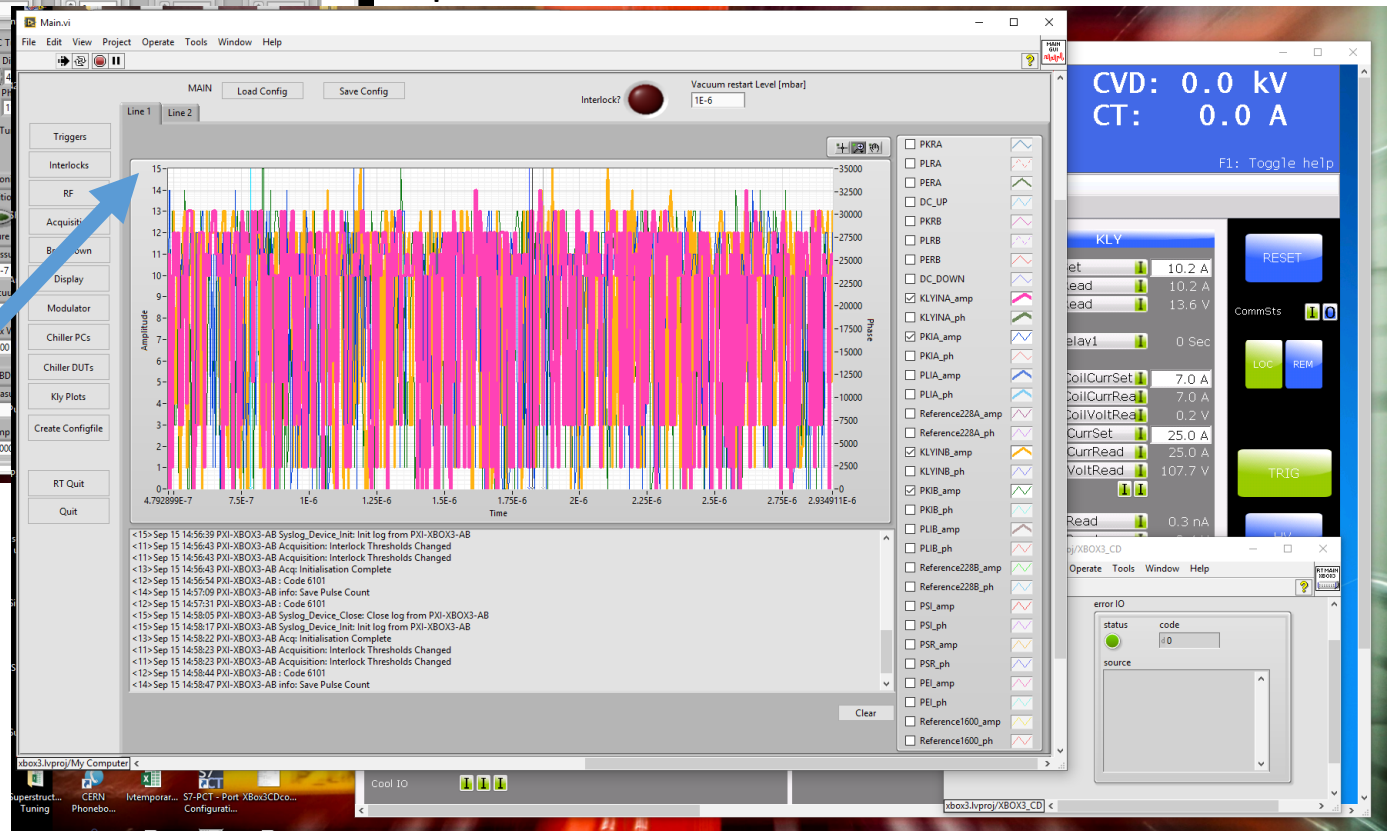
XBOX3 AB – Crazy Times

After restart the channels (PKI_B, PKI_A, KLY_INA, KLYIN_B) can look like either of these two.

Modulator is ON which can explain this pulse

Amplitude is very small though, it's essentially noise.
