Tunnel Asset Management SCE-DOD-FS & BE-CEM Collaboration Meeting

John Osborne, Roddy Cunningham & Darragh O'Brien
SCE-DOD-FS

19/03/2021

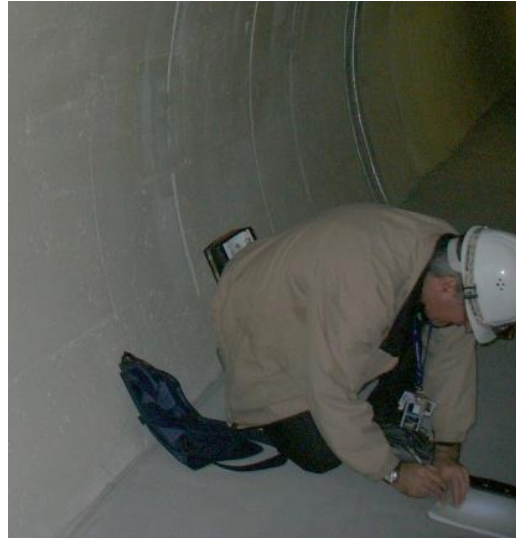
Traditional Tunnel Inspections

Section CP33 - Tunnel LHC (haut 6350)

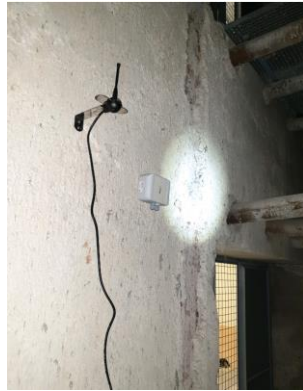
Tell Tales
(TT10, RB26
etc)

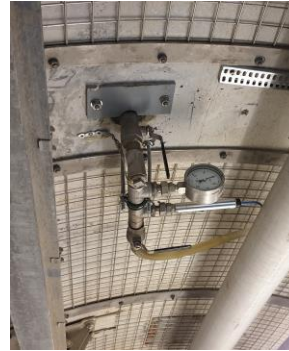
Extensometers
(LHC P.4
headwall)

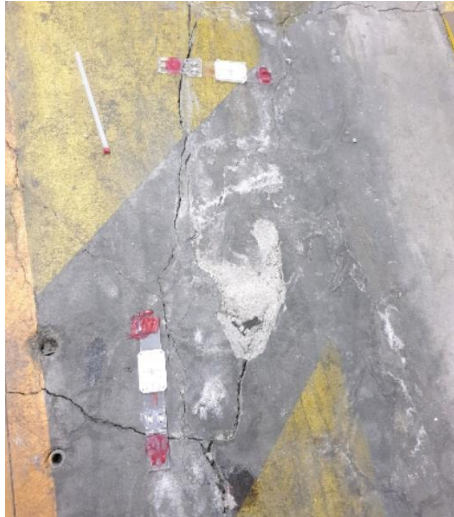
Fibre Optics in
collaboration with UCC
(TT10, Atlas cavern)

Monitoring Central Database

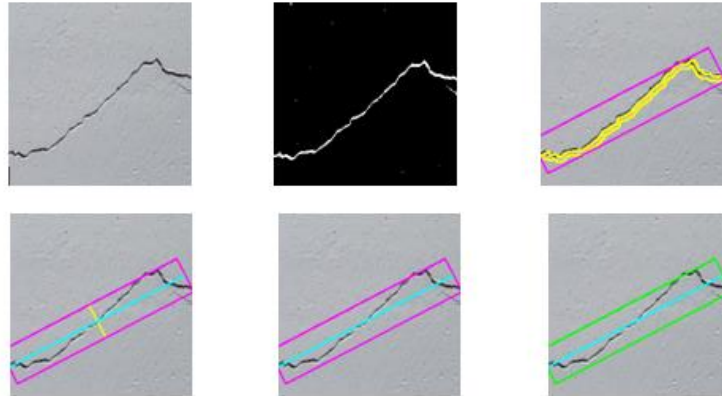
The main objective of research is to automatically detected and subsequently classify crack in tunnel lining images using a **Convolution Neural Network (CNN)**.

Outputs from the CNN

1. Numerical information on the crack % and crack type % in a tunnel.
2. A further breakdown of the numerical information into the chainage of the tunnel

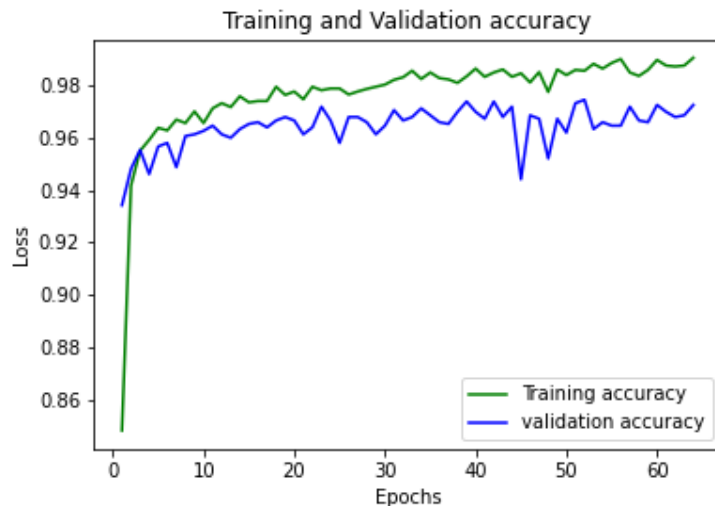
CNN for Crack Detection

Using ~350 images of cracks from tunnels within CERN a database of 7600 smaller images of crack and non crack was created.

Using the technology of transfer learning a CNN was developed to detect cracks in input images.

The CNN achieved an accuracy in training of ~ 97 % in relation to training and validation and out of sample test accuracy of 90%.

The CNN is now implementing the sliding window technique to detect cracks in larger Images.

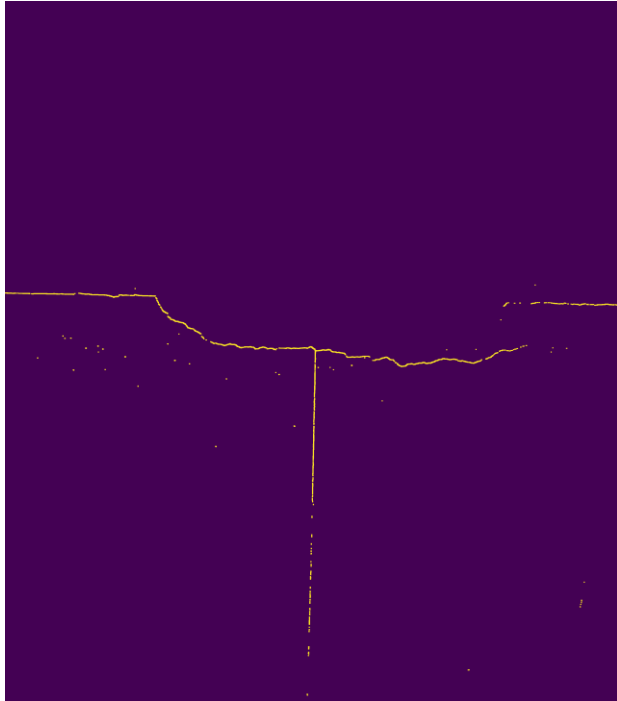
Classification of the Images

If a crack is detected in the stitched images it is then passed to be classified in 5 simple steps :

1. Images are processed.
2. Contours of the cracks located.

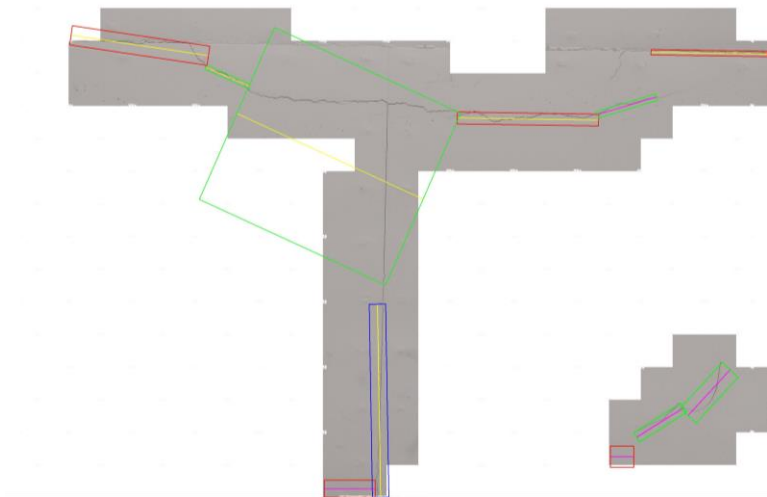
Classification of the Images

The stitched images are now ready to be classified in 5 steps :

1. Images are processed.
2. Contours of the cracks located.
3. Bounding Box put around the contours.
4. The angle of the bounding box defines the class.
5. Bounding box colour changes per class given.

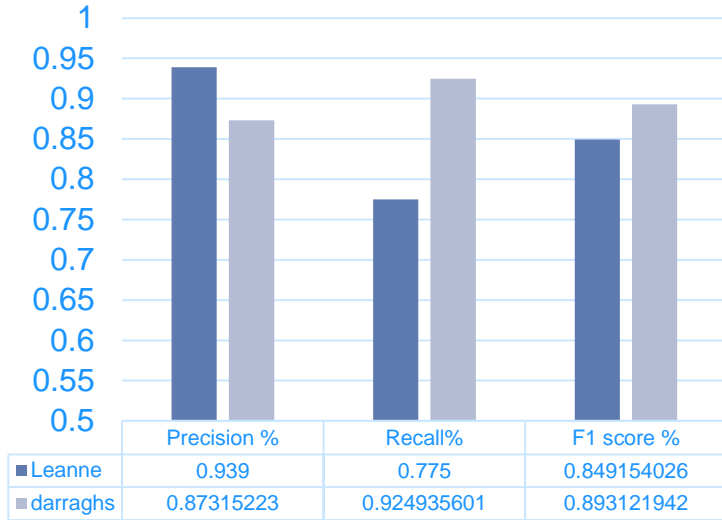
Crack Detection Comparison with Previous Studies

- Precision shows how much of the detected cracks were actually cracks.
- Recall is a measure of how much of the actual cracks were detected

Previous work used an Intersection over Union (IoU) while current works use a CNN trained directly on smaller image sizes and implemented with the sliding window technique.

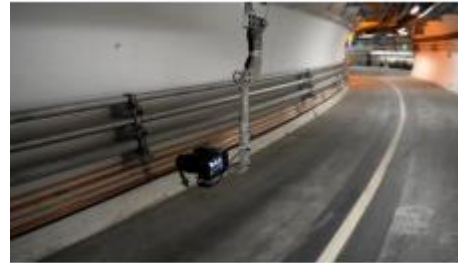
**Camera on the RP arm
extending from TIM**

- A comparison of manually collected tunnel data vs CNN data for a selected section of tunnel potentially using BE image accusation technology (CERNbot or RP arm of the TIM) over a controlled designated length of tunnel.
- This would give an idea of the accuracy of the algorithm and indicative the feasibility of future implementation in replacing current inspection methodology.

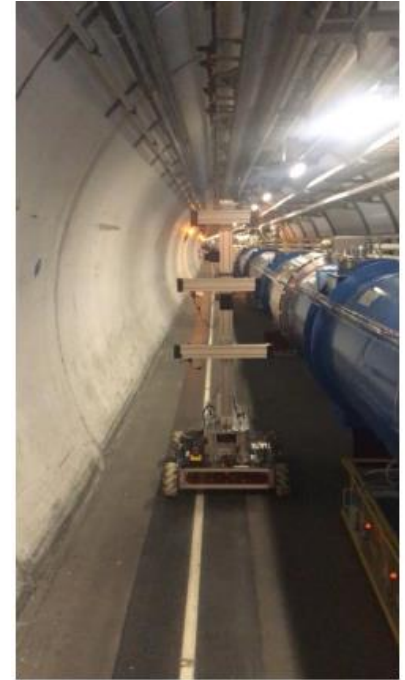
CERNbot
