PSB FOM Report W15

for the PSB operations and beam commissioning team

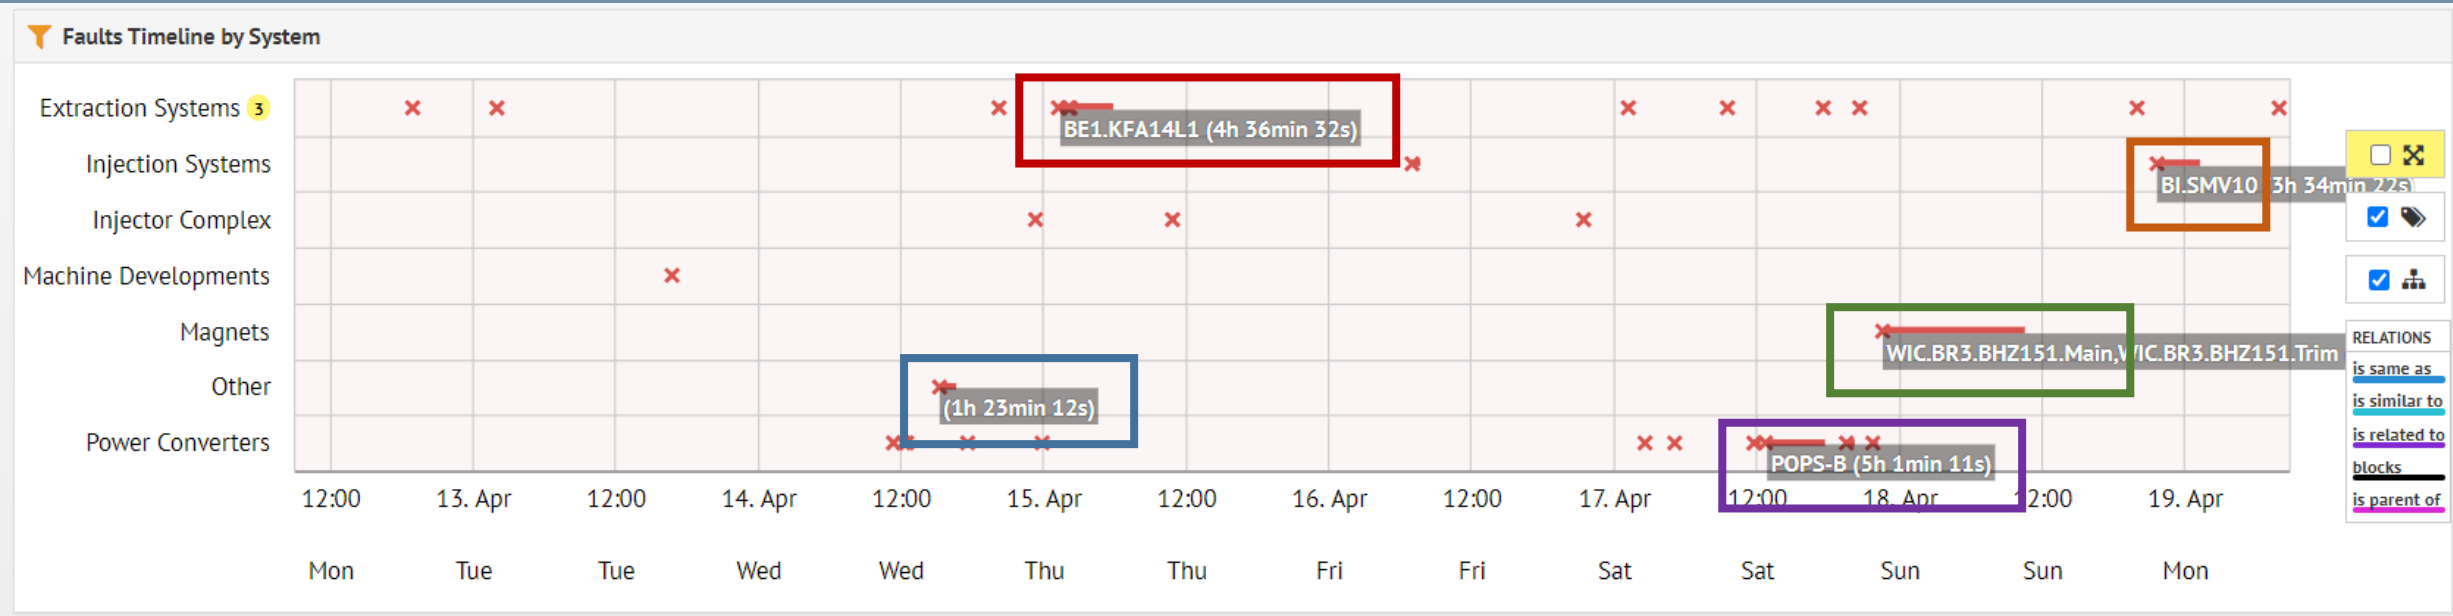
Main Faults

Beam Permit delivered by the **Extraction BIC** bypassed at the extraction kicker level and not removed from LS2.

R1 extraction kicker: new crate needed.

Spare converter on quads: bypassed for now to be checked during the TS.

Bending magnet in R3: Flowmeter needed to be replaced, access on Sunday morning.

Injection Septum: Faulty electrovalve, valve coil was changed, access on Sunday night.
