# Xboxes Update

31/03/2021

# XBOX3 AB – Line 2

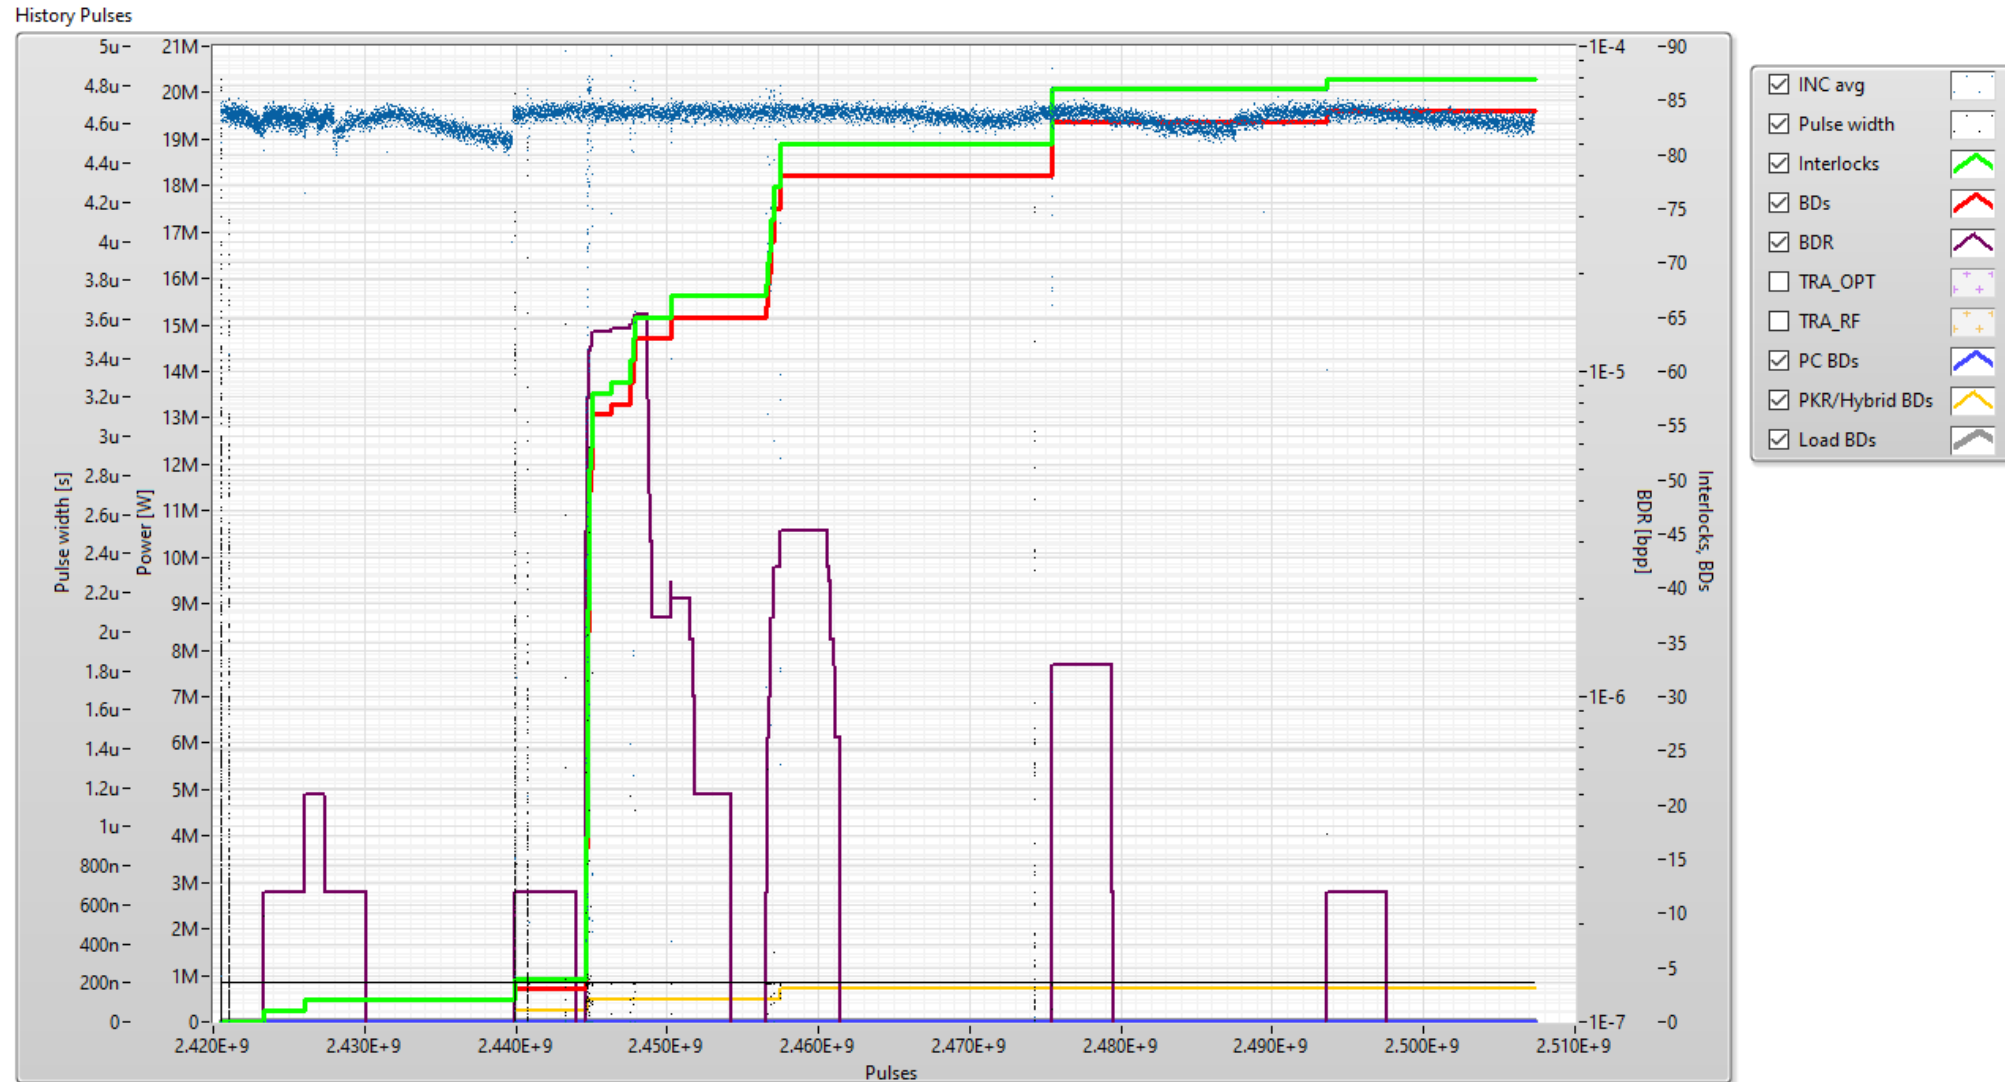
- 1.9us klystron pulse
- 200ns comp. pulse
- 200Hz rep rate per line
- **Current Power: 20.5 MW (peak)**

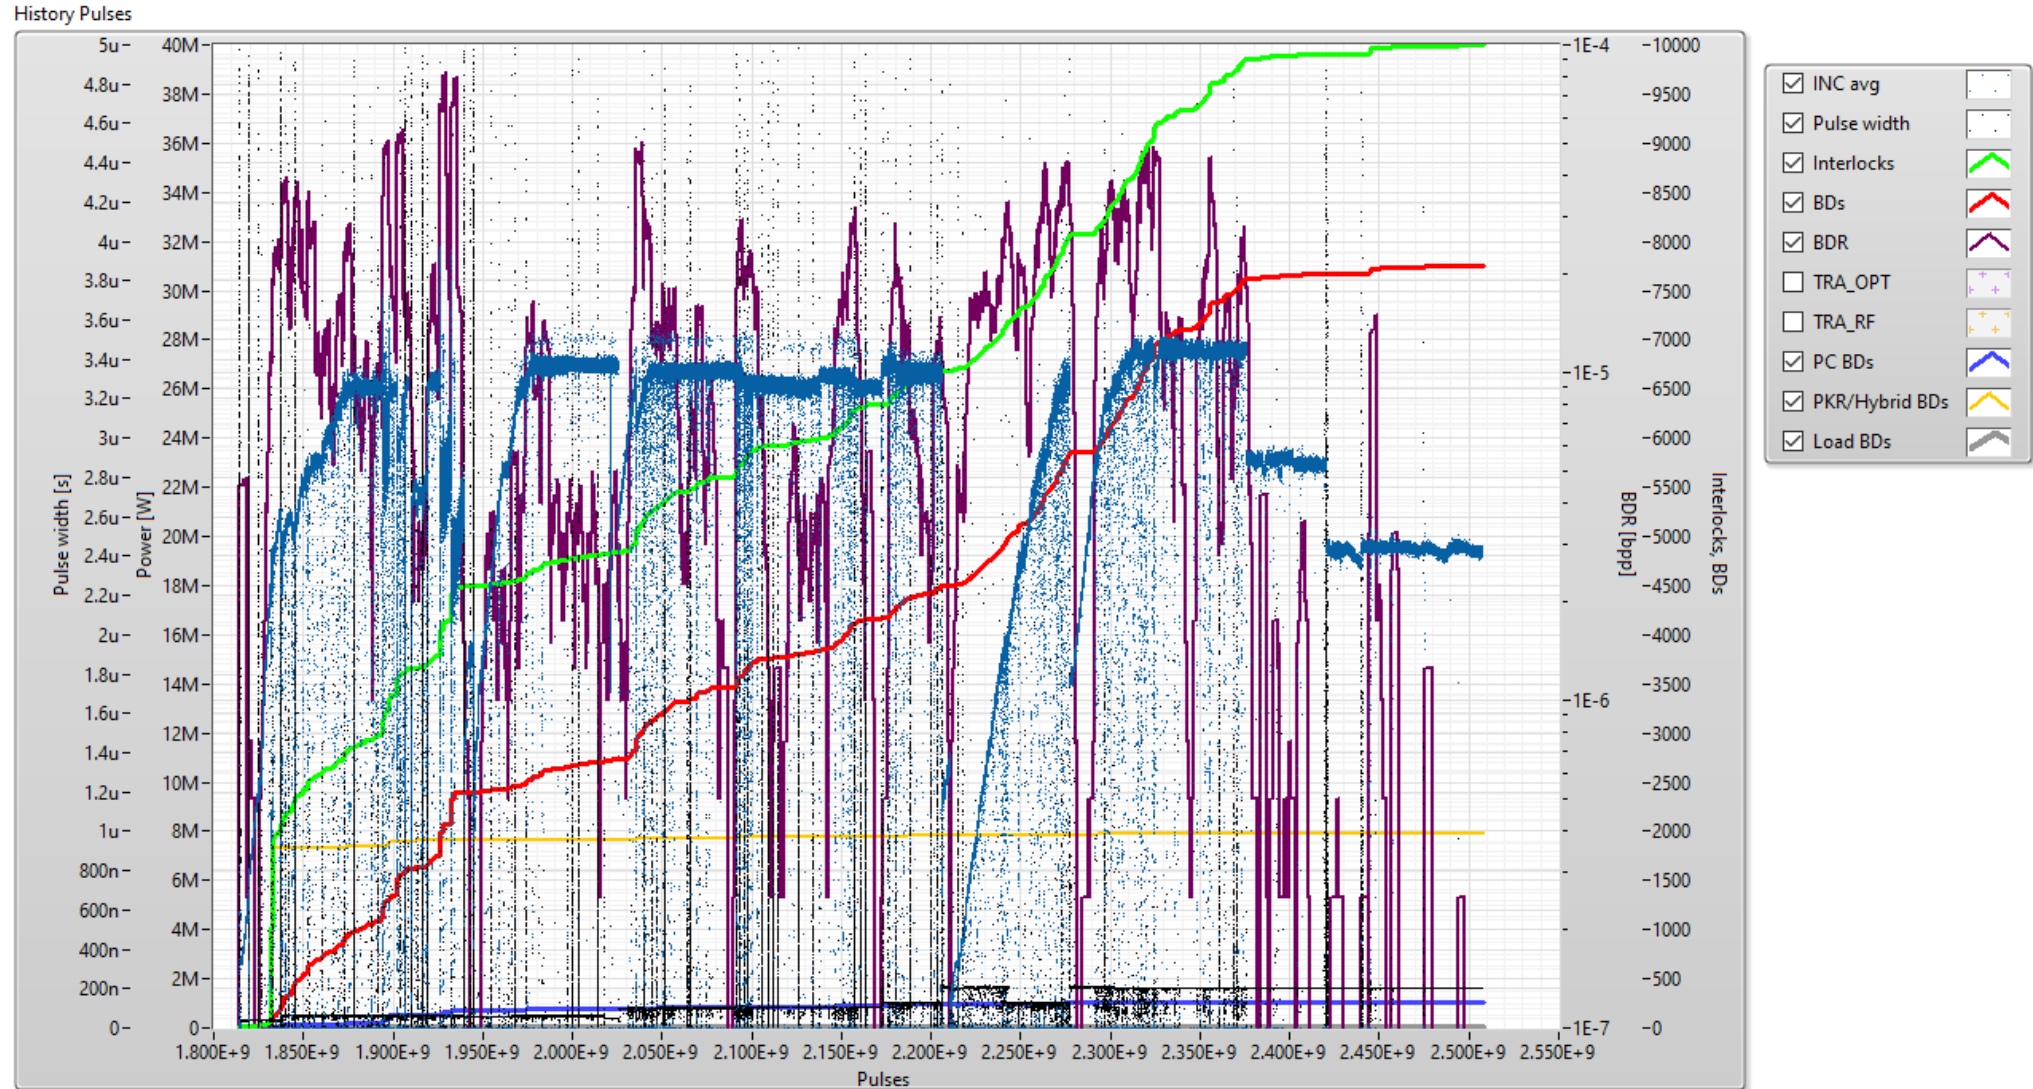
# XBOX3 AB – Line 2

- 1.9us klystron pulse
- 200ns comp. pulse
- 200Hz rep rate per line
- **Current Power: 20.5 MW (peak)**

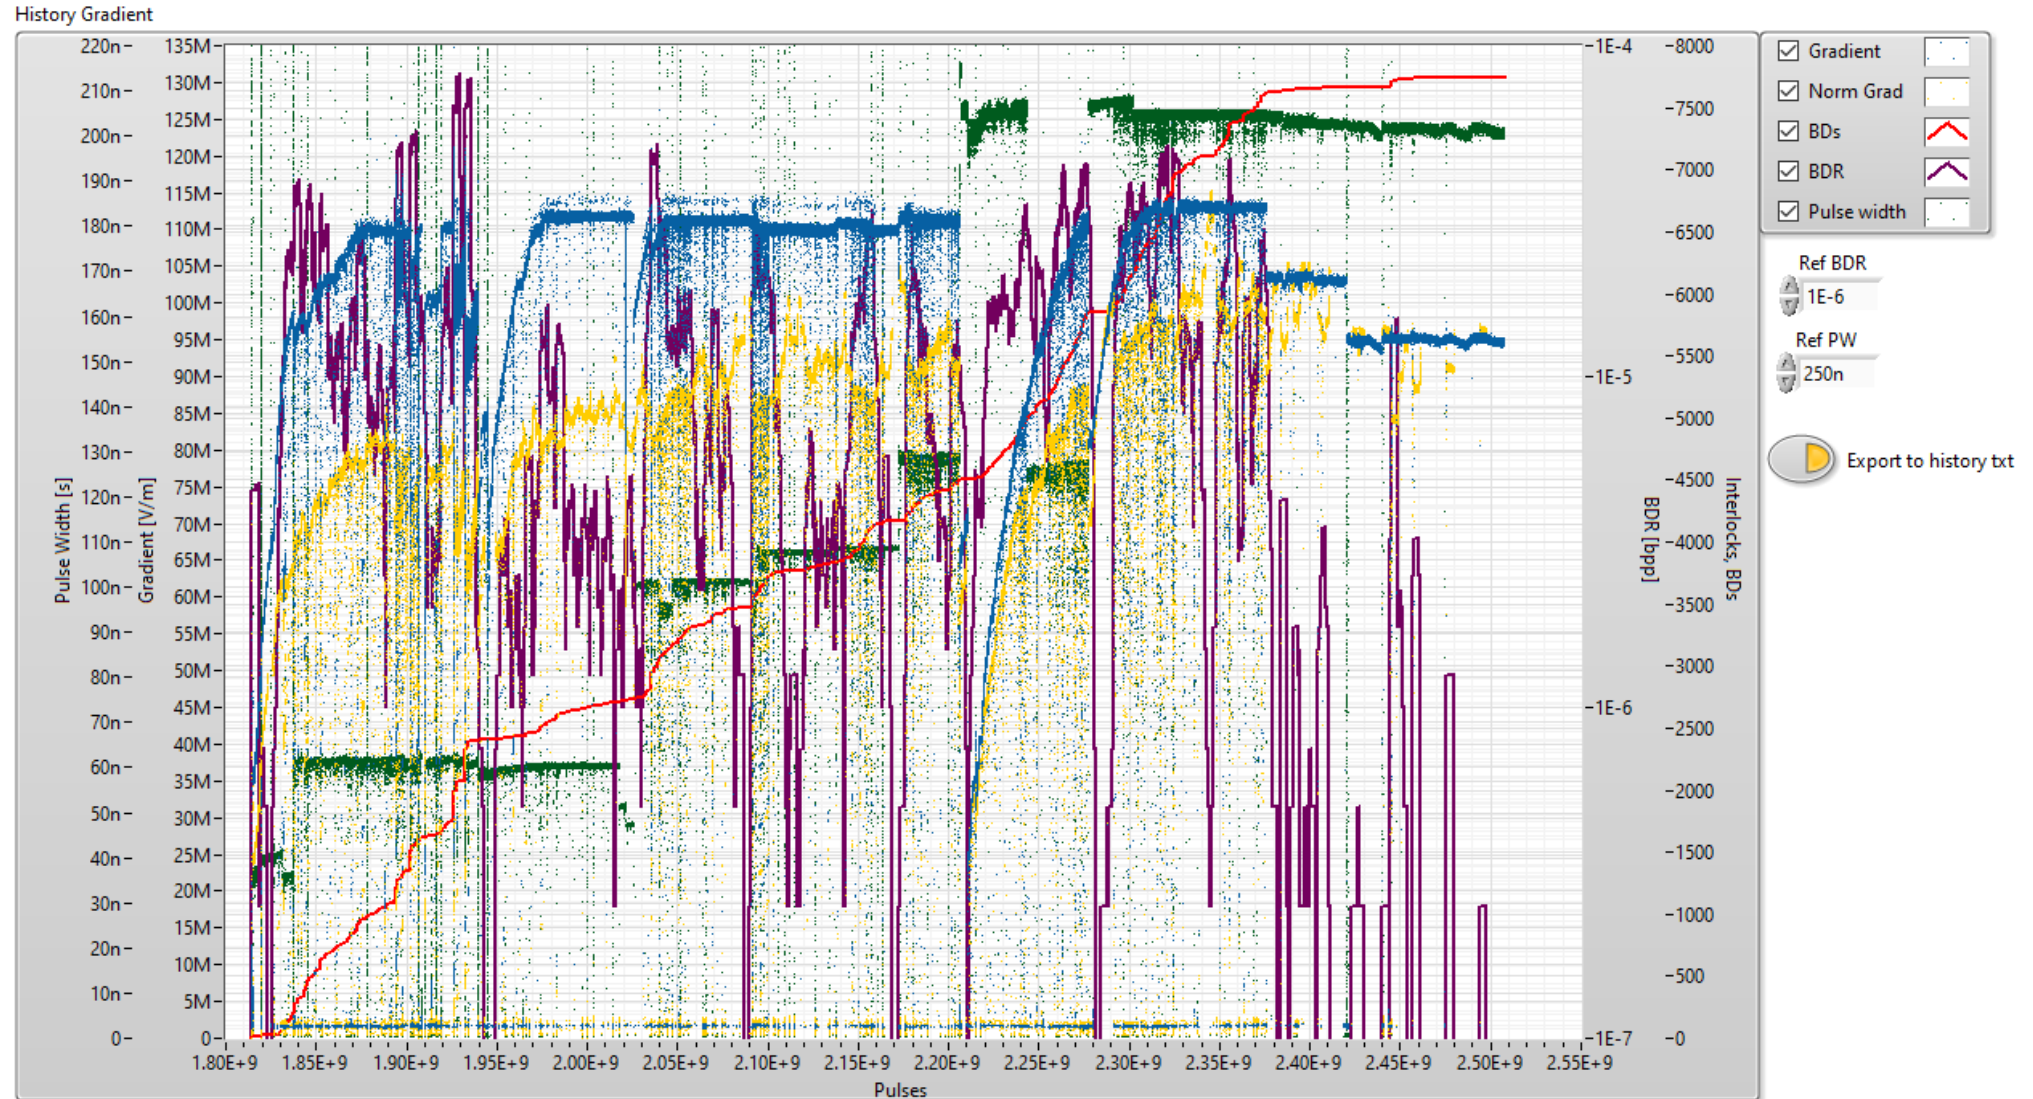
# XBOX3 AB – Line 2

- 1.9us klystron pulse
- 200ns comp. pulse
- 200Hz rep rate per line
- **Current Power: 20.5 MW (peak)**

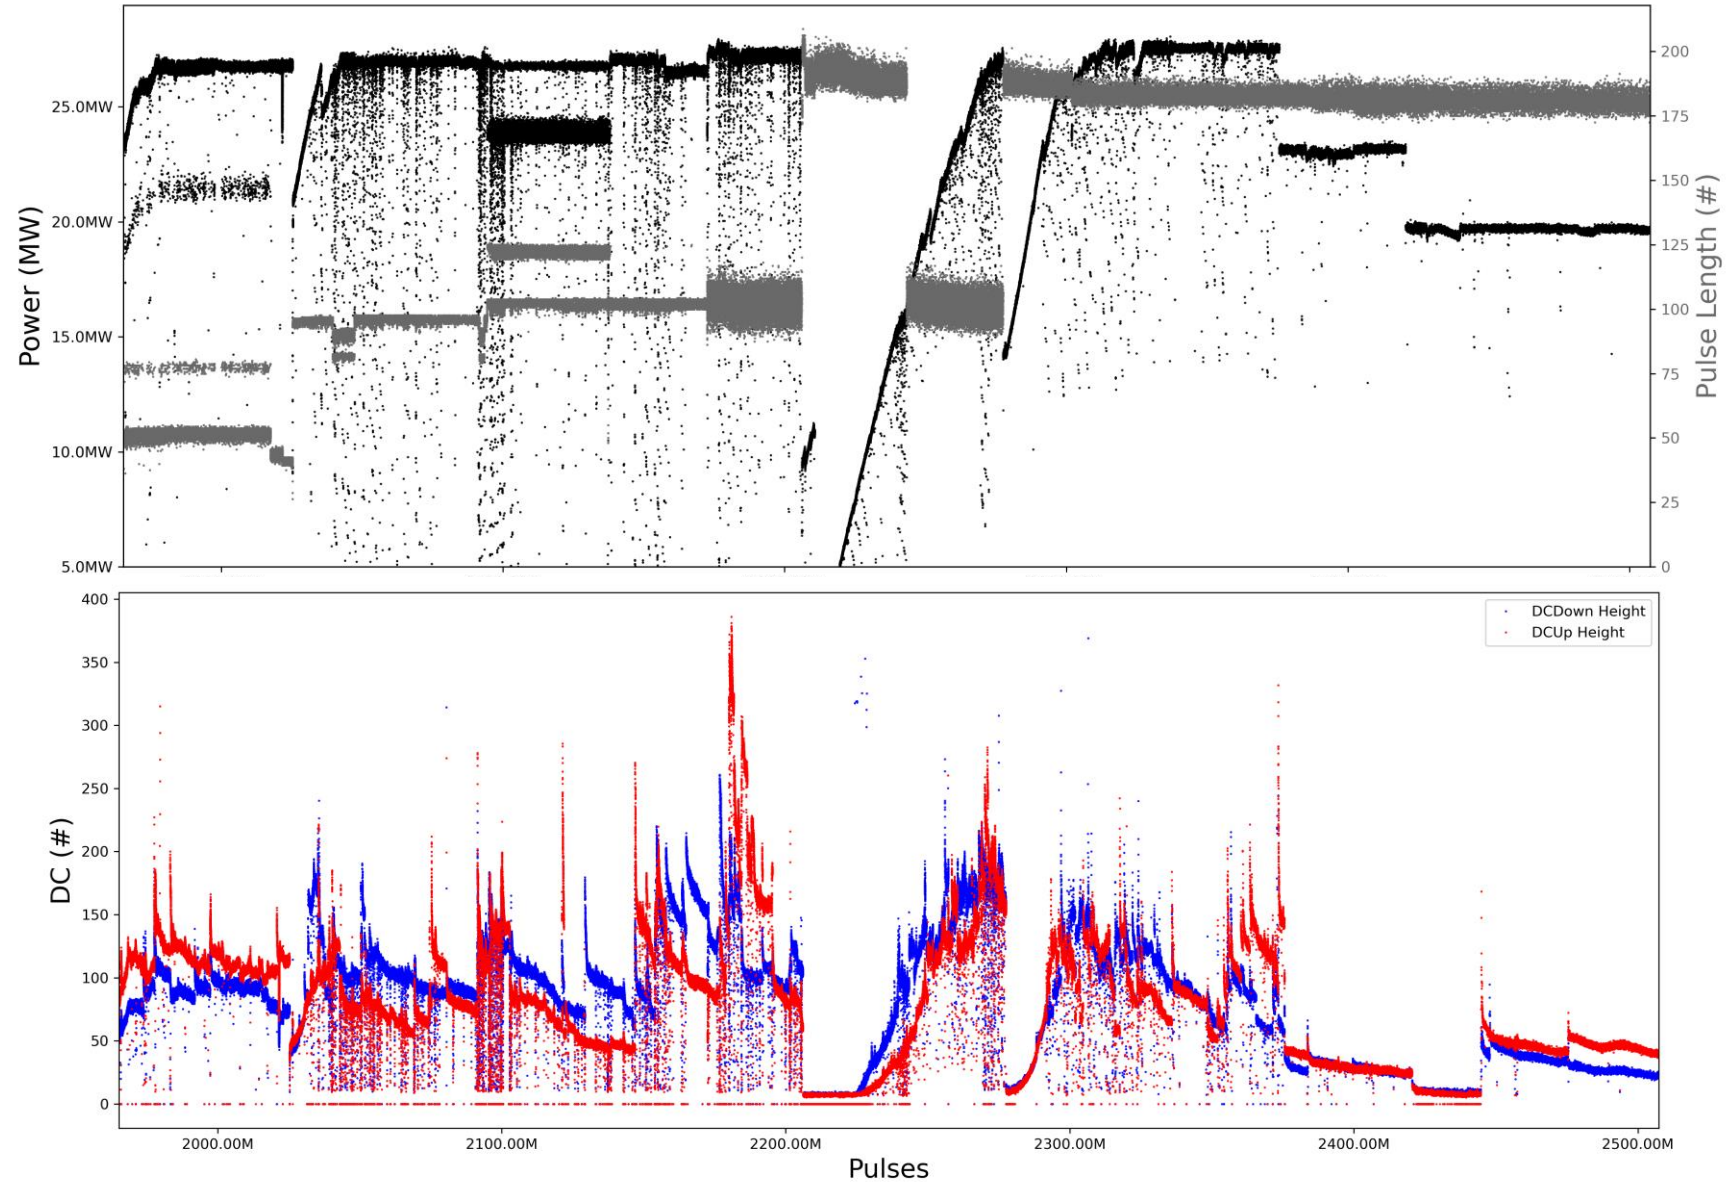
# XBOX3 AB – Line 2 – BD Localization (October - Now)

- 1.9us klystron pulse
- 200ns comp. pulse
- 200Hz rep rate per line
- **Current Power: 20.5 MW (peak)**
