Current Status of **Nanometer Beam Size Monitor** for ATF2

TIPP 2011 Chicago, 11 Jun. 2011

Shintake Monitor's largest difficulty at present

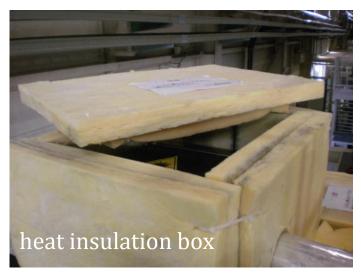
stabling and monitoring laser system temperature

vibration removal in laser transport

laser position fluctuation at IP ${\sim}10~\mu m {\rightarrow} {\sim}1~\mu m$
