# A Machine Protection Systems perspective on the commissioning

November 25<sup>th</sup>, 2021, 10<sup>th</sup> LHC Operations "Evian" Workshop

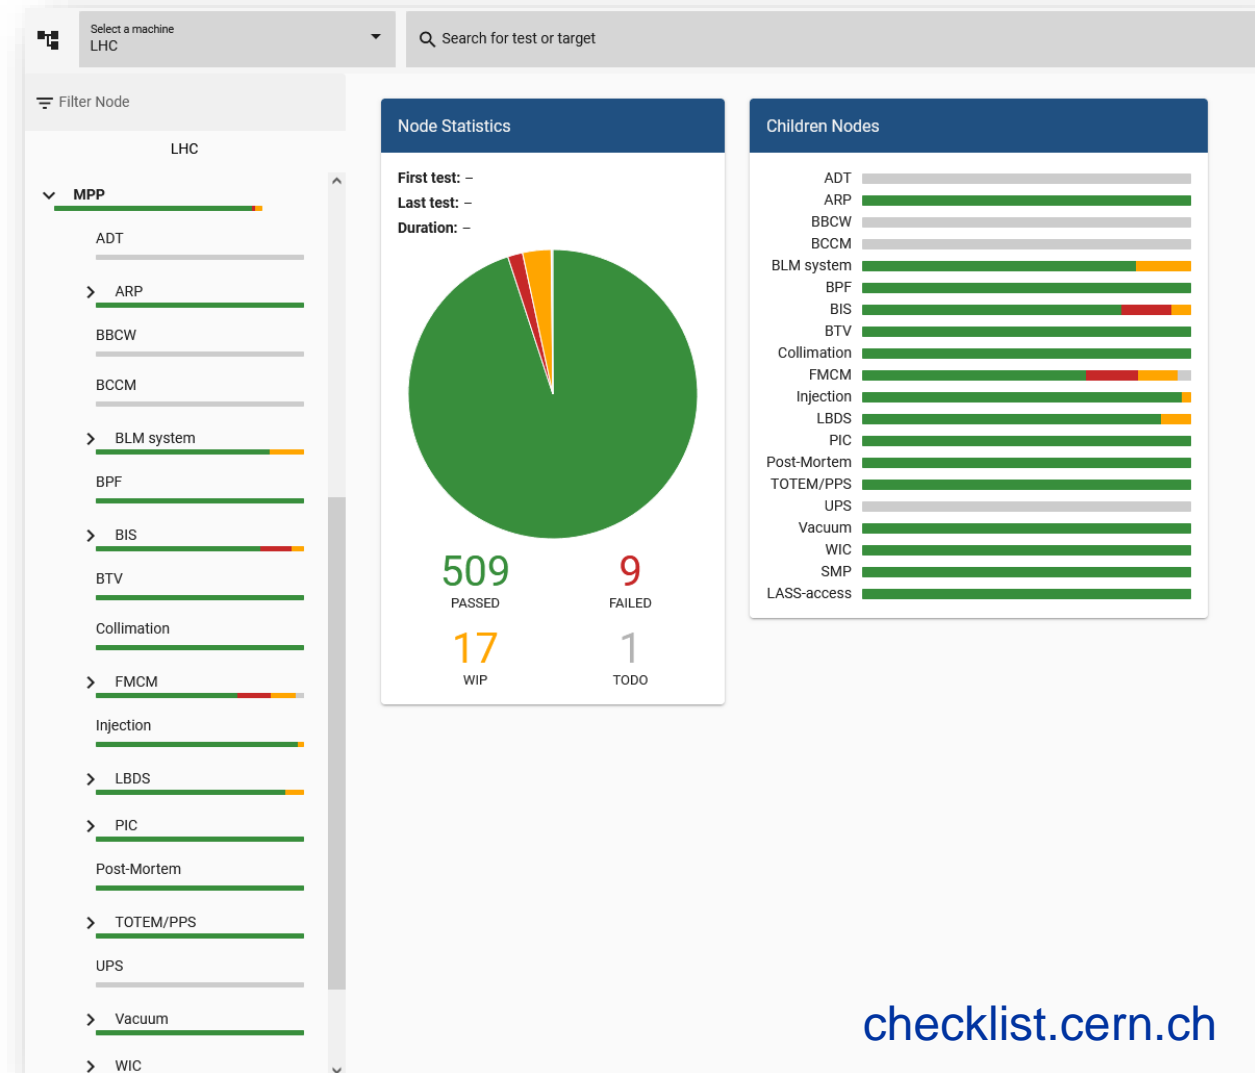
# Checklist tool and beam test

- Commissioning tasks were implemented in the new **LHC-MPP tree inside the OP checklist tool\*** before the beam test
- The progress of tests was **tracked by the operation and equipment teams**
- **Checklist tool** will be used **to follow the commissioning** of the machine-protection systems in 2022
- Beam test allowed to apply the defined commissioning tasks in practice:  
→ **Obsolete and missing tests** (e.g., INJ BIS) **identified**
- Commissioning procedures to be updated for 2022 based on the discussion in the MPP and the experience gained from the beam test → **To be circulated for approval before end of January 2022**

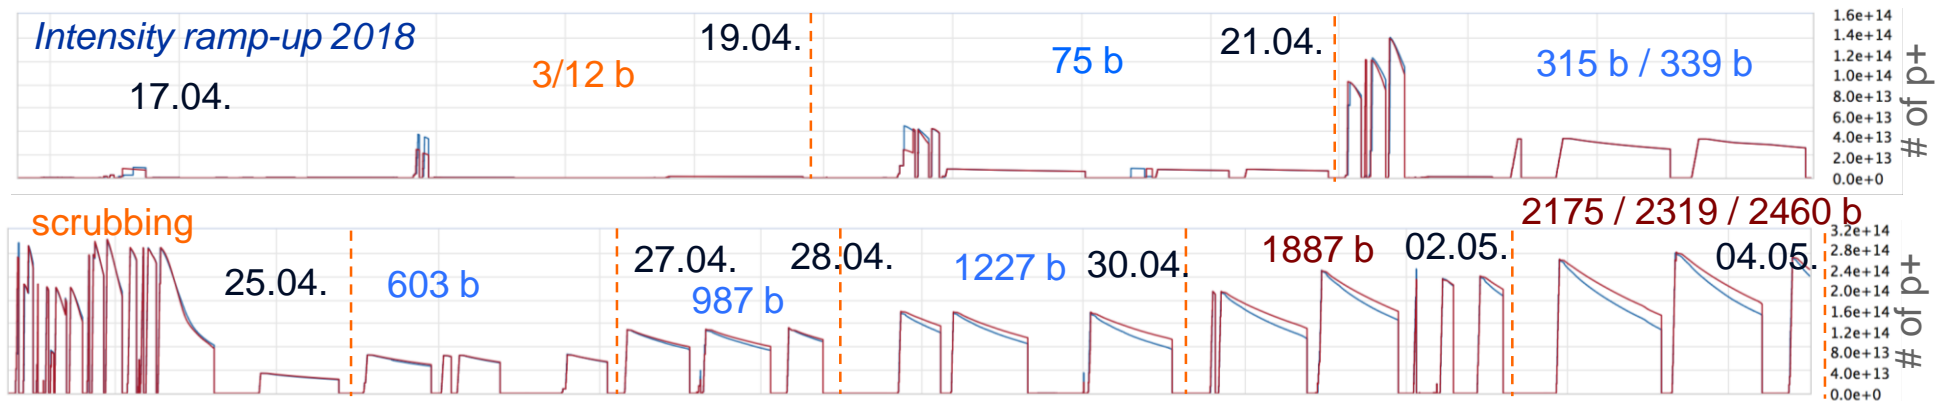
- Checklist tasks to be updated until FEB 2022
- **From 2016 to 2018, intensity ramp-up duration reduced from 22 days to 14.5 days**
  - Disclaimer: don't expect 2022 (coming out of the LS) to be as smooth as 2018...

Establish cycle  
 MP dominated  
 Intensity dominated

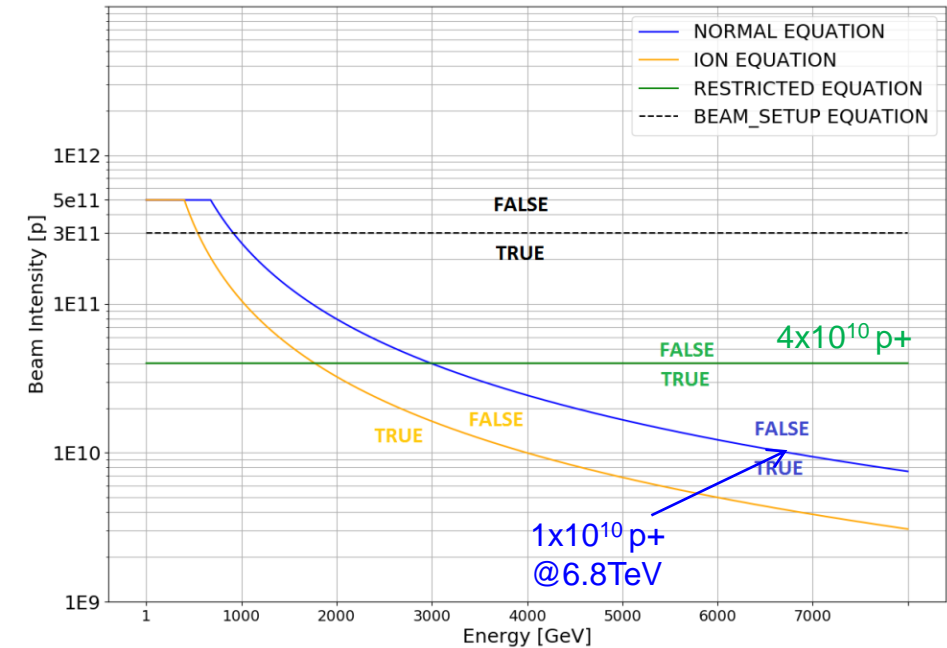
LHC\_SBF intensity limits

R. Secondo, Safe Machine Parameters, [EDMS No. 1096447](#)

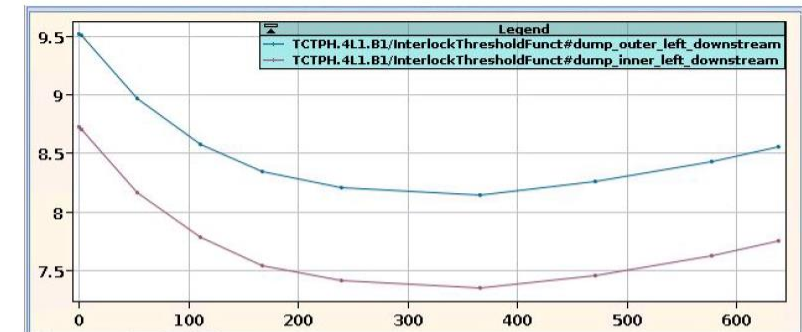
standard interlock functions

M. Hostettler, [COLLWG #260](#)

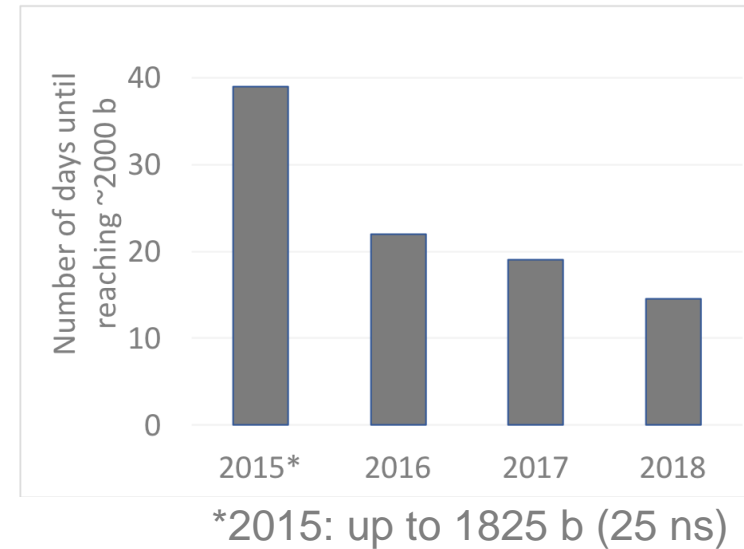
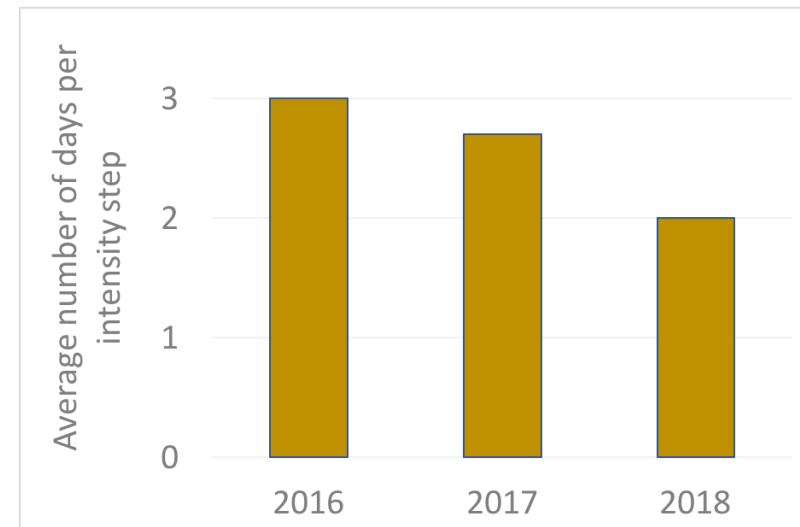
# Durations of intensity ramp-ups in Run 2

- **2015: commissioning year**
  - Two ramp-ups (50 ns & 25 ns operation); intensity increase until end of proton run
- **2016/17/18: 7 steps to reach 2000+ bunches**
  - 2016 → 2018: reduction of ramp-up duration by 35%
  - The 14.5 days achieved in 2018 are close to the theoretical minimum
- **44 intensity-ramp-up and scrubbing checklists issued during Run 2**

See D. Wollmann, [Evian'19](#)
