Update 3Ds:

Update 3Ds

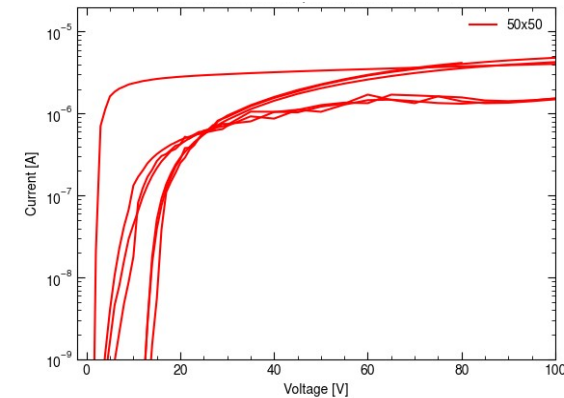
IVs of single pixels on same detector

- Various Problems at the moment:
 - Multiple Timing Boards "breaking", after swapping sensors no signal detectable
 - 3D specific (13C80):
 - Very small (smaller than hole in boards) resulting in issues with securing to boards and especially bonding
 - Very high leakage current --> sensor has to be cooled to -20°C even unirradiated, with two bonded pixels ~20 uA at 100V (Timing boards developed for 1-2 uA)
 - Measurements conducted so far (with multiple trigger settings) show no voltage dependency

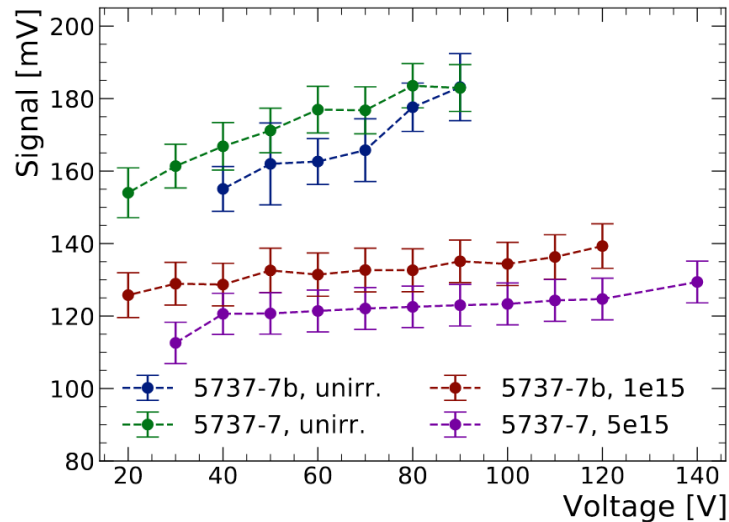
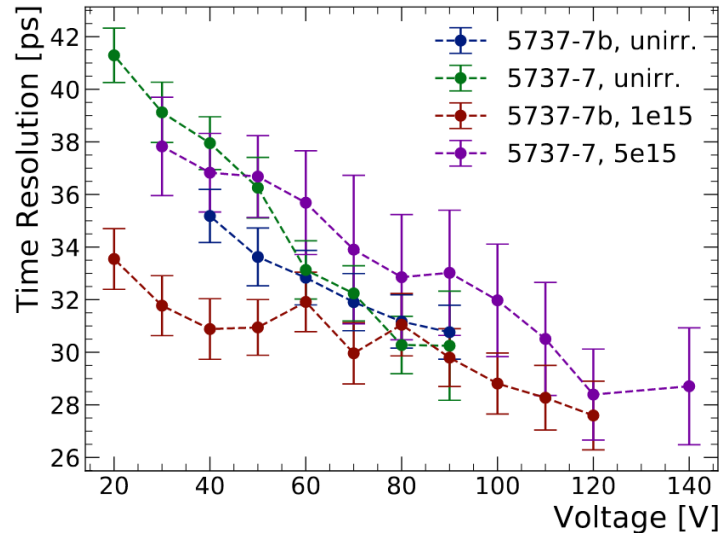
Revision irradiated 3D

- Irradiated sensors measured cold --> less Jitter, so better time res. for 1e15
- 5e15 sensor overall slightly worse than 1e15, as expected

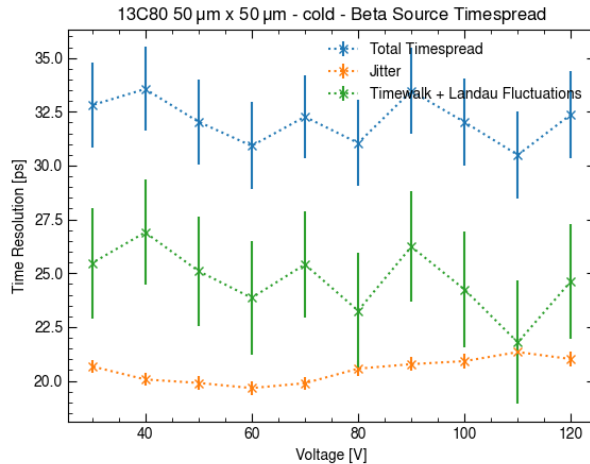
Jitter and Timewalk preliminary,
Trigger on REF, 3D and PMT
(Similar for 2 Trig setup)
Time resolution fluctuates slightly but within fit
error and no tendency visible

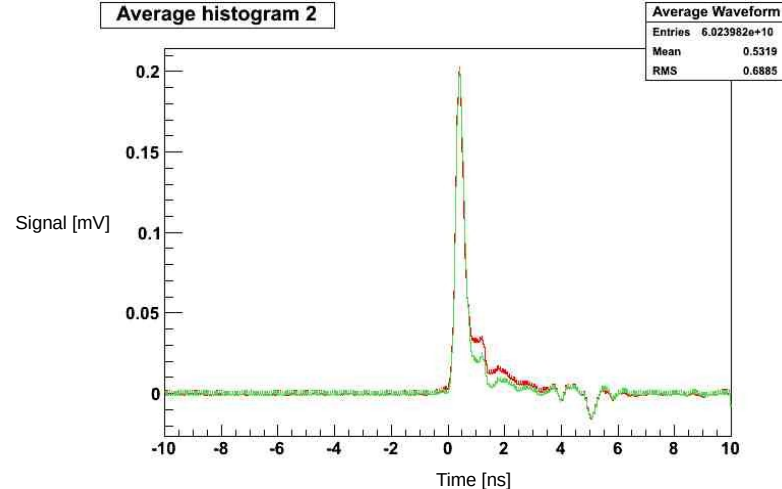
Average histogram 2

Average Waveform for 120V (red) and 40V,
Trigger on REF and 3D (~40mV)
(Similar for 3 Trig setup)
Peak of signal is basically identical for all
voltages, only second peak shows voltage
dependency (not certain why we see a second
peak)

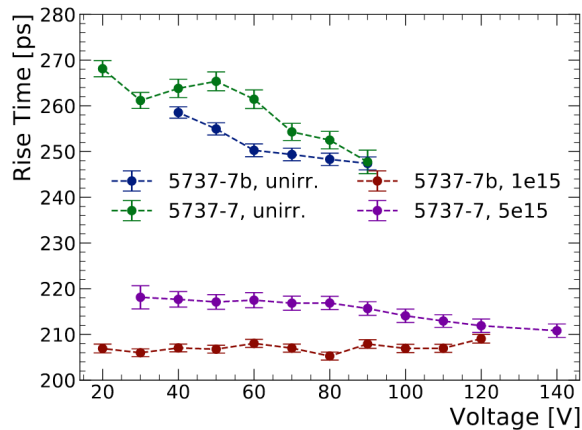
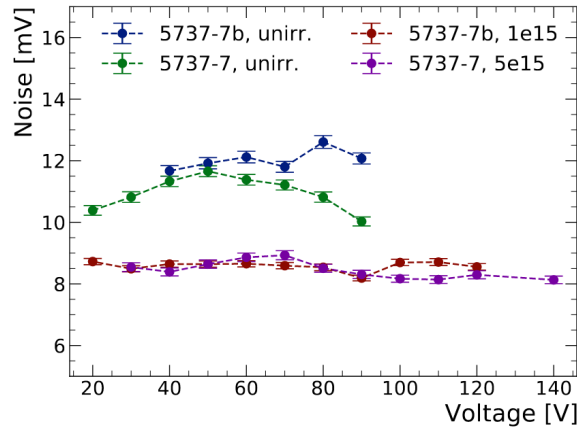
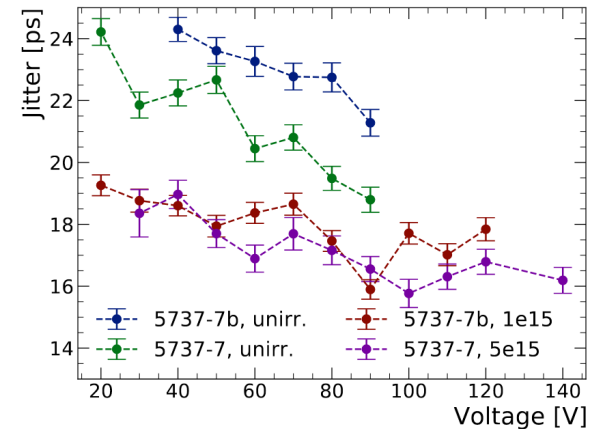
Revision irradiated 3D

- Risetime similar for all 3D, except for strongly irradiated sensor--> Higher E-Field
- Jitter lower for both irradiated 3D --> Lower Temperature = less noise
