Performance and lesson learned with the CMS Pixel Detector

For the CMS Pixel Group

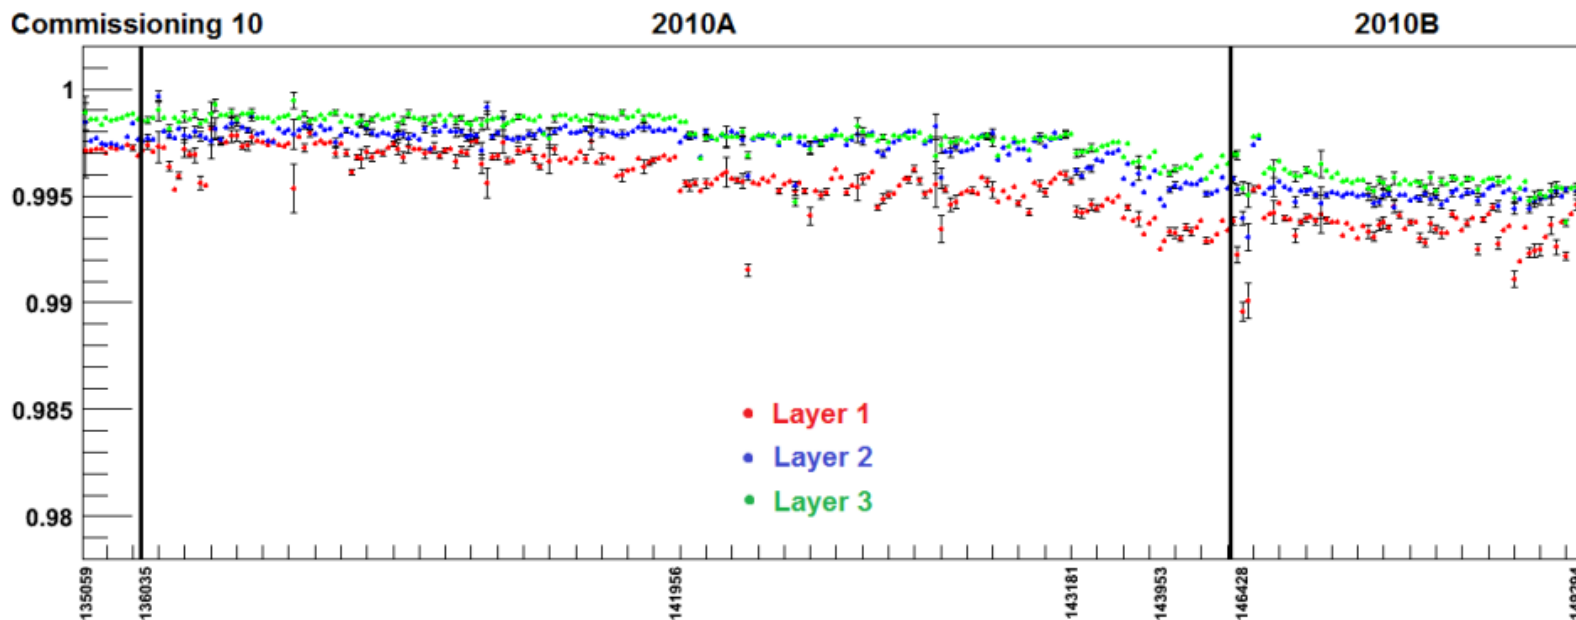
Efficiencies in 2010 (new)

- 1% drop experienced starting with CMSSW 3_6_X is recovered
- Overall pattern similar to old efficiency – efficiency loss as function of luminosity is visible
- Inner layers experience consistently larger efficiency loss

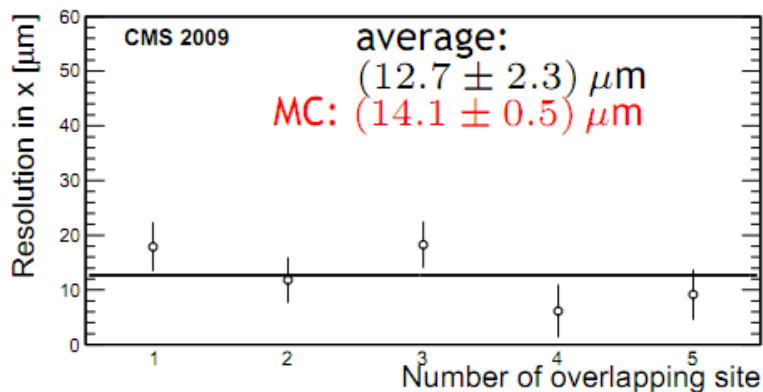
- Method: Compute double difference
 - ▷ difference of measured hit positions
 - ▷ difference of extrapolated hit positions
 - ▷ difference of the two differences
- reduces sensitivity to misalignment
extrapolation errors

- Caveat: overlaps only at the edges of the track α -acceptance
 - ▷ cluster x sizes deviate from the optimal size (of two)
 - the x resolutions are somewhat worse than the typical x resolution

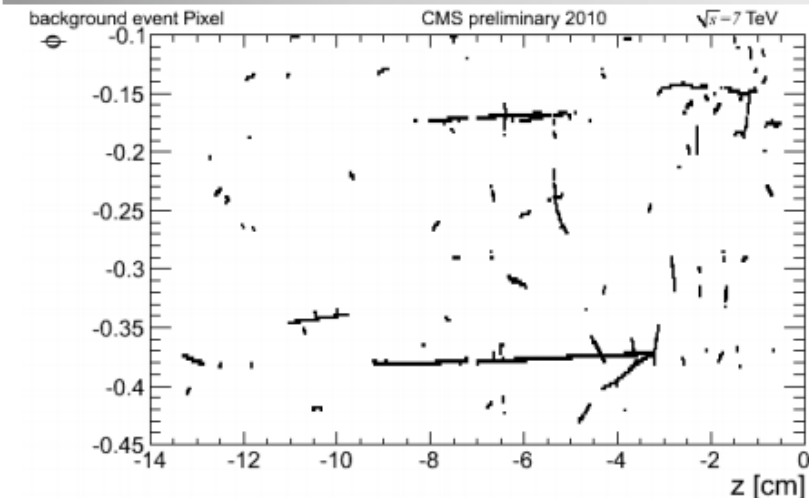
occupancy map from a single event

Beam-background events:

- We observe showers of particles that graze the detector along the beam axis (z).
- They occur coincident with bunch crossings.
- These events are consistent with beam interactions with gas in the beam pipe.

- lead to a *huge* occupancy, especially in the barrel layers.
- impose challenges to maintaining event synchronization, especially at high trigger rates.

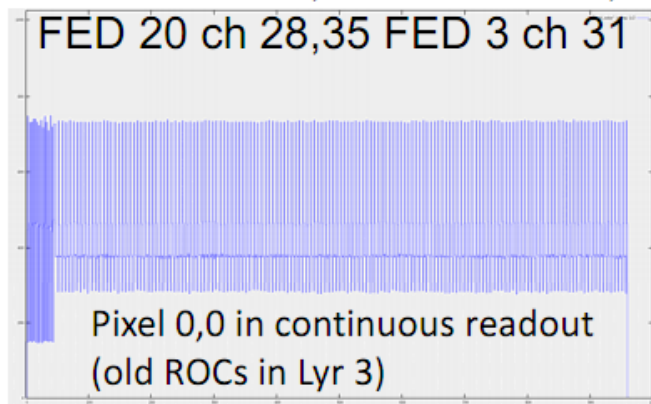
Trapped Readout Error (TRE)

FED 27 ch 36, FED 21 ch 34,
FED 20 ch 28,35 FED 3 ch 31

While reading out an event the ROC start sending out a illegal repeated pattern of data.
The only way to exit the infinite readout is to send the ROC a reset.

This is a problem with the ROC that was identified and solved back in 2005.

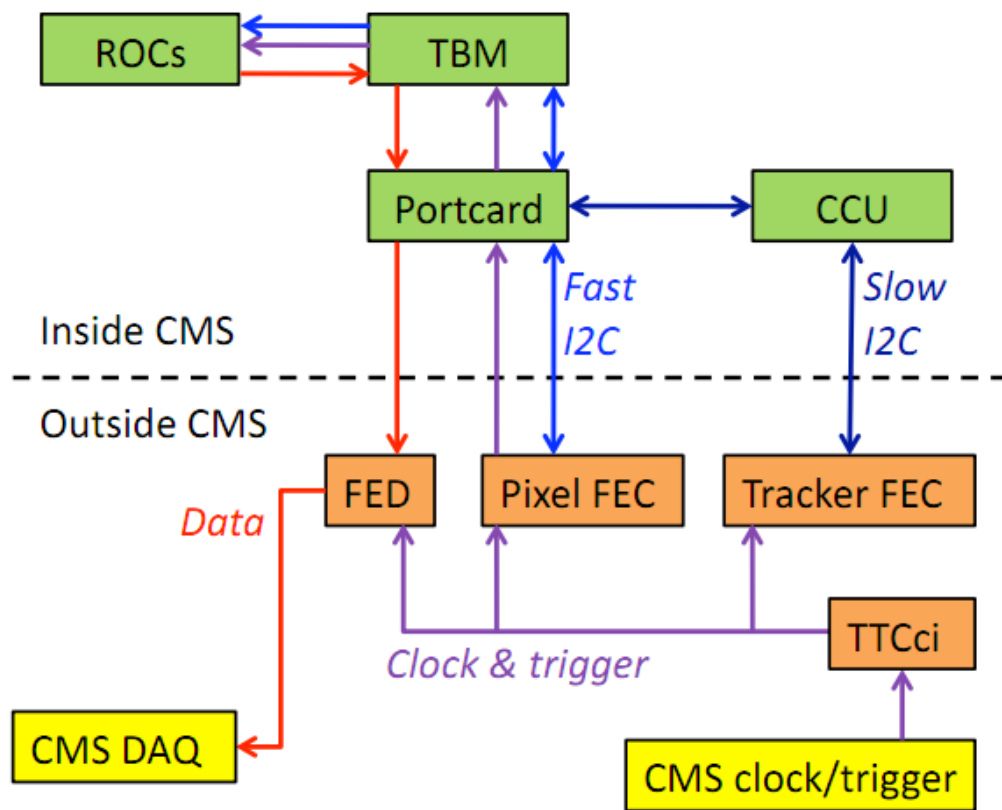
- Configures ROCs & DAQ before running
- Monitors DAQ status while running
- Implements calibrations

The Pixel Online Software controls these **VME devices**.

Front End Driver (FED):

- Receives optical data signal
- Digitizes and sends it to CMS DAQ
- Must be triggered to read & send data!

Important note: there is no internal (to the pixel system) communication from the FED to the FEC. Such communication exists only via TTS (Trigger Throttling System)

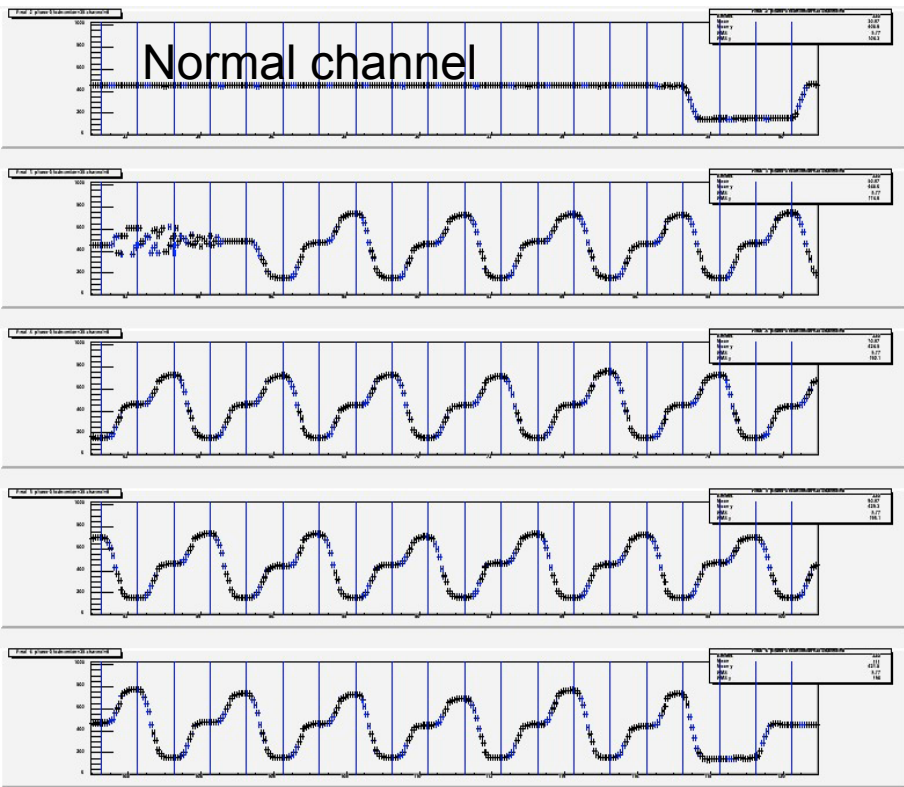
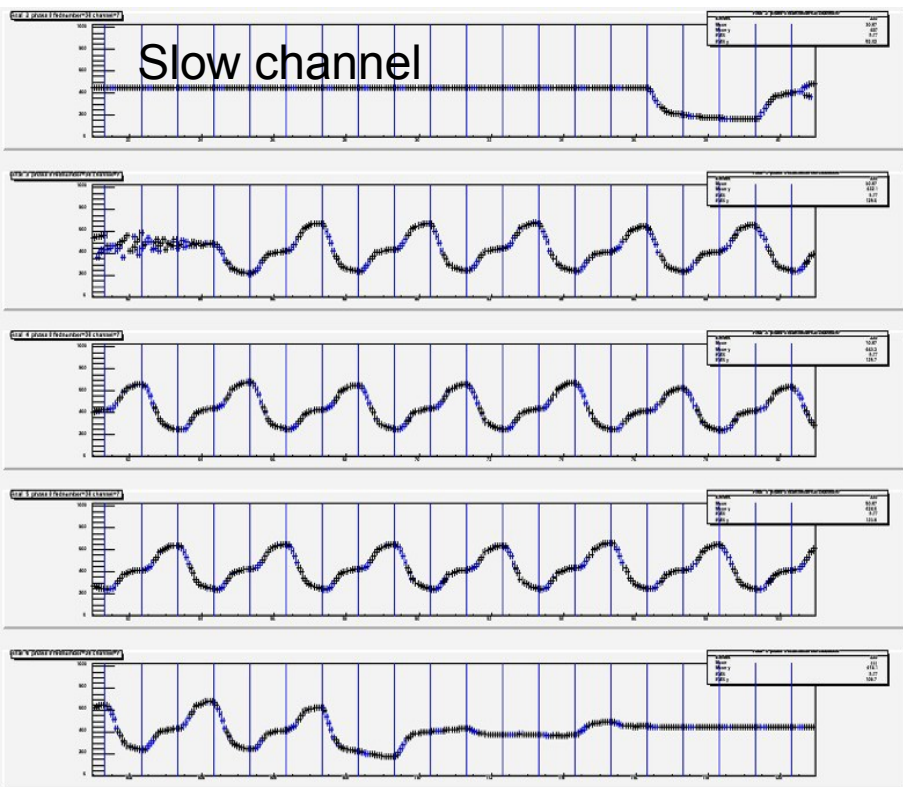
- 75% of the FPIX failures suffer from the same symptoms.
 - Low rise-time of the analog output signal.
- It is impossible to separate the address levels (Undecodable information)
- The CMS pixel system was inserted in CMS last summer

- Long list of tests performed in the lab with spare components
- We managed to generate a long list of scenarios to be investigated
 - but none of them reproduce the symptoms as measured in the experiment.
- We are now trying to deal with the problem in situ
 - developing FED firmware modifications to:
 - measure the rise-time on the fly event by event from the TBM header (3 clock cycles long)
 - Event by event apply the measured correction to the address levels.
- Also considering removal/diagnose/repair of the FPIX MINUS during the 2012 shutdown.

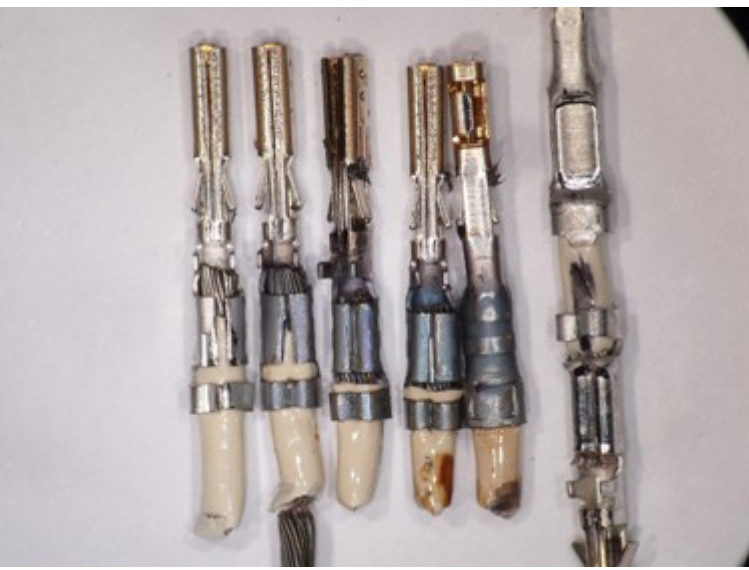
• A number of connectors at the Filter Board end of the cables was replaced and new resistance measurements taken

mOhm	-Z2, 1.4		-Z2, 1.2		-Z2, 2.2		-Z2, 1.3	
	before	after	before	after	before	after	before	after
Va+	30.1	28.6	54.2	28.3	29.8	27.2	32.5	29.5
Va-	33.3	28.6	86.9	31.7	30.6	26.1	30.6	28.6
Vd+	43.7	28.2	31.6	29.6	34.2	27.1	33.8	28.8
Vd-	33.5	28.3	37.4	28.6	26.5	26.6	44.9	28.6

mOhm	-Z2, 2.3		-Z1, 2.4		-Z1, 1.2		-Z2, 1.3	
	before	after	before	after	before	after	before	after
Va+	52.3	27.7	55.1	27.6	33.1	28.8		
Va-	21.5	26.4	26.5	26.3	29.4	28.8		
Vd+	28.4	26.4	26.9	26.9	35.7	29.8		
Vd-	33.1	26.8	26.4	26.1	33.2	29.4

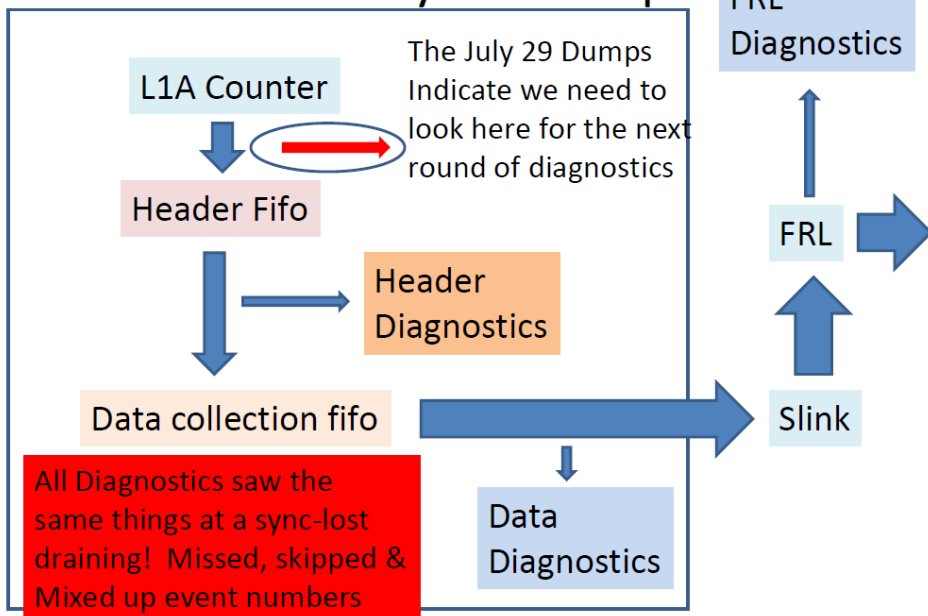
The July 29 Dumps

- For the first 6-7 weeks the problem was visible only during data taking with collisions.
 - Not visible with random triggers (but no data coming from the detector).
- Managed to reproduce the symptoms outside of stable beam by taking data with the HV OFF.
 - Sensor not depleted
 - Huge noise
 - Several pixel above thresholds
