Utrecht update  
22-3-2022

BBM4 (cooler fins to have a comparison to the carbon foam)

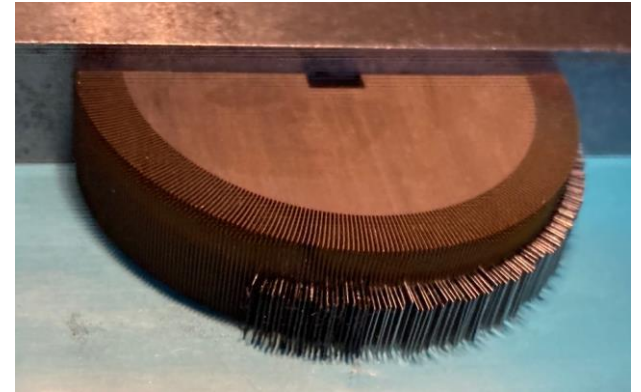
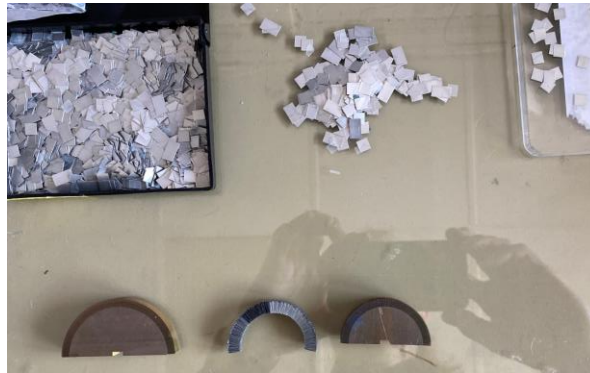
Tried to 3d print molds on formlabs and wanhaoD7 -failed-

Molds now made with wire EDM

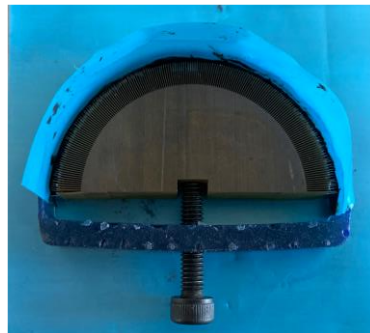
AL 210 W/m-k dt=0.7

Carbon 20 W/m-k dt=6

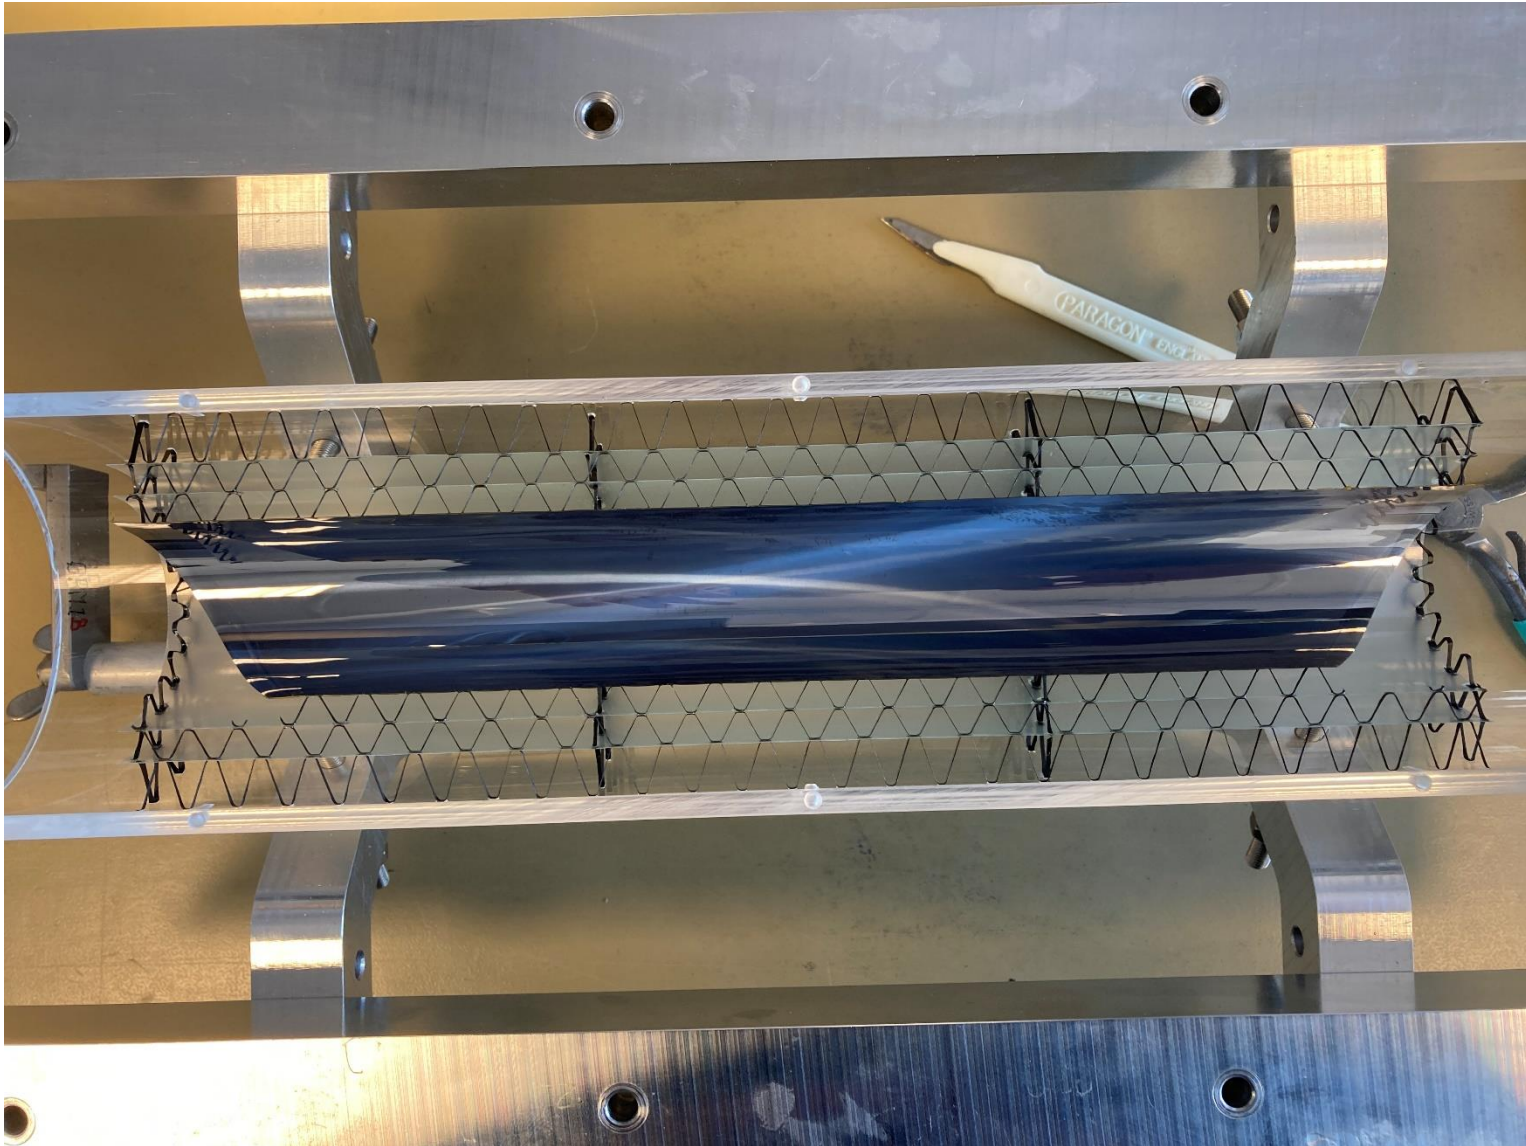
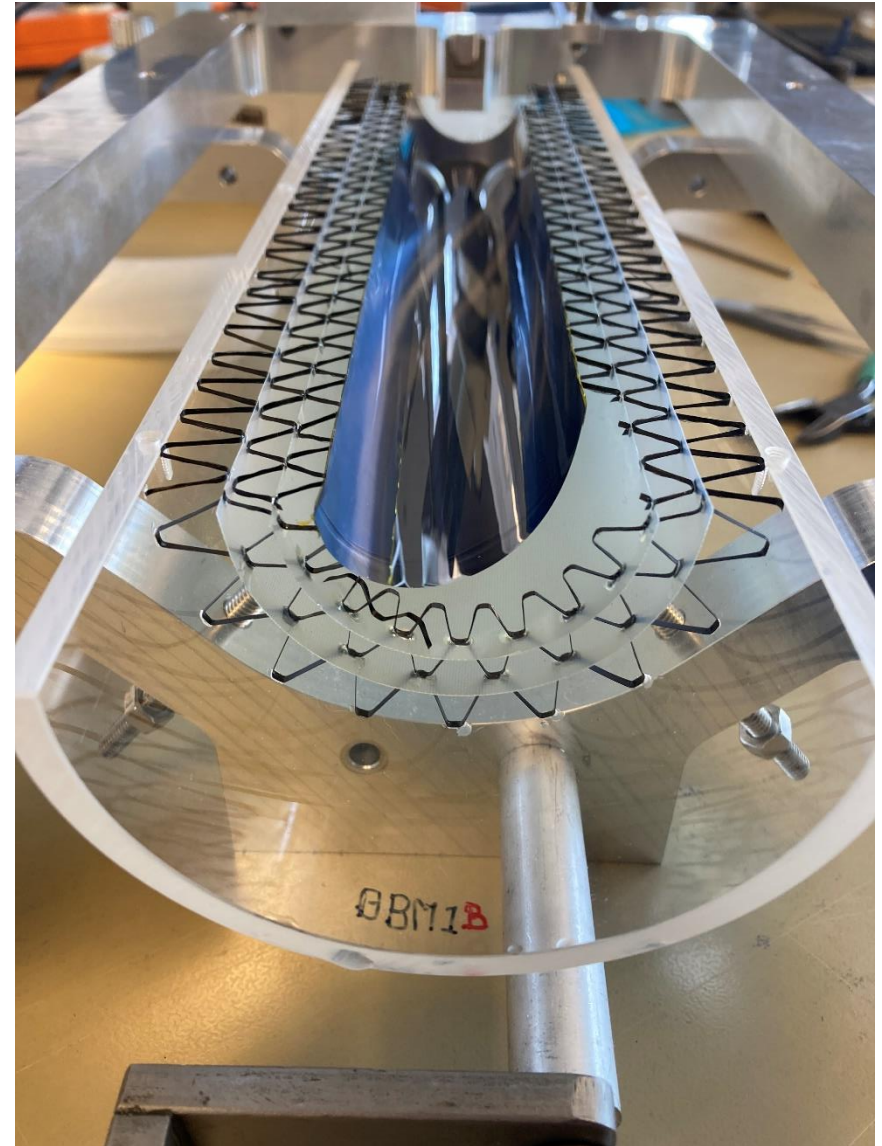
Aprox 0.5 mm conductive glue  
One part broke off wil add  
Carbon fleece on next

Demonstration of silicon layer with carbon fibre support structure done with "tape to mandrel" method

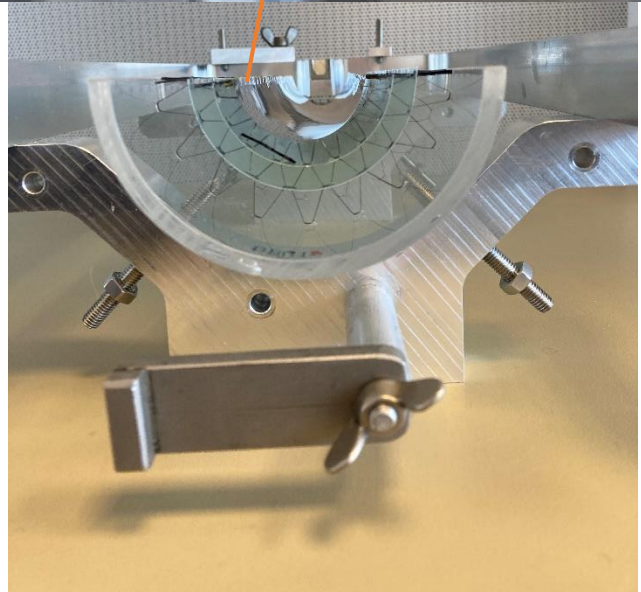
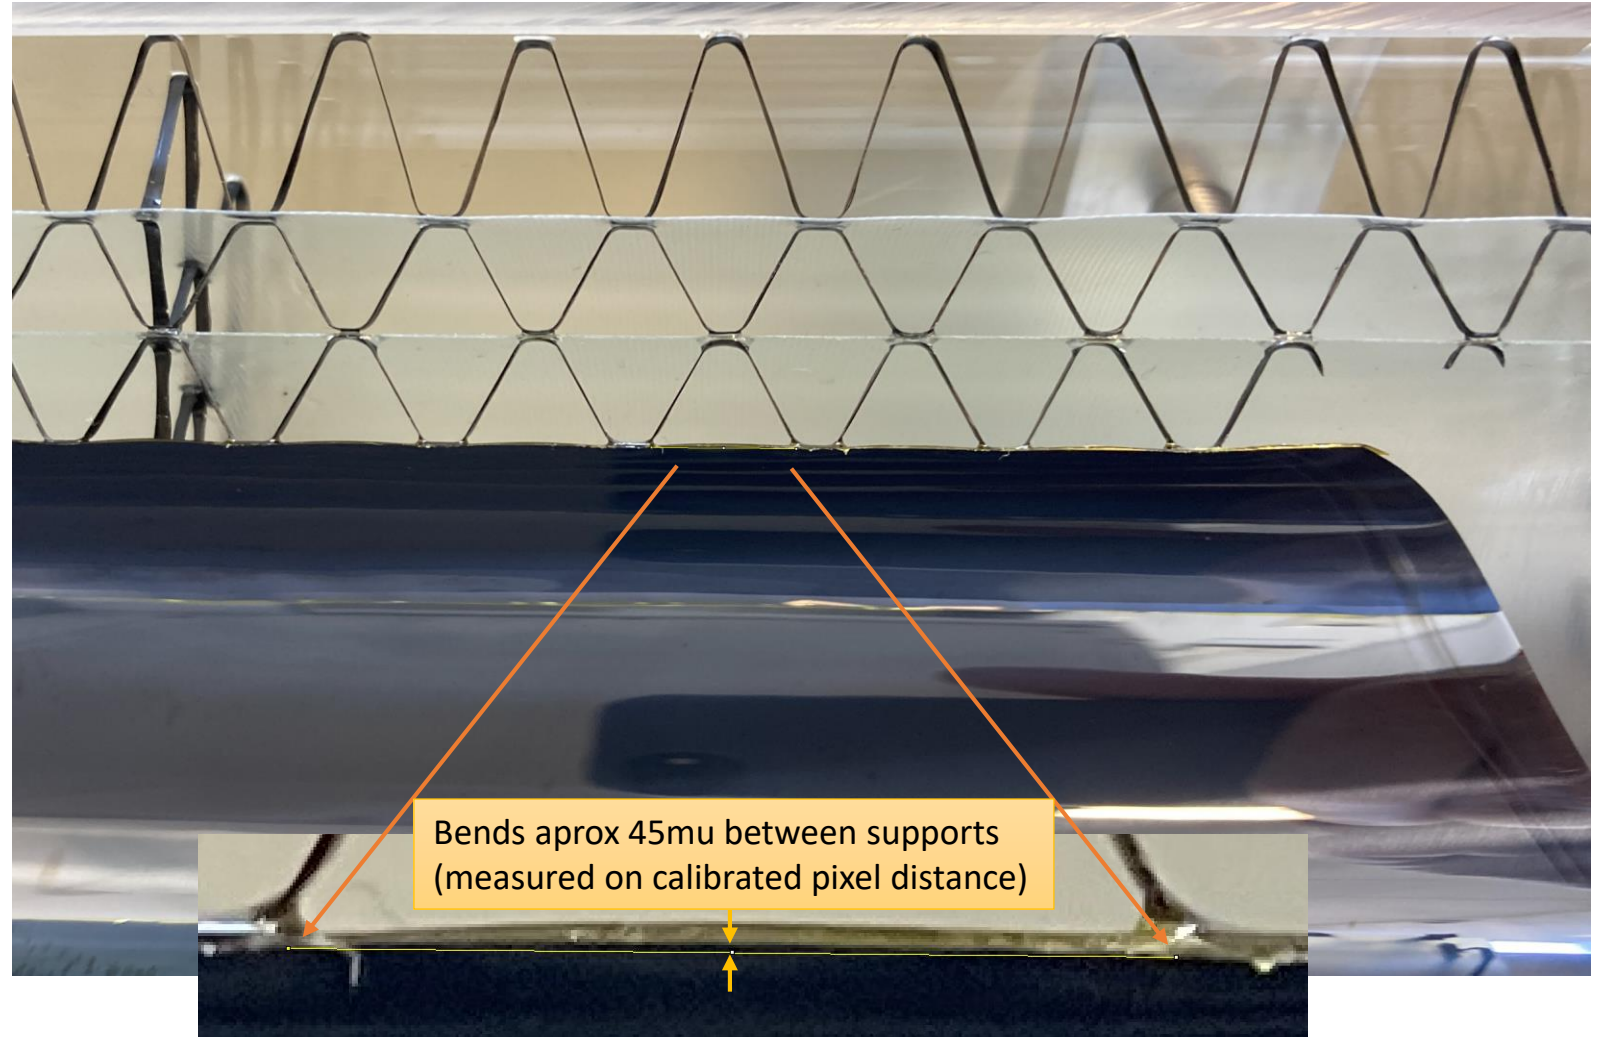
Zooming in on light reflections

Bends aprox 45mu between supports  
(measured on calibrated pixel distance)

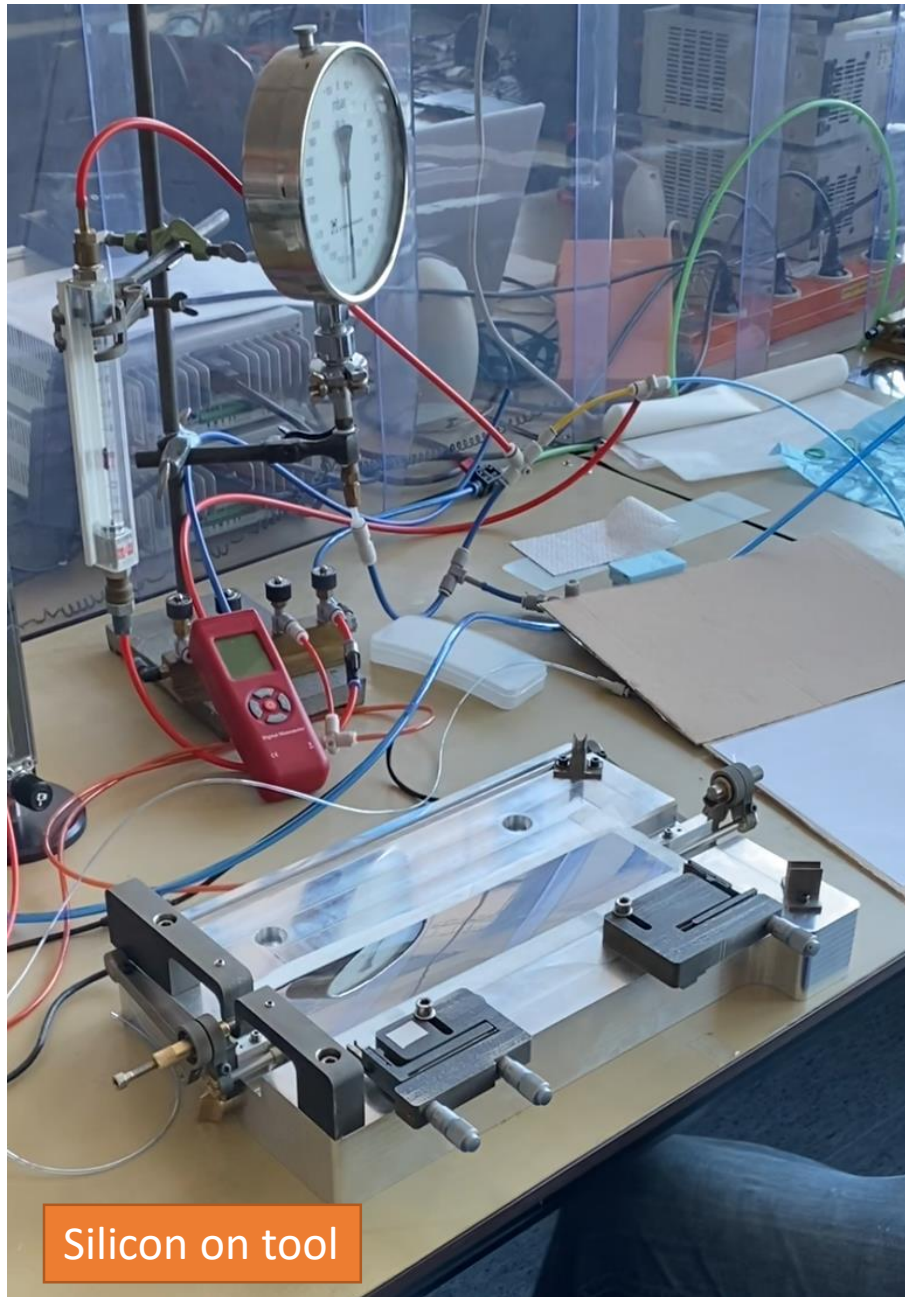
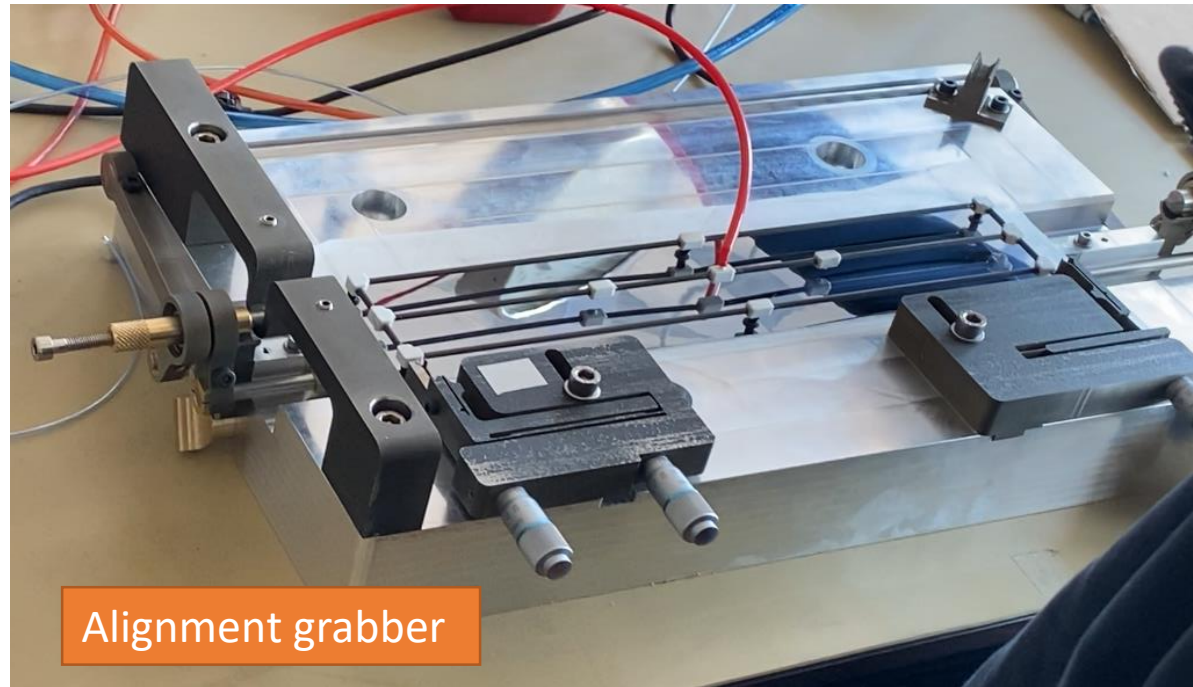
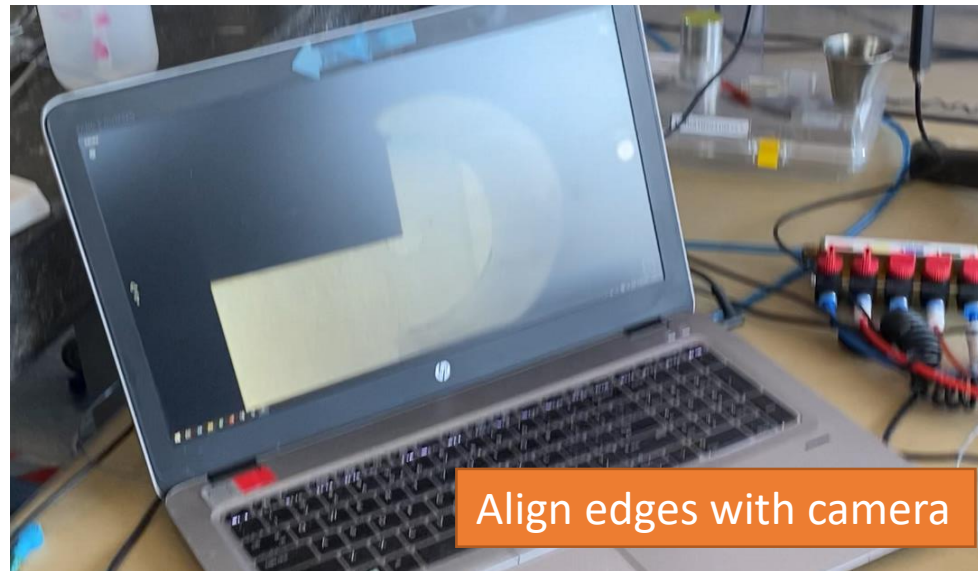
Vacuum grabbing (spoiler failed....)

After alignment silicon is held with vacuum from below (see small distortion in mirror)

First piece of silicon probably Broke on bending second piece broke when applying the vacuum silicone rubber seal on mandrel broke when cleaning of broken silicon

Place manderel and Lock roller assembly to mandrel  
Bend and switch vacuum to mandrell

Bellow seal of 100mu silicone rubber  
Inflatable to touch silicon

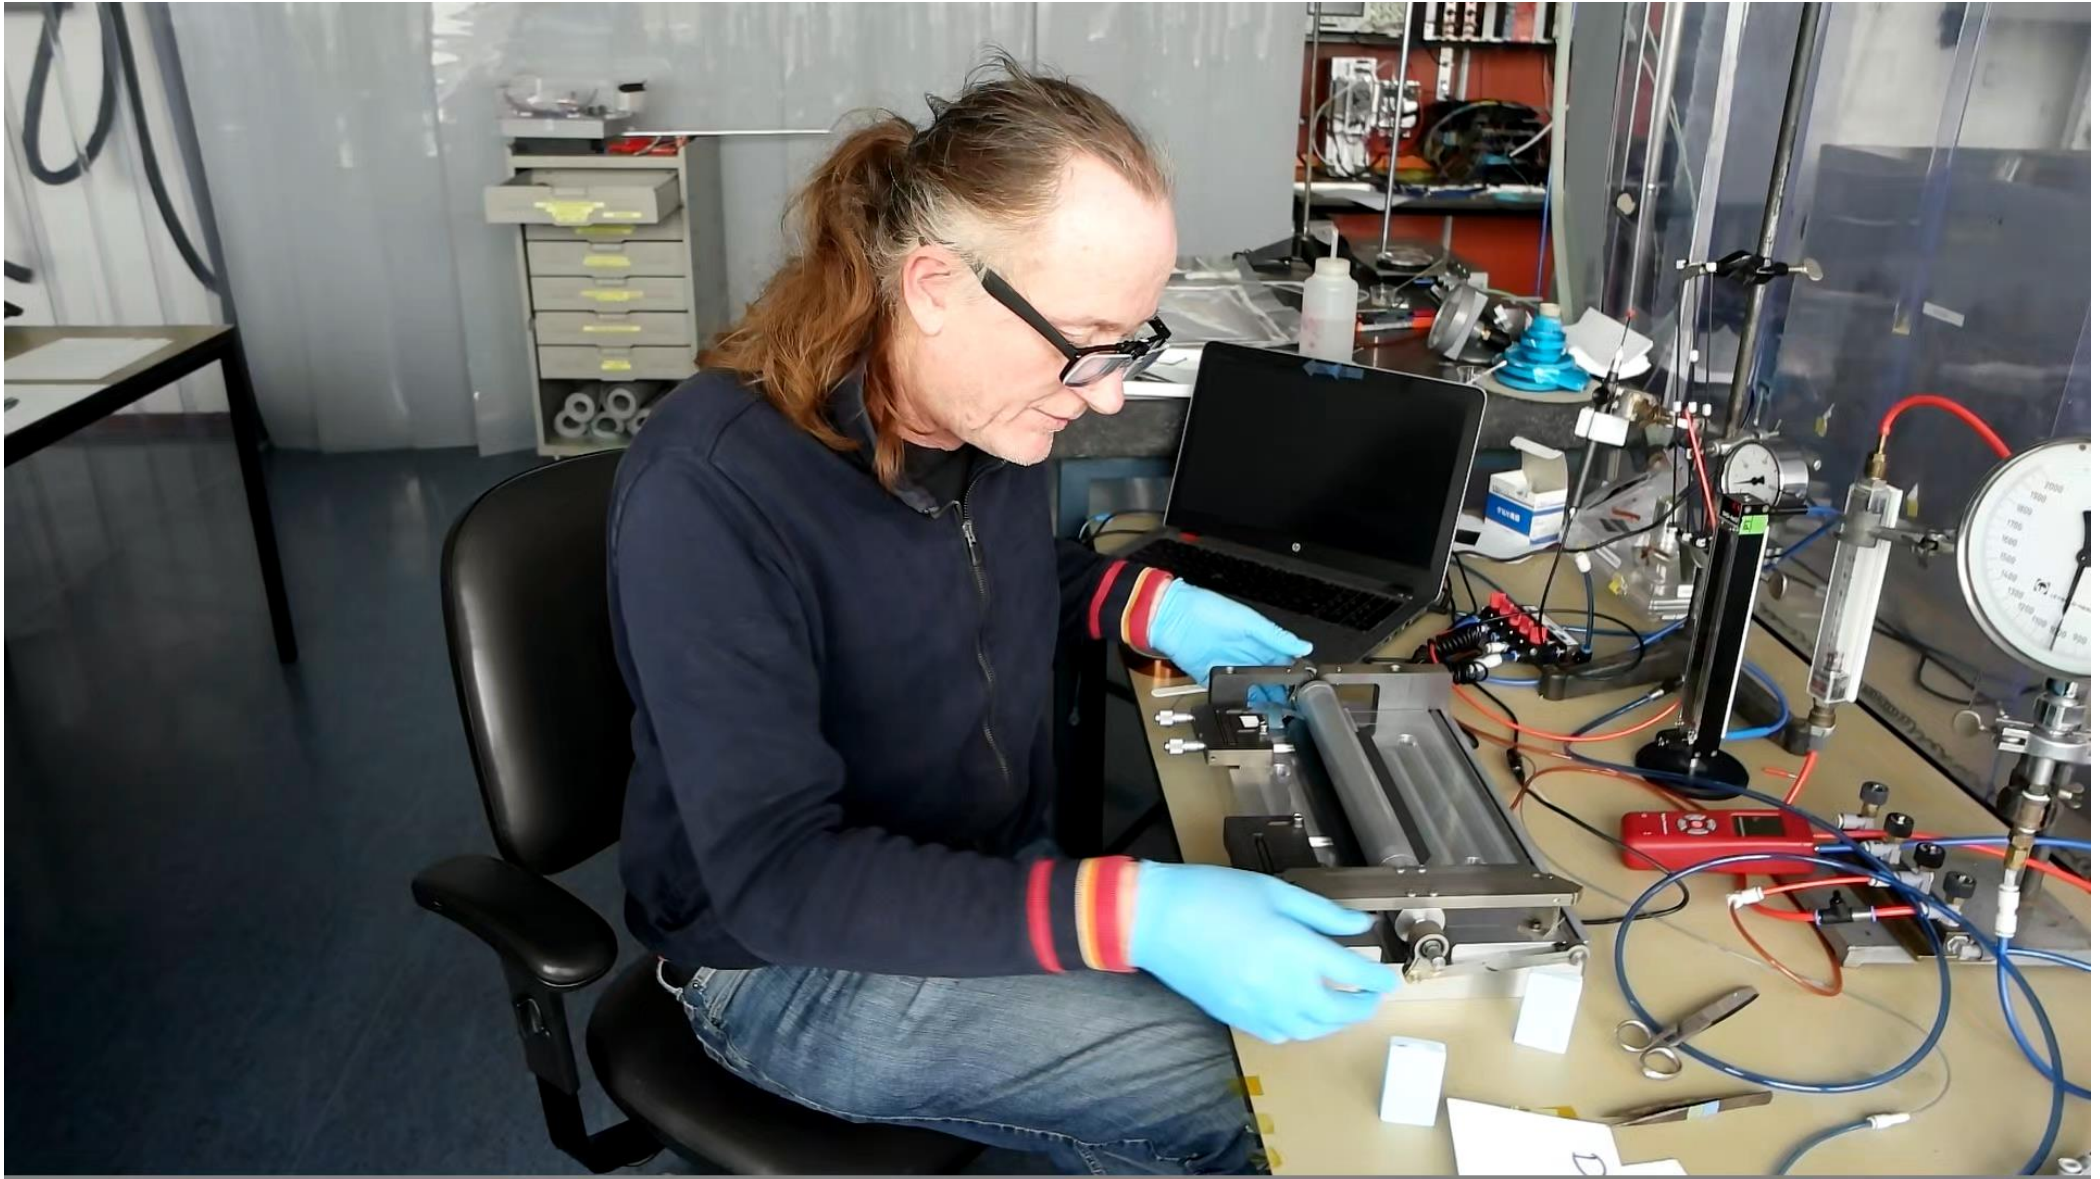
Once you have a piece which is not breaking on first try, bending seems not a problem.....  
(sorry had no time to edit video and its in dutch)
