Interlocks and Commissioning of the In-Jaw Wire BBLR Compensator (BBCW) without beam, for Run 3

#263 Collimation Working Group / #224 Machine Protection Panel
28/04/2022

LHC Long Range Beam-Beam Compensator Wire (BBCW) Commissioning and Revalidation after Failure Recovery

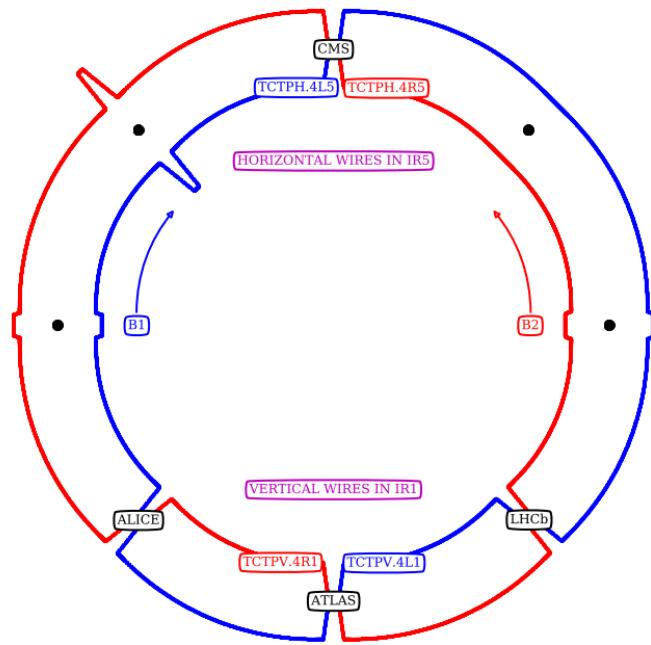
Current installation layout of TCTW collimators

- ❖ TCTVP.4L1.B1
- ❖ TCTVP.4R1.B2
- ❖ TCTHP.4L5.B1
- ❖ TCTHP.4R5.B2

- 2 wires per collimators in series with current parallel to beam.
- Design current ± 378 A
- Nominal PC current per wire ± 350 A
- Required current during Run 3 0 – 350 A
- Compensation on Q4/Q5 necessary during operation (not discussed)

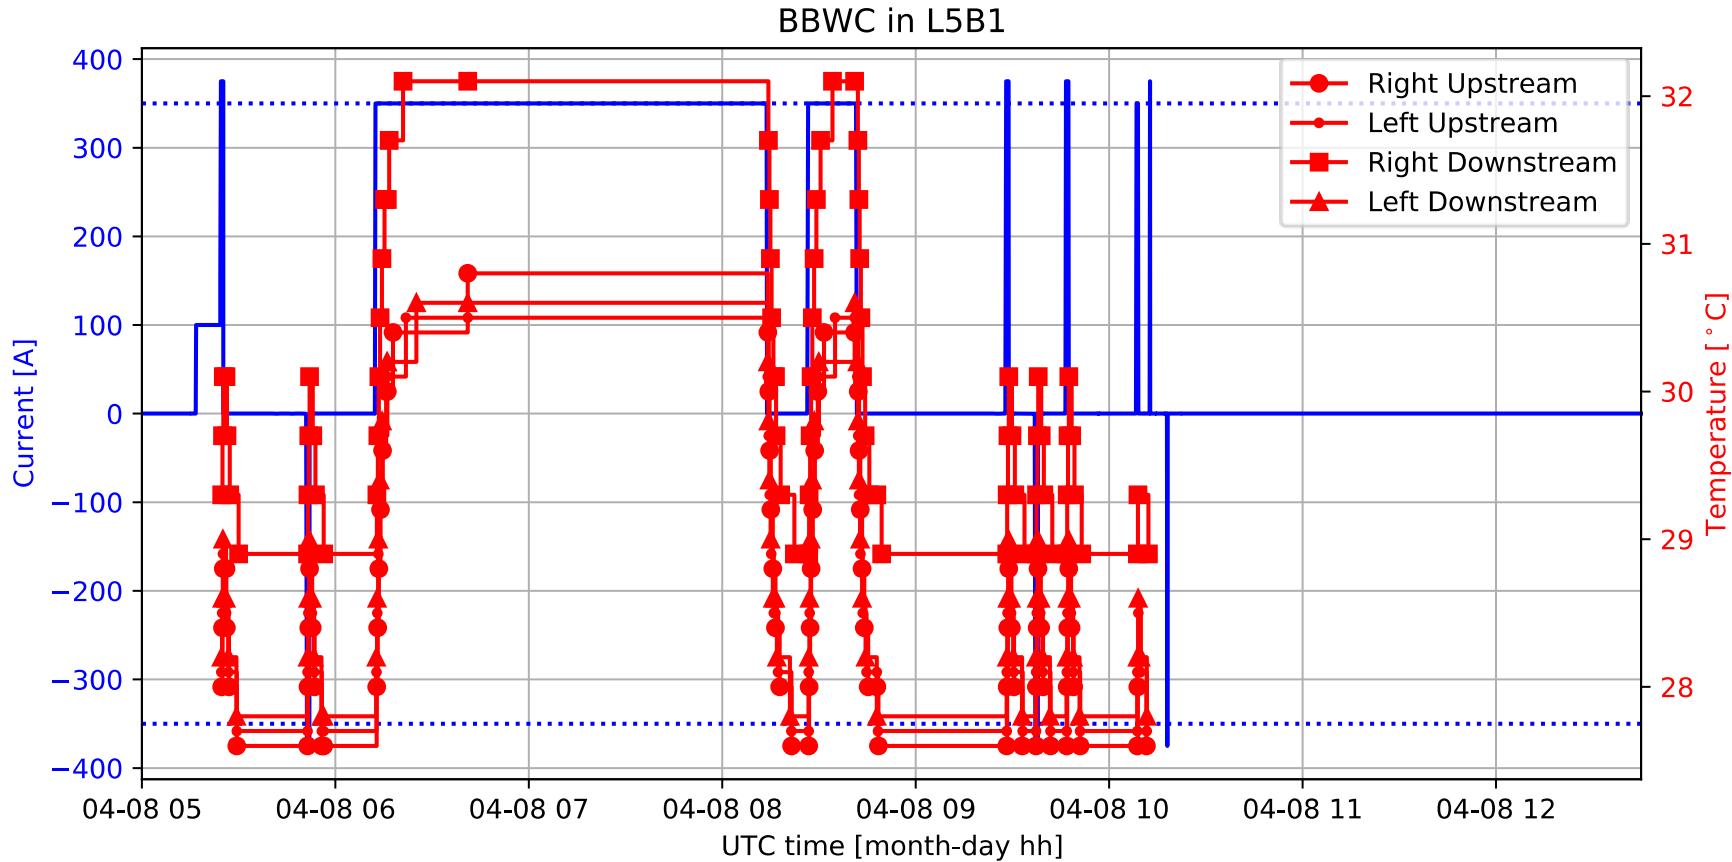
2022 commissioning

Jaw temperature

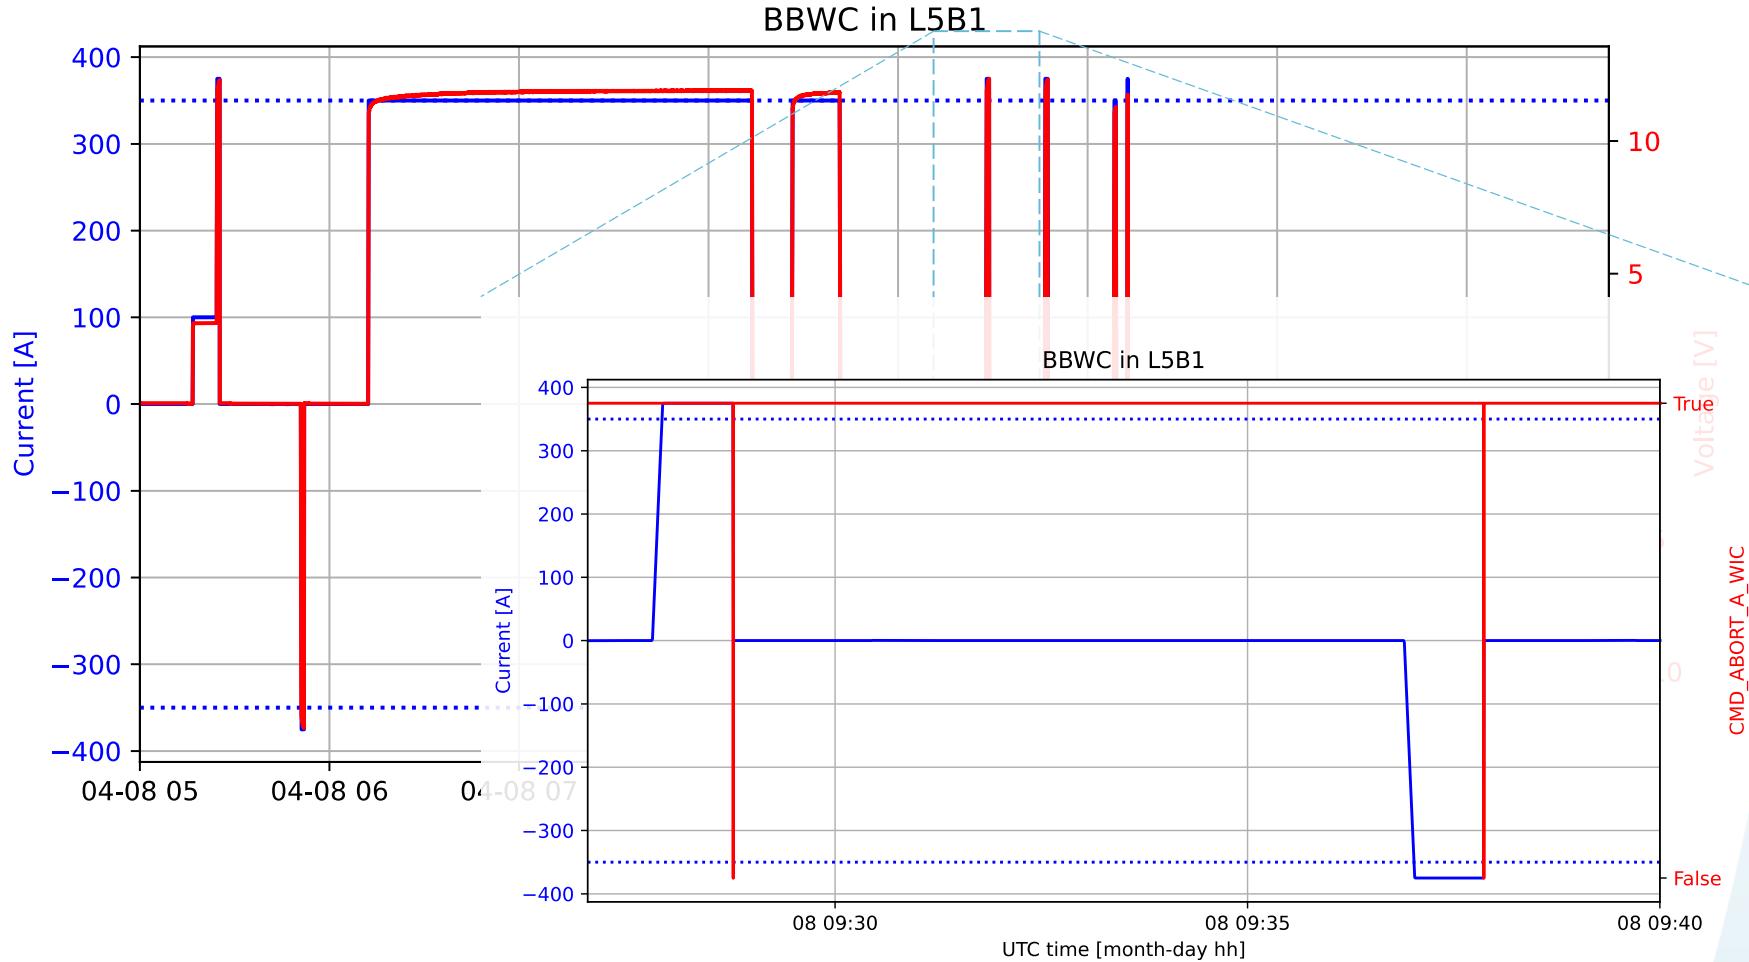
2022 commissioning

Voltage seen at Power Converter

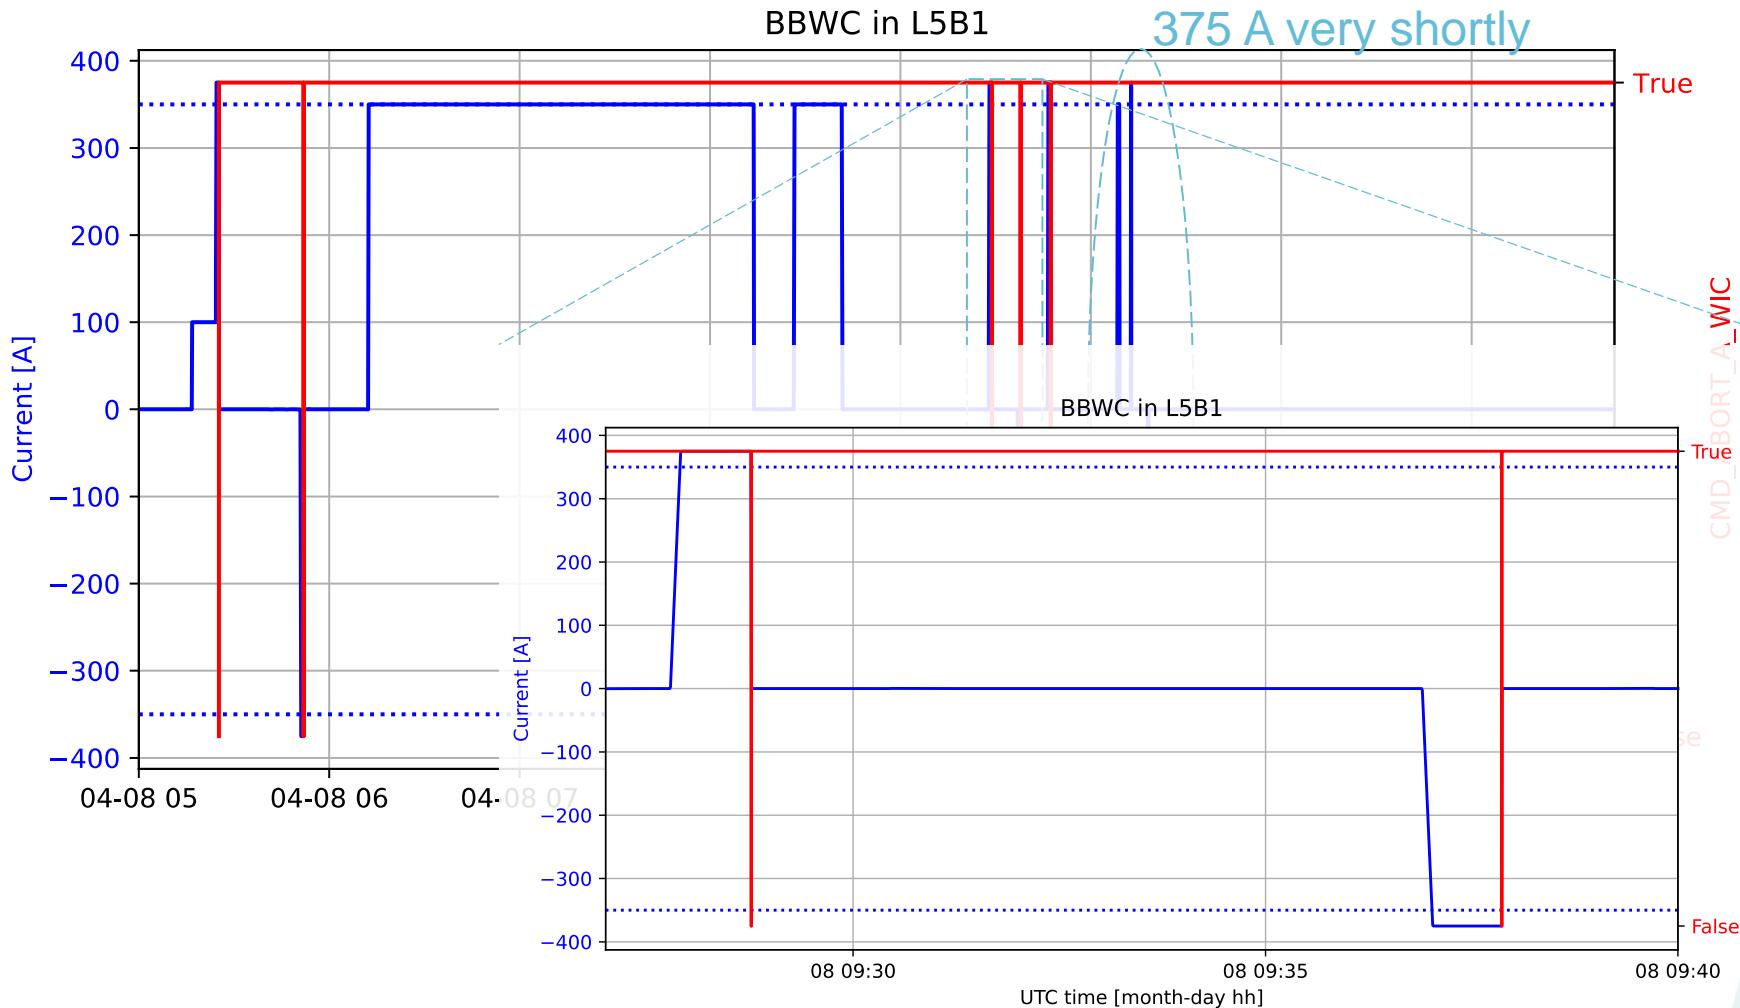
2022 commissioning

WIC – temperature interlock

If $\Delta V_{BBCW} >$ fixed threshold $\approx 200^\circ\text{C}$ at 350 A, => interlock cards opens a switch to the WIC.

- The WIC will dump the LHC beam and
- Switch off the concerned power converter (external fault).
- The temperature interlock works for both polarities of the wires.
- Tests at ± 375 A and trigger temperature interlock after max. 2 min

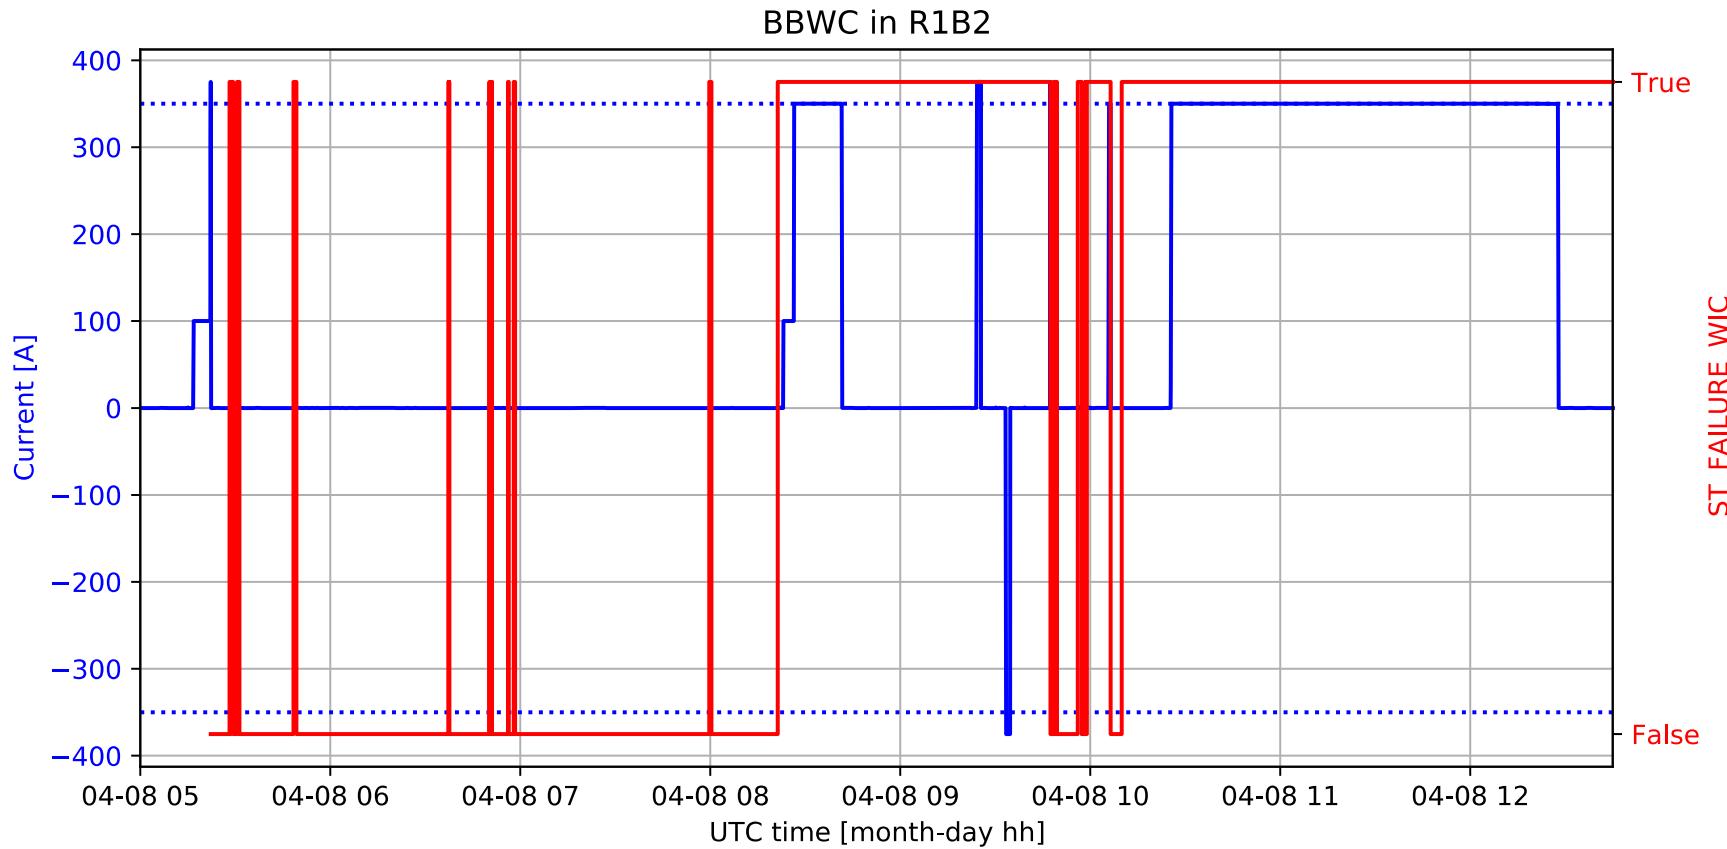
2022 commissioning WIC – power converter interlock

If PC_Status = FALSE => LHC beam dump

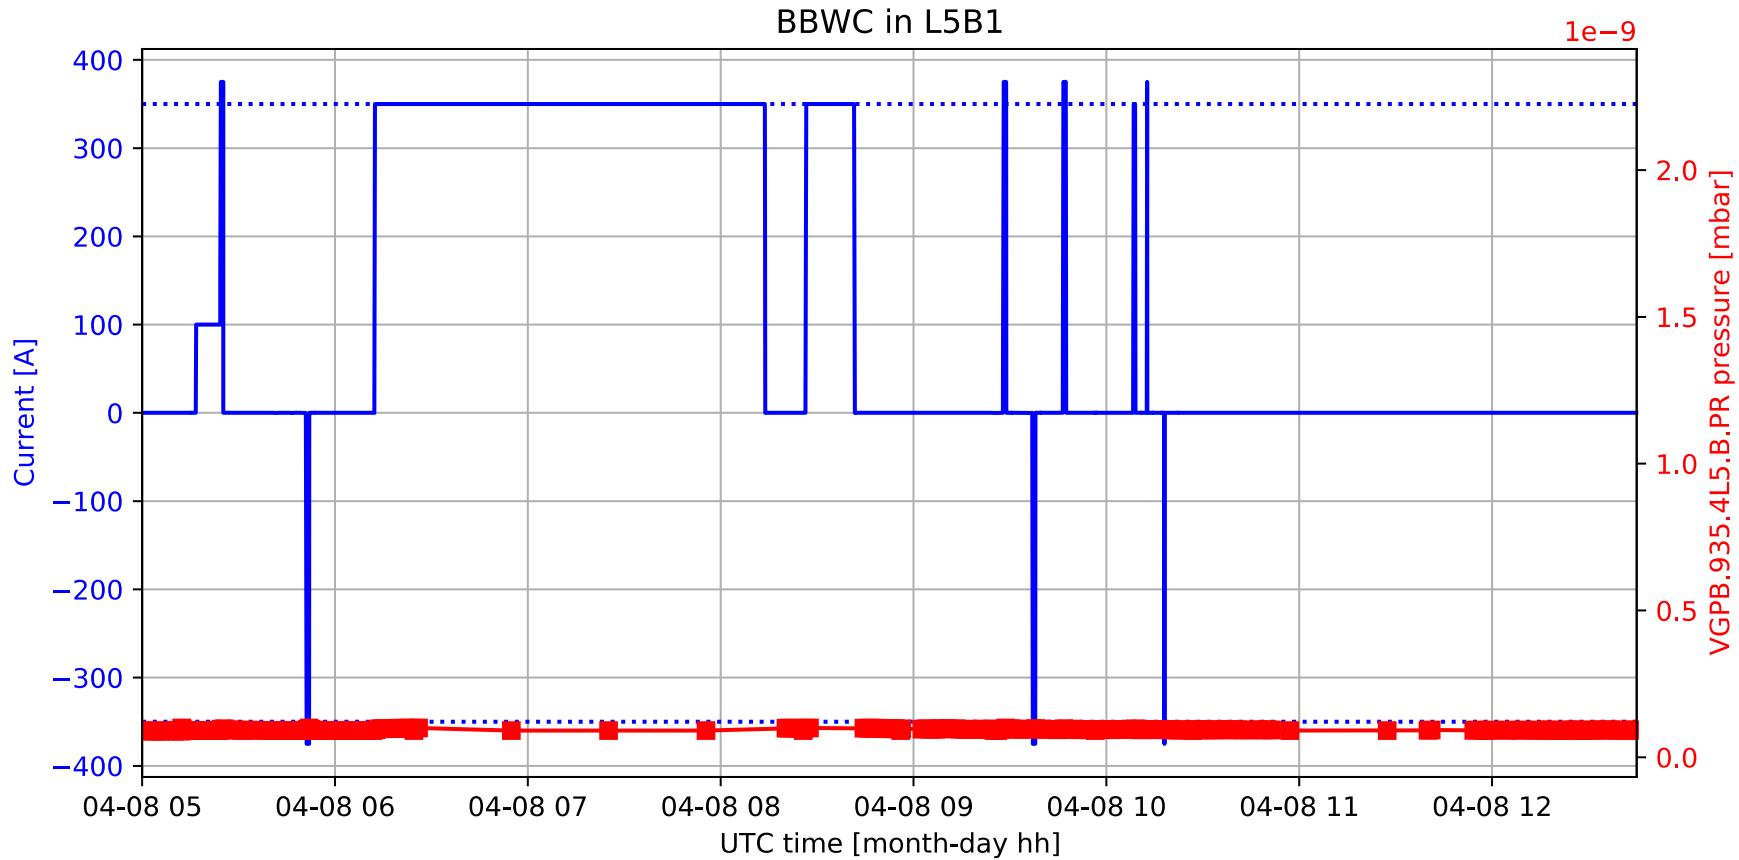
2022 commissioning

Vacuum pressure

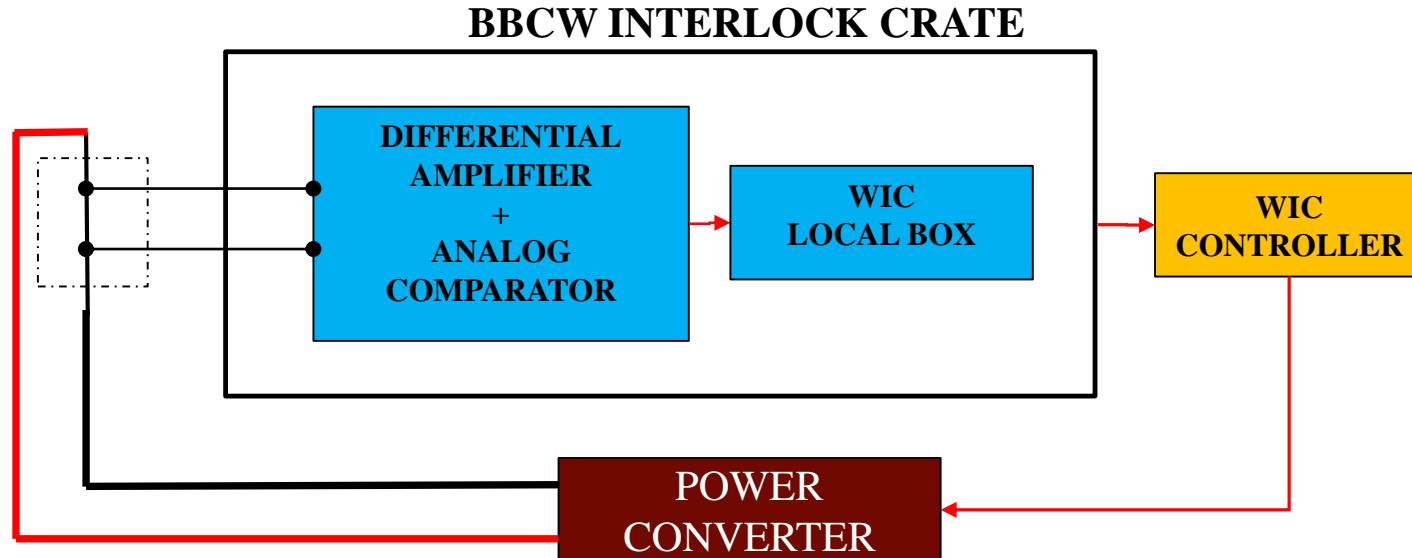
BBCW Interlock

- Interlock generated for BIPOLAR current
- THRESHOLD = 2.7V corresponds to
 - +/- 375A cooled (tested)
 - or ~200°C at hottest point on wire when loss of coolant
- FAIL SAFE SYSTEM :
 - Local power supply break
 - Cable removed
 - REDUNDANCY (2 RELAYS) OUTPUT
- Well known basic electronics assembly
- 1 card per wire

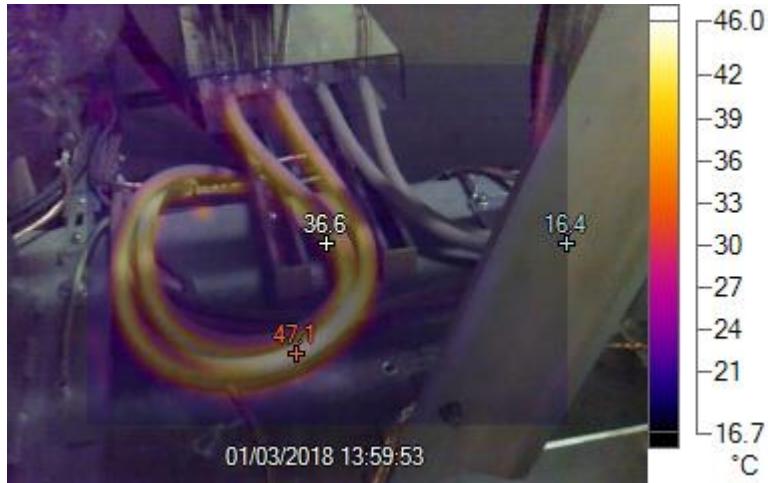
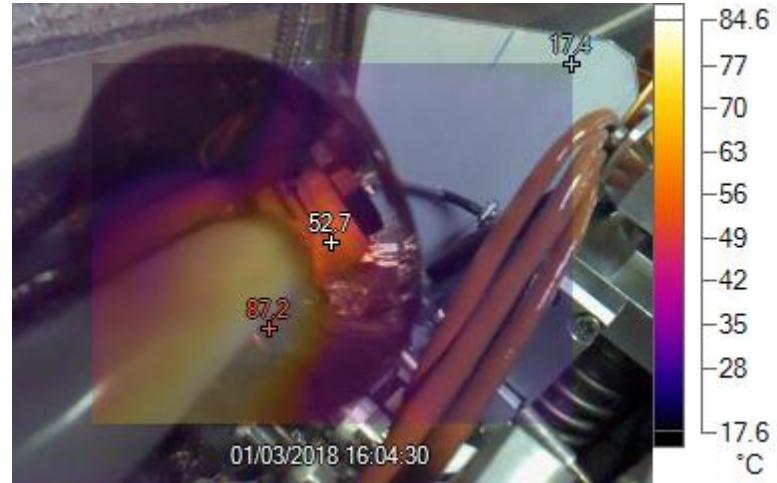
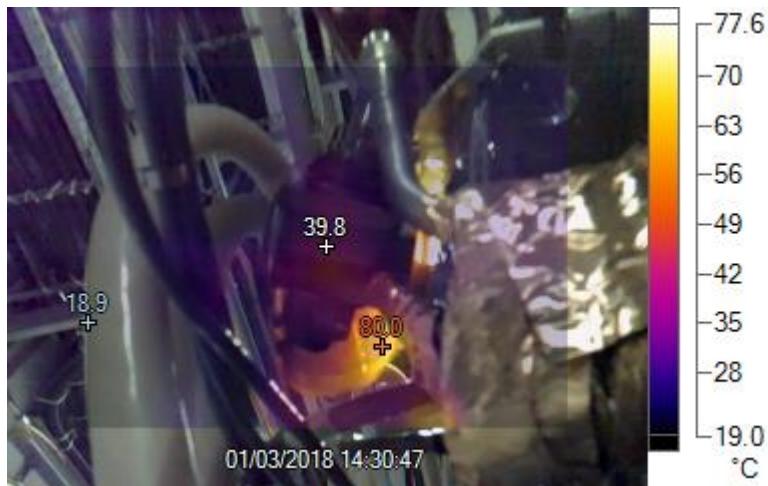
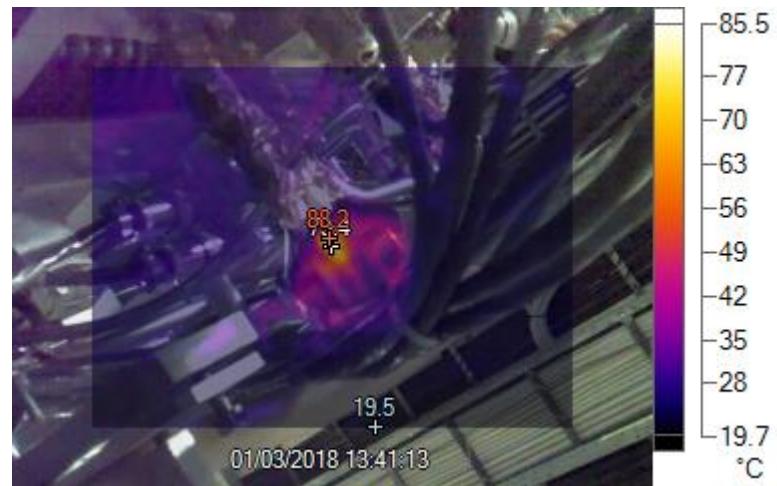
Temperature at cable transitions in IR1

- 350 A on BBCW (=700 A total) for 30-45 min and check
 - Temperature at cable connectors from wire to large power cable should not exceed 60-70 °C after 15 min
 - Collimator jaw temperature should not exceed 35 °C

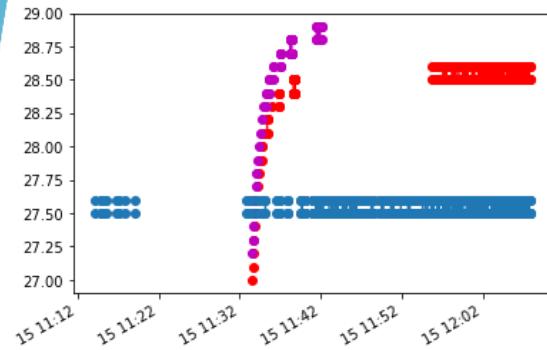
TCLVW.A5L1.B2

15/03/18 tests: PC current and jaw temperatures
