Modifications of the SMP and Implications for the YETS 2022-23

231st Machine Protection Panel Meeting

25th November 2022

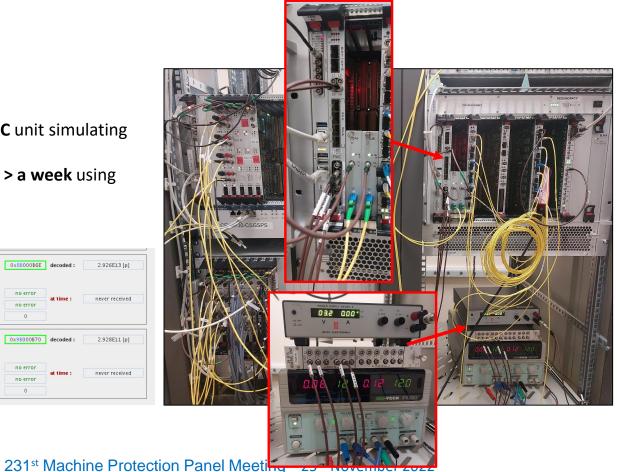
Test Setup in the Lab

- Lab Setup in Bldg. 30:
 - SMP lab crate
 - 1x VFC-HD
 - 2x CTDAB
- **Power supply** connected to an **ADC** unit simulating the BCT5 signal
- No errors on the receivers side for > a week using two intensities: 1.4e11, 2.9e11

SOURCE 3 - SPS/BCT	5						
Value received :	0×4D000B6E	at time: 14-11-	-22 10:12:38	Value transmitted :	0x8800086E	decoded :	2.926E13 [p]
Polarity :	NORMAL	Ms received :	TRUE				
Source Alive :	TRUE			Mon. Error transmitted :	no error		
Error received :	no error	at time : neve	er received	Ctrl. Error transmitted :	no error	at time :	never received
Error Count :	0			Error Count :	0		
SOURCE 4 - NOT REC	OGNIZED						
Value received :	0×0D000B70	at time: 14-11-	-22 10:12:38	Value transmitted :	0x <mark>98</mark> 000870	decoded :	2.928E11[p]
Polarity :	NORMAL	Ms received :	TRUE				
Source Alive :	TRUE			Mon. Error transmitted :	no error		
Error received :	no error	at time : neve	er received	Ctrl. Error transmitted :	no error	at time :	never received
Error Count :	0			Error Count :	0

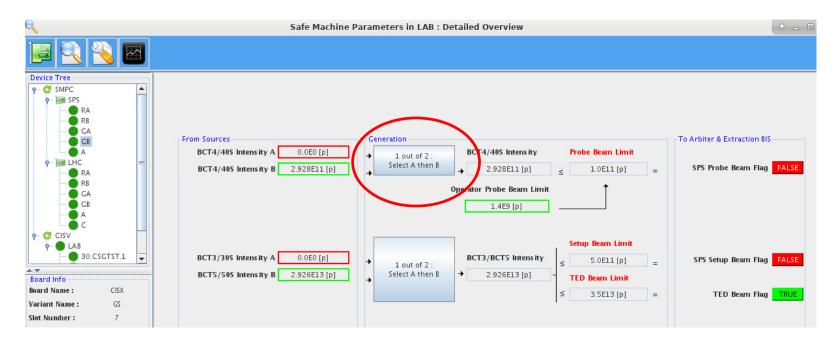
SMP-SPS Generators - CISG

- Probe Beam Flag Generator logic is 1002: the first VALID
- Proposal with two redundant sources: 1002 the HIGHEST

- New BCT5 connection to replace the previous BCT4-B
- SMP CISR and CISG requires reprogramming
 - New Header values
 - Generator logic changed to "1002 the highest"
- FPGAs hard to reprogram
