CERN Computer Centre(s) Network evolution (Part II)

Vincent DUCRET – vincent.ducret@cern.ch
HEPiX Spring 2023 – Taipei

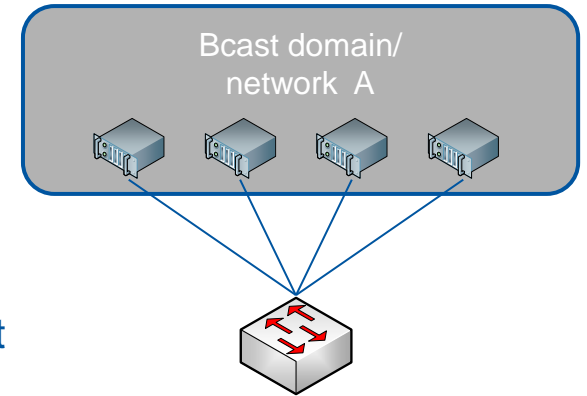
- Vlan on the ToR switch
 - Multi domain support on a single switch
- **Before:**
 - All servers on a switch must belong to the same Network/Bcast domain
 - Needs and server allocation may evolve over time.
 - If some servers need to be moved, we must connect them to a different switch

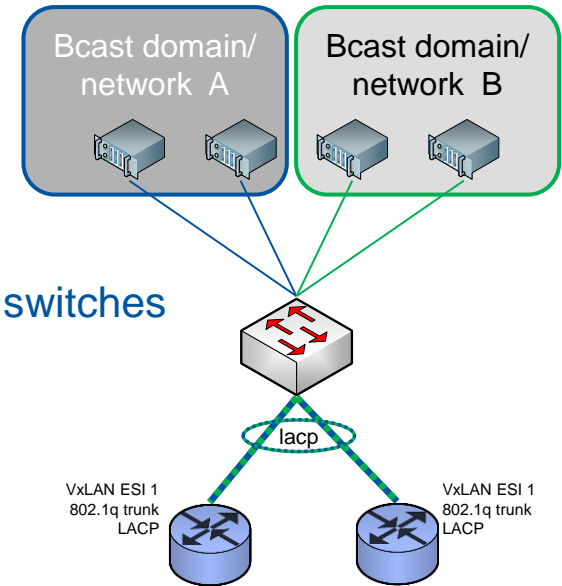
- Vlan on the ToR switch
 - Multi domain support on a single switch
- After:
 - Need to configure 802.1q trunk between routers and switches
 - Migration implies small downtime
 - Adding Vlans afterwards is transparent
- Currently applied on a limited number of switches

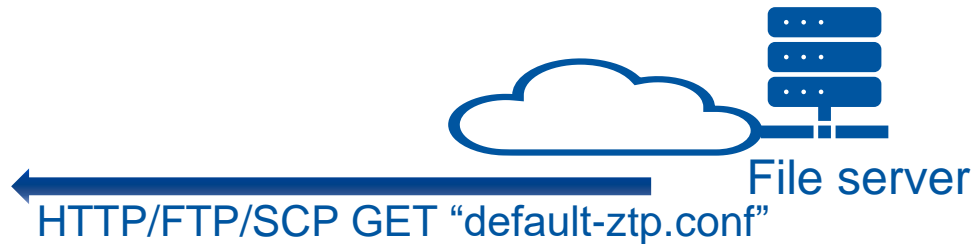
- Zero Touch Provisioning (ZTP) for Juniper devices
 - Juniper ZTP + enhancement via SLAX scripts:

1. Load "default-ztp.conf"
2. End of Juniper ZTP
3. Start "ztp-discovery.slax" script (called by the configuration file)

- Check our DB to get the hostname corresponding to the S/N
- Apply hostname to switch and run next script

- Based on the hostname or model type, upgrade the devices following a specific upgrade path (multiple upgrades if required)
- Once target version is reached, run next script

- Based on the hostname or model type, apply the configuration
- If required, apply licences
- If required, power-off device (ex: stock device preparation)

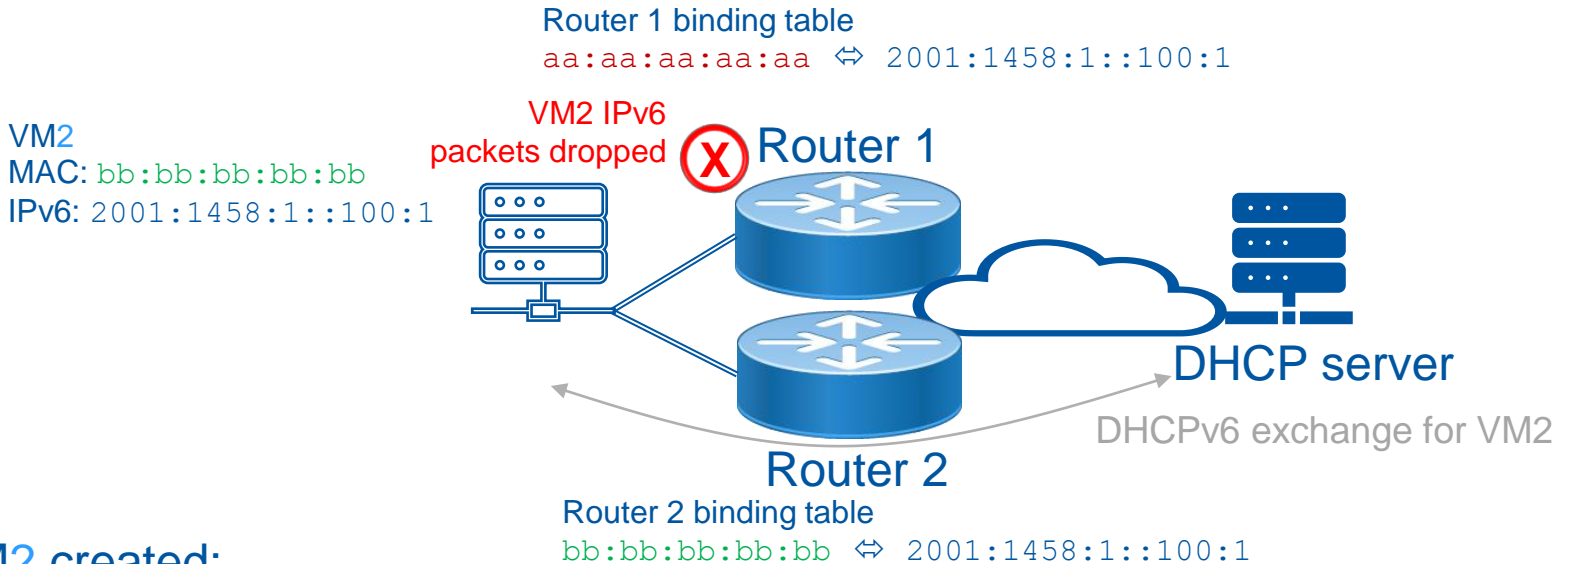
DHCPv6 relay issues: DHCPv6 binding and dual router setup

- VM2 created:
 - DHCPv6 relayed by Router 2
 - It reuses VM1 IPv6 address
- Router1 will drop packet from VM2 due to DHCPv6 binding old entry

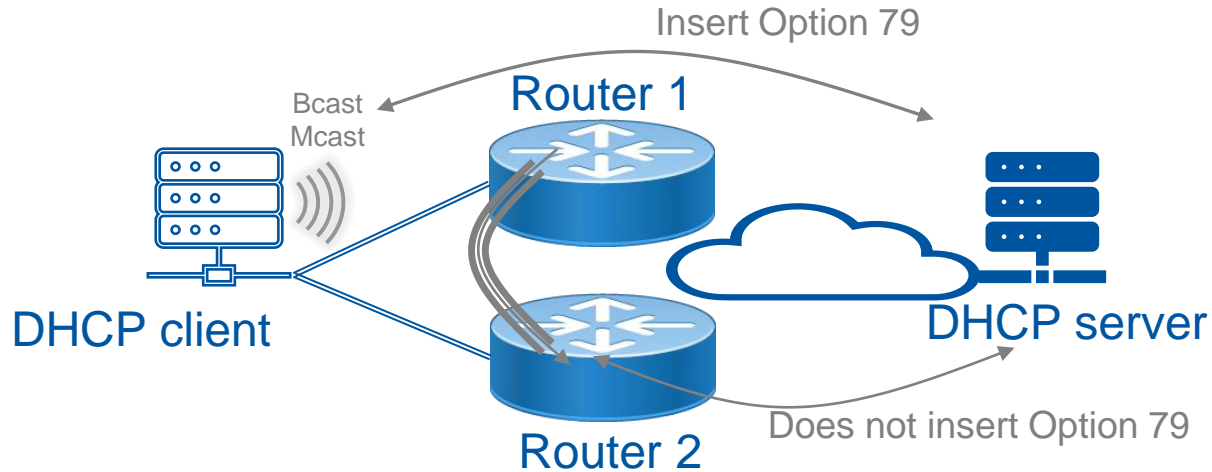
DHCPv6 relay issues: Option 79 not inserted via VxLAN tunnel

- On version 21.2, DHCPv6 Bcast/Mcast packets are replicated to the 2nd router via VxLAN tunnel
- DHCPv6 packets crossing VxLAN are relayed by 2nd router without Option 79
- DHCP server sees two requests coming, one with Option 79, the second without

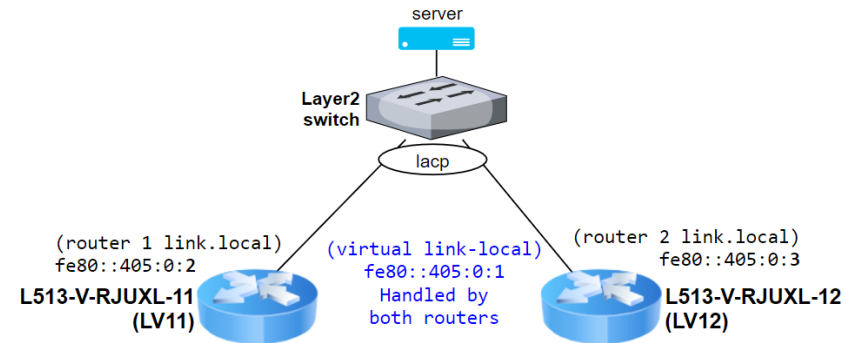
CEPH Client and IPv6 default route handling: fix

- This was fixed by changing the router configuration to use a virtual link-local address shared by both routers
- Servers will have only one default gateway pointing to this virtual link-local address (similar to IPv4)
- Behaviour is no more OS/System dependent
- Virtual addresses shared by routers were already configured for IPv4 and all IPv6 addresses, except link-local...

```
[root@server ~]# route -6
Kernel IPv6 routing table
Destination      Next Hop          Flag Met Ref Use If
[::]/0           fe80::405:0:1    UG    100 65  0  enp59s0f0
```

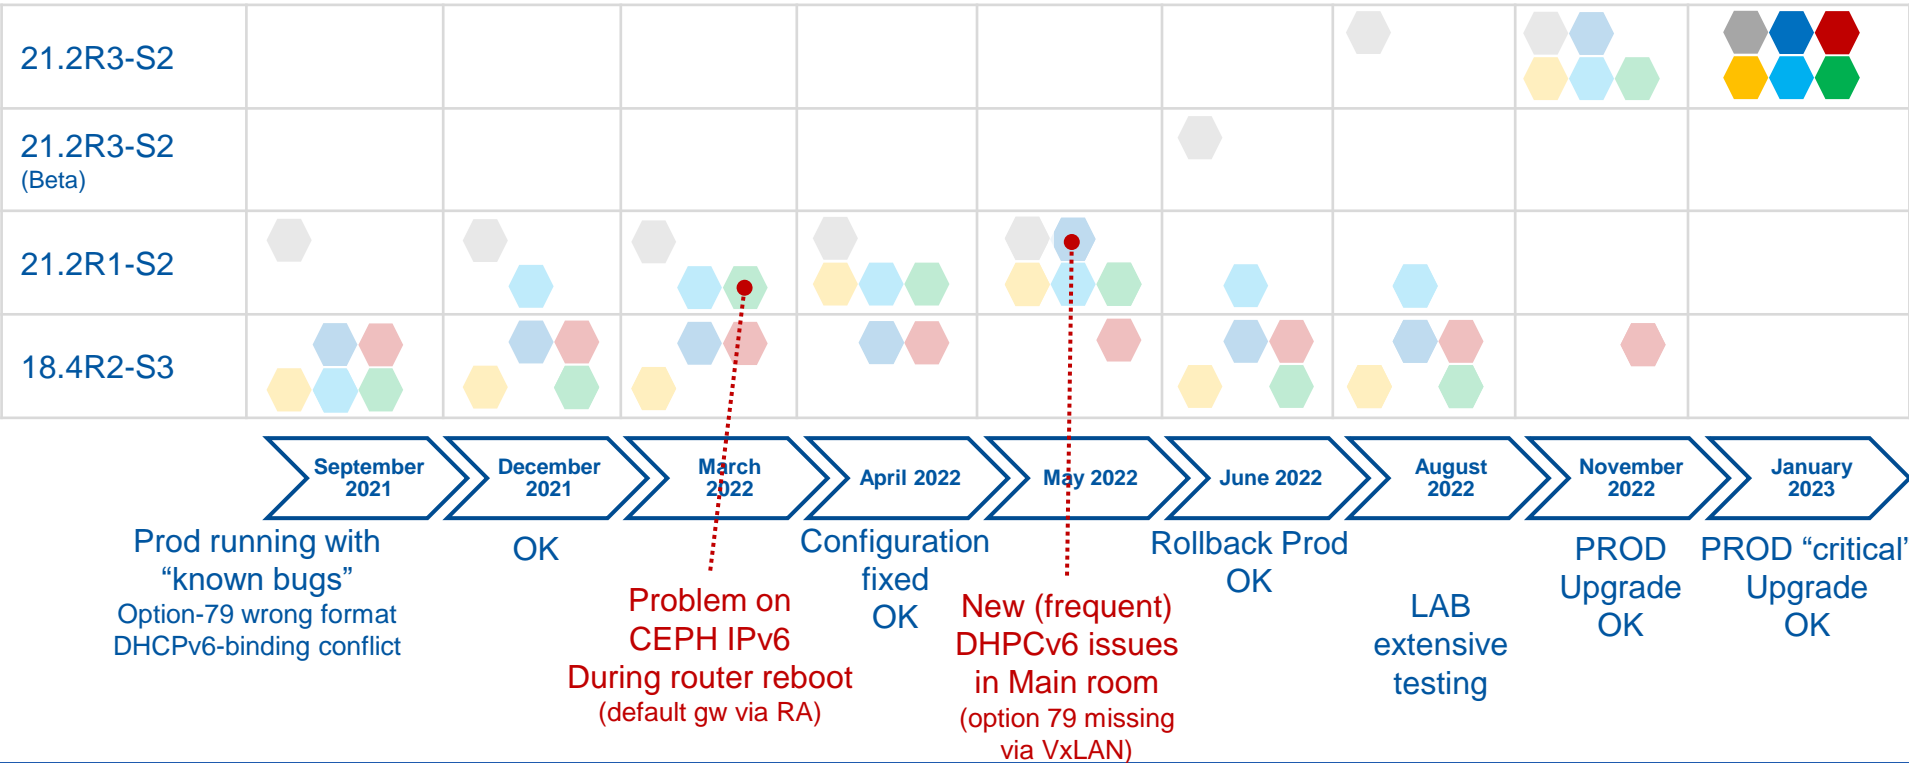
Router Upgrade path

LAB

773(Prévessin)

513 Main Room

513 Main Room 100G

513 Barn (Critical)

513 Vault
