3rd CERN Baltic Conference

Latvian Industry in CMS

CMS MTD BTL subdetector cooling

CO₂ system qualification:

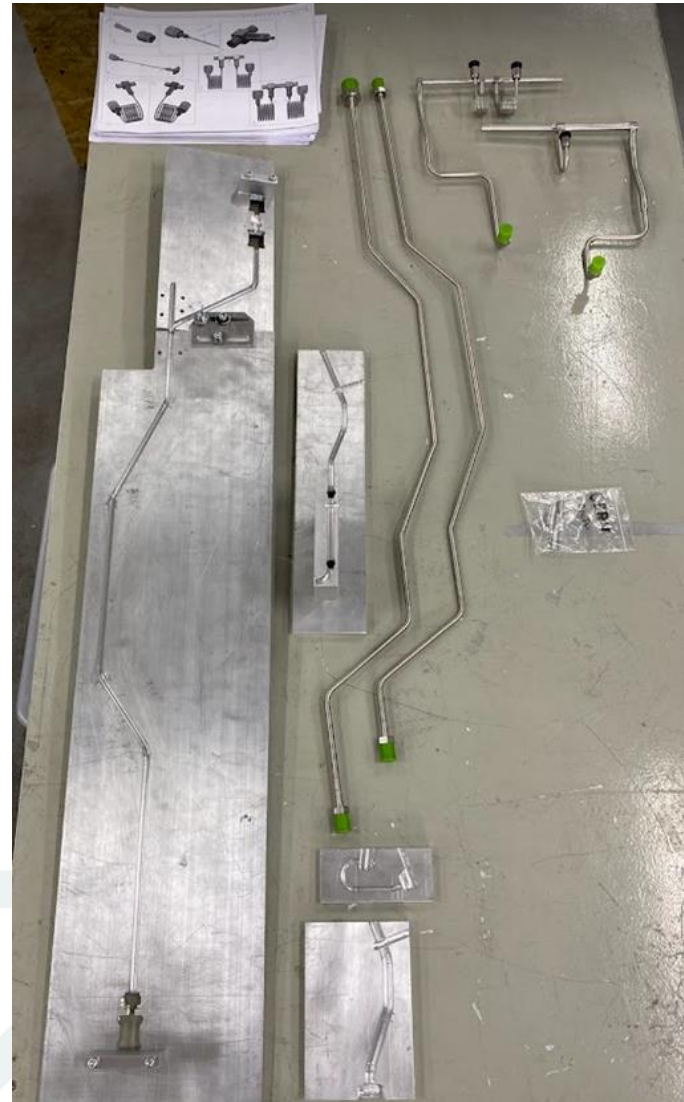
Defects in first manufacturing trial:

- tungsten inclusions;
- seam root porosity;
- lack of penetration
