X-Box Update

30.08.2023

X-Box 2: TD31 N3 N4

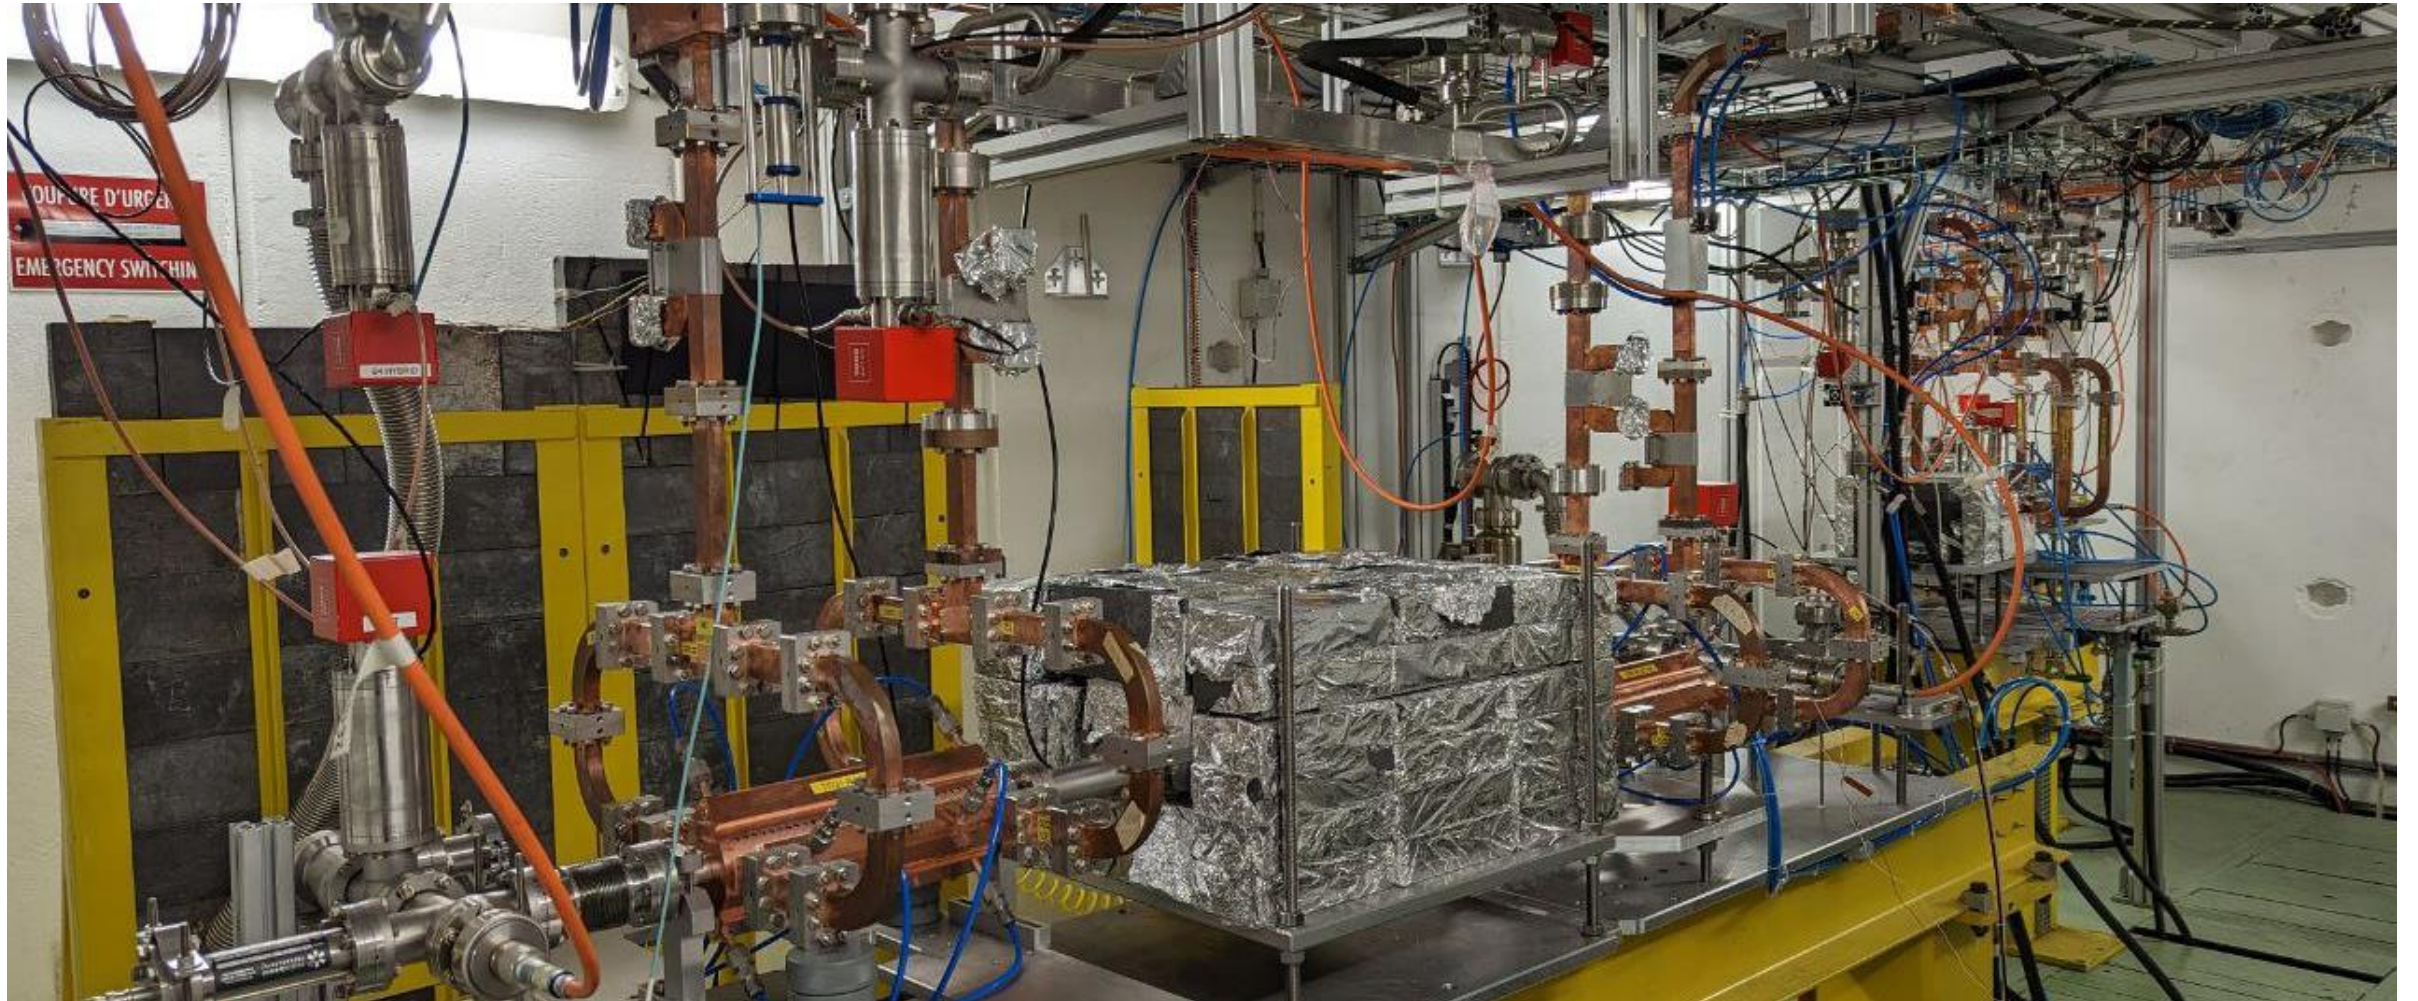
X-Box 2 TD31 N3 N4: Structure B

- Restarted 22.08.2023
- 100% power going to Structure B
- Calibration lines B – checked
- Currently: 25MW

- Not operating – new electrical installation

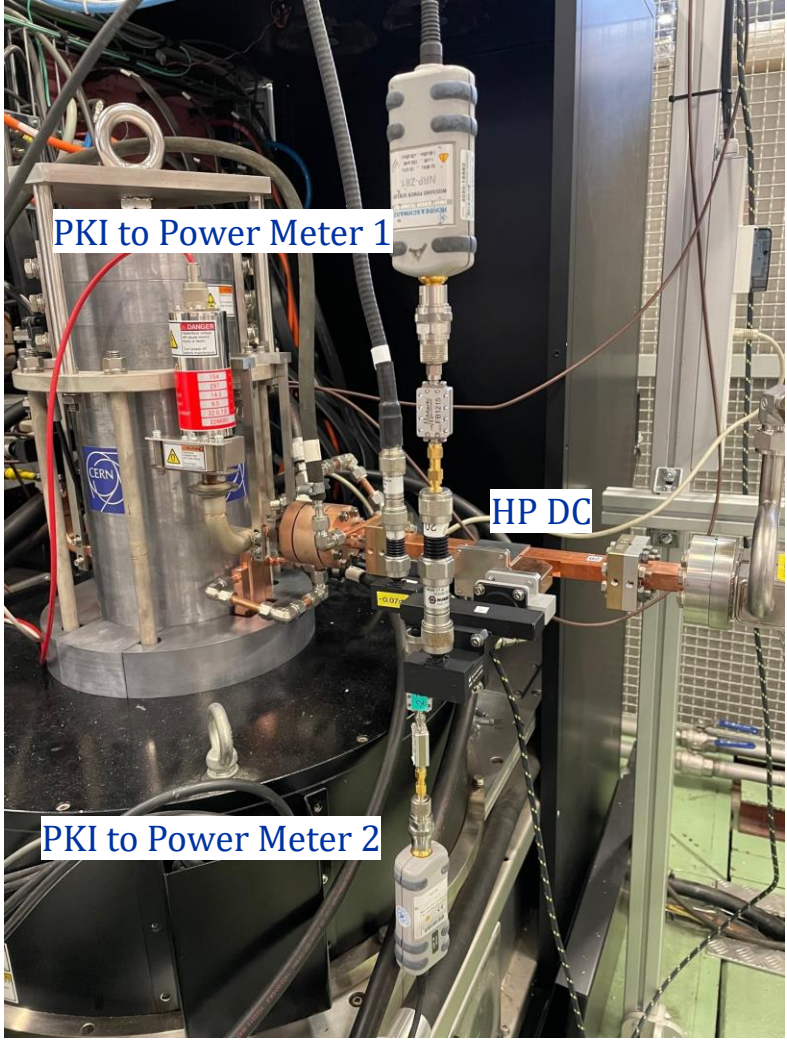
Measurement setup

High Efficiency Klystron ER37117 TUBE1

Same Configuration as CANON

Beam Current (A)	94 (*)
RF pulse width (us)	1.00
Klystron pulse width(us)	6.4
Frequency (Hz)	11.994
PRR	50
Main Coil Sol Curr (A)	32
Counter Coil Sol Curr (A)	7

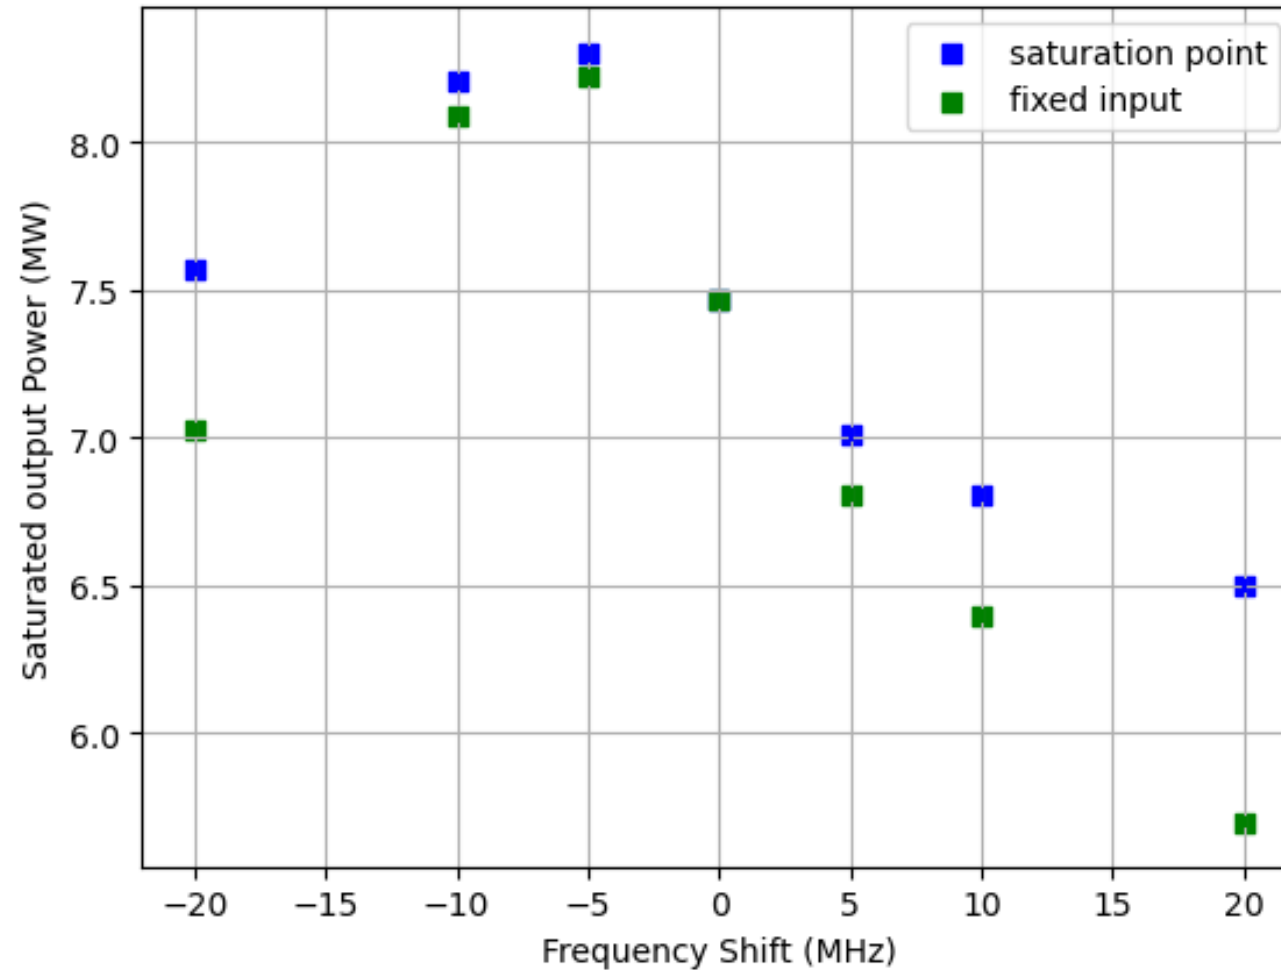
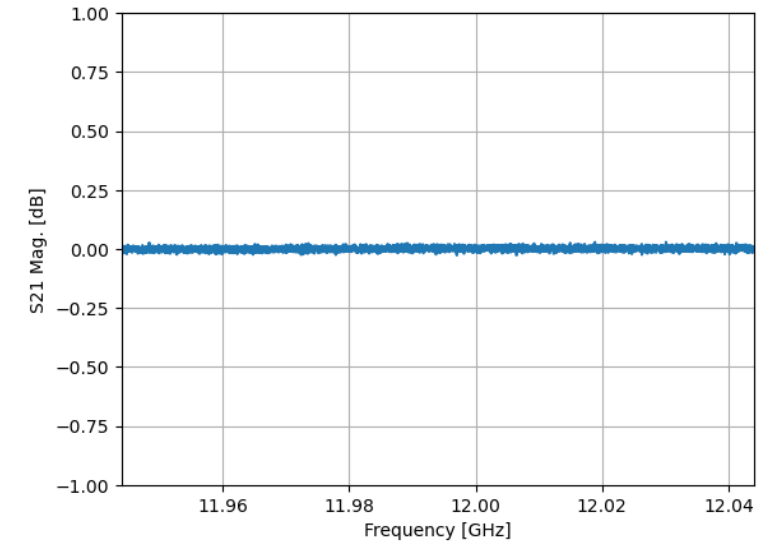
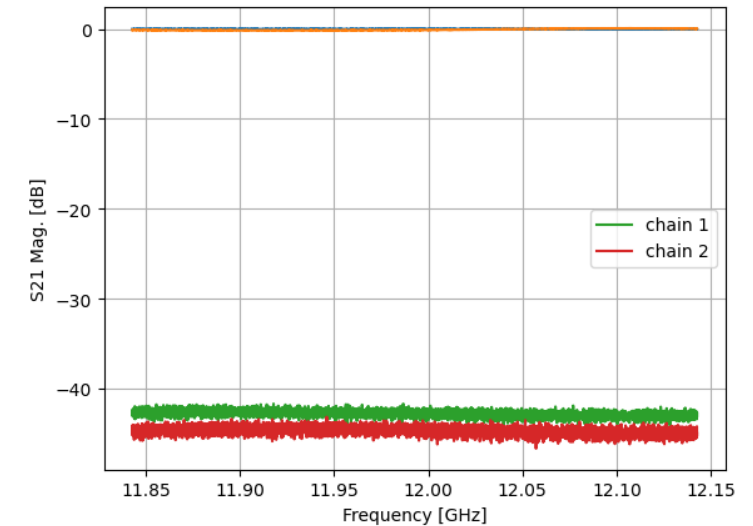
Frequency behaviour

High Efficiency Klystron ER37117 TUBE1

(*) Canon curve has been shifted -5 MHz

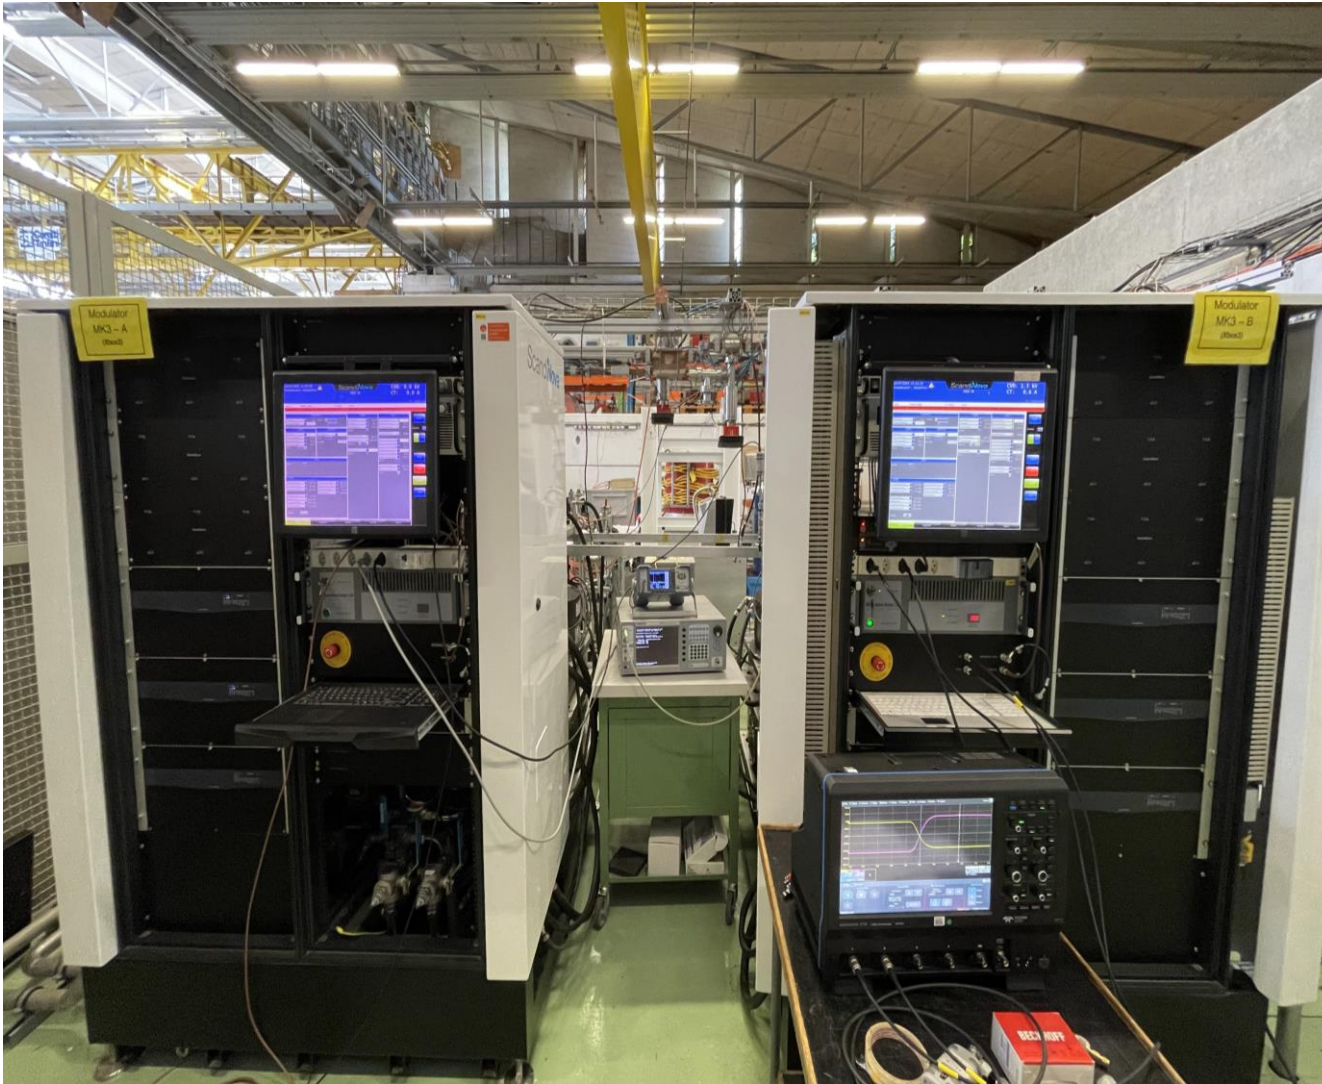
X-Box 3: High Efficiency Tubes Characterisation

- **Calibrated setup – problems with VNA -> recalibrated using VNA with coaxial type N ports**
- **Measured curves of first TUBE (mod A)**
- **Now – no tension in filament (under investigation)**
