# **X-Box Update**

**20.09.2023**

# X-Box 2: TD31 N3 N4

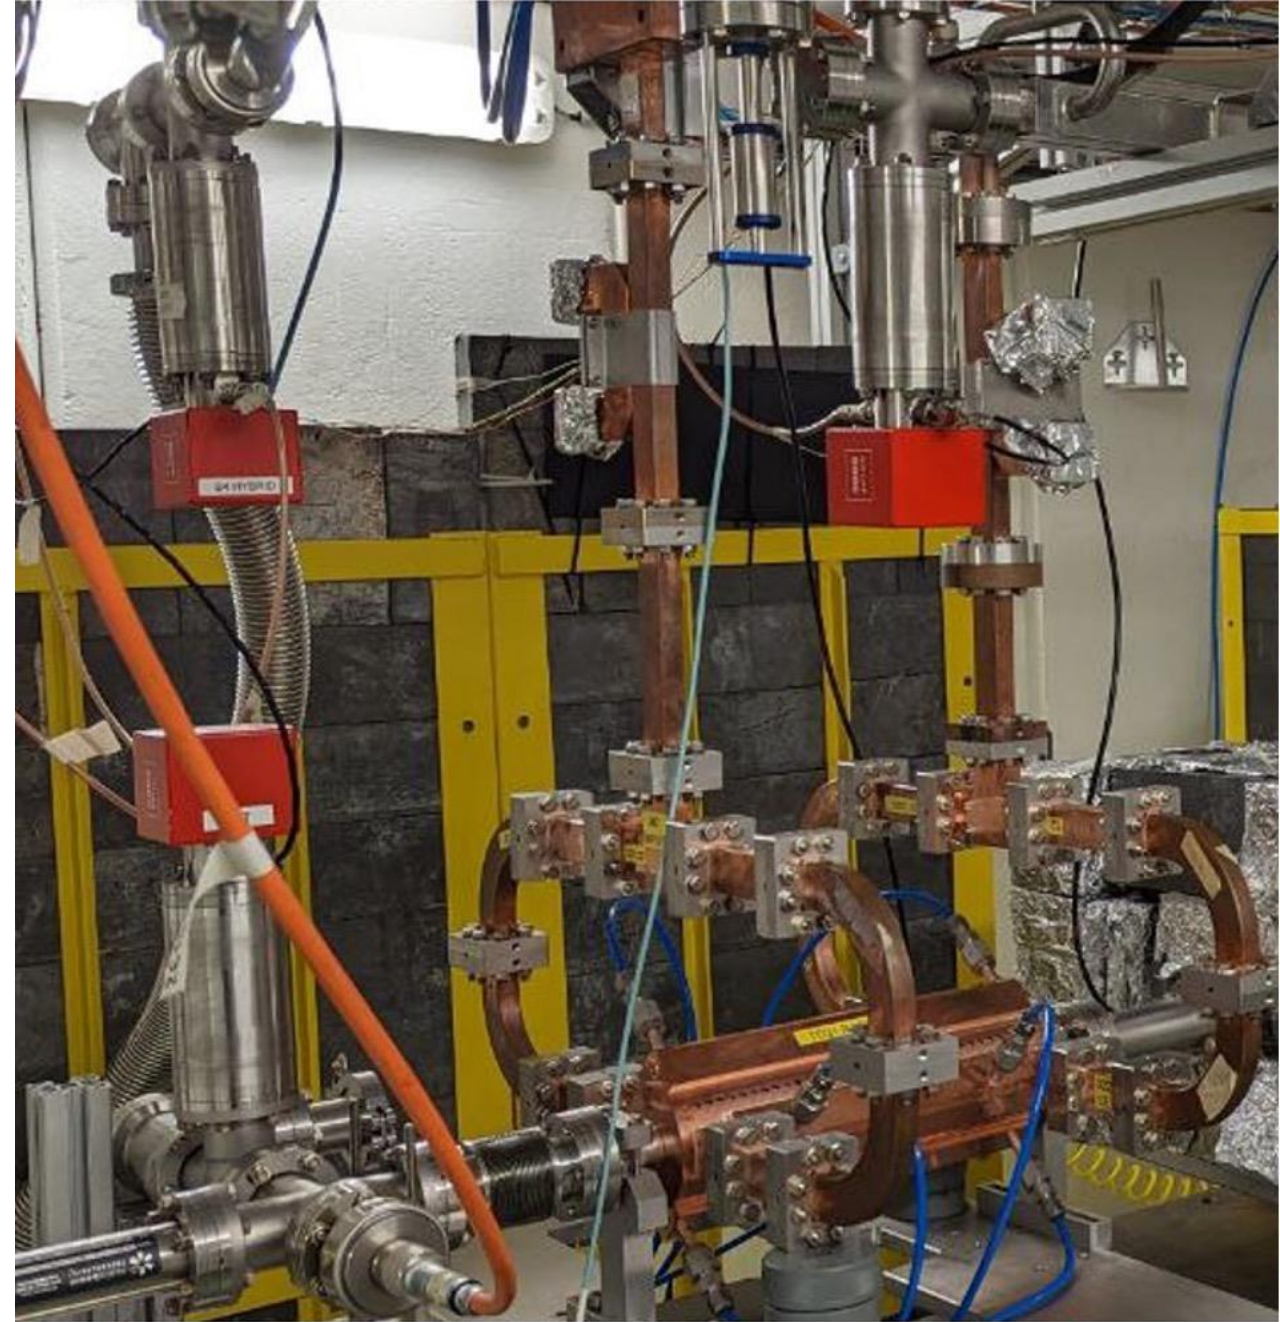
# X-Box 2 TD31 N3 N4- Structure B

- Restarted 22.08.2023
- 100% power going to Structure B
- Calibration lines B – checked
- Currently: 25MW

- New electrical installation is ready

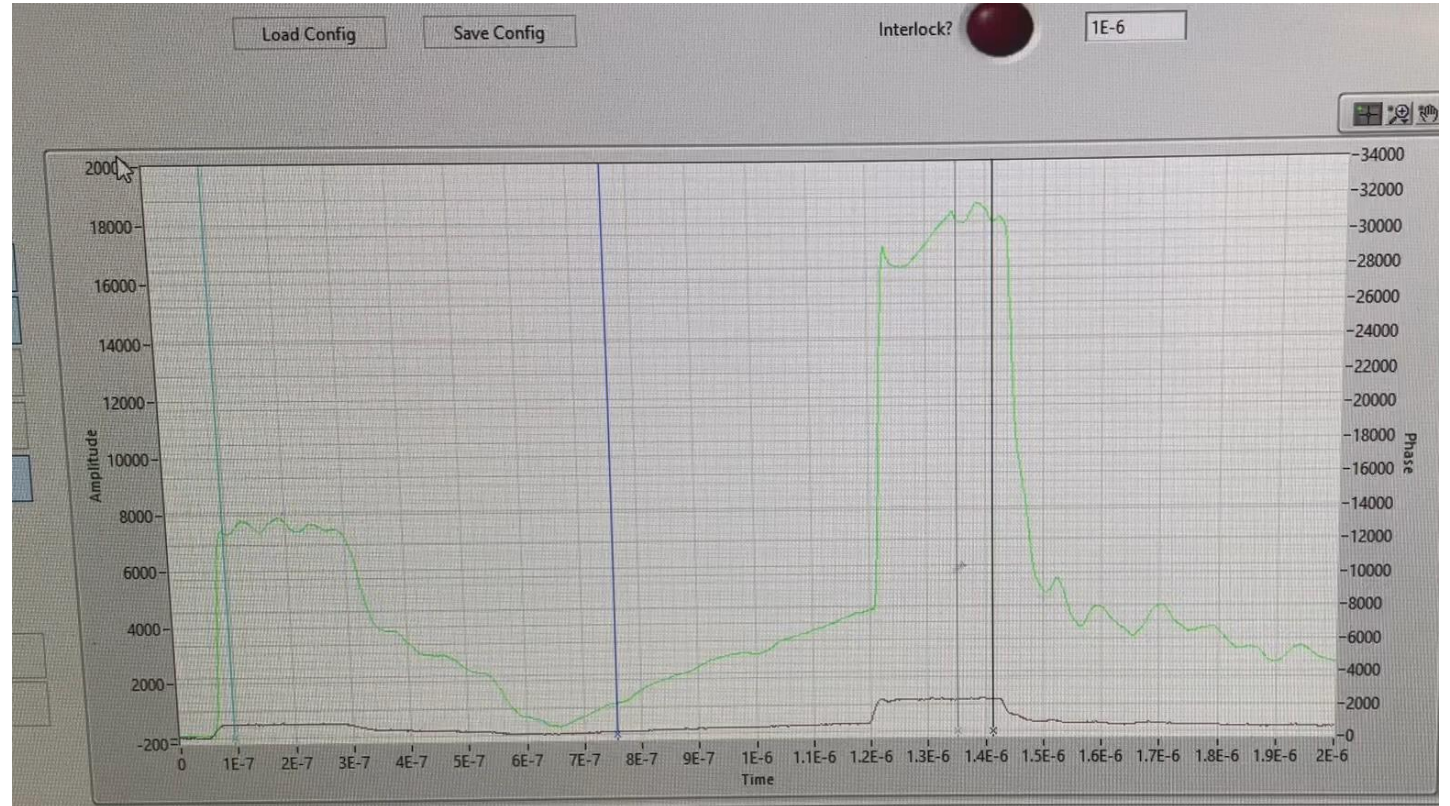
# X-Box 2 TD31 N3 N

- **Weird behaviour >26 MW**
  - Structure B / Phase shifter / Power splitter / Pulse compressor
  - PXI / ADC

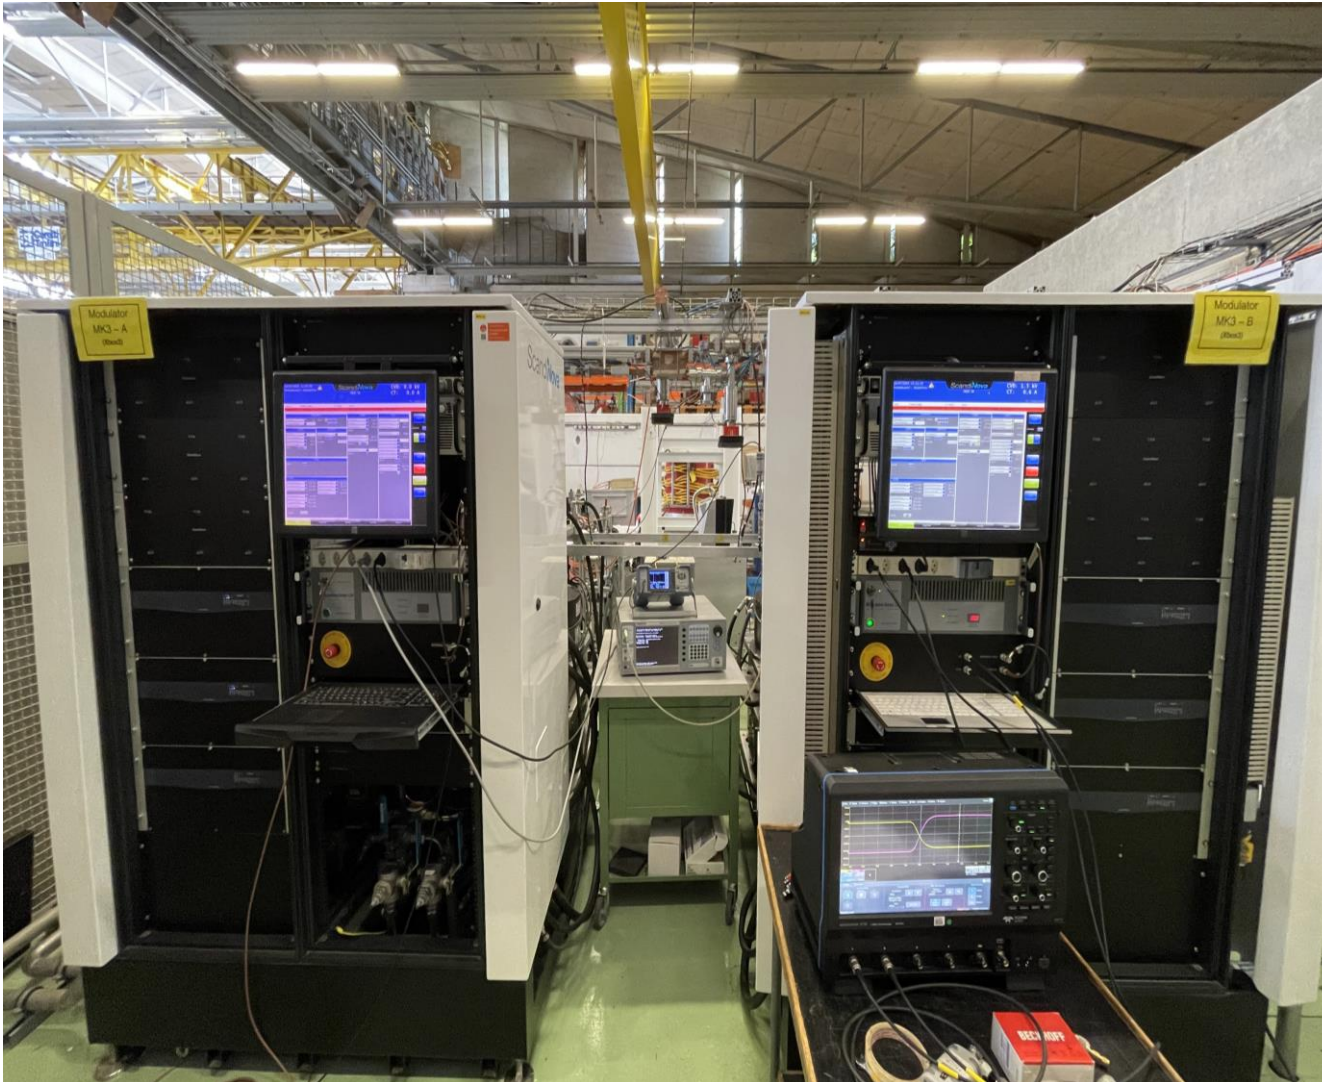
# X-Box 3: High Efficiency Tubes Characterisation

- **Calibrated setup – problems with VNA -> recalibrated using VNA with coaxial type N ports**
- **Measured curves of first TUBE (mod A)**
- **Now – no tension in filament (under investigation)**

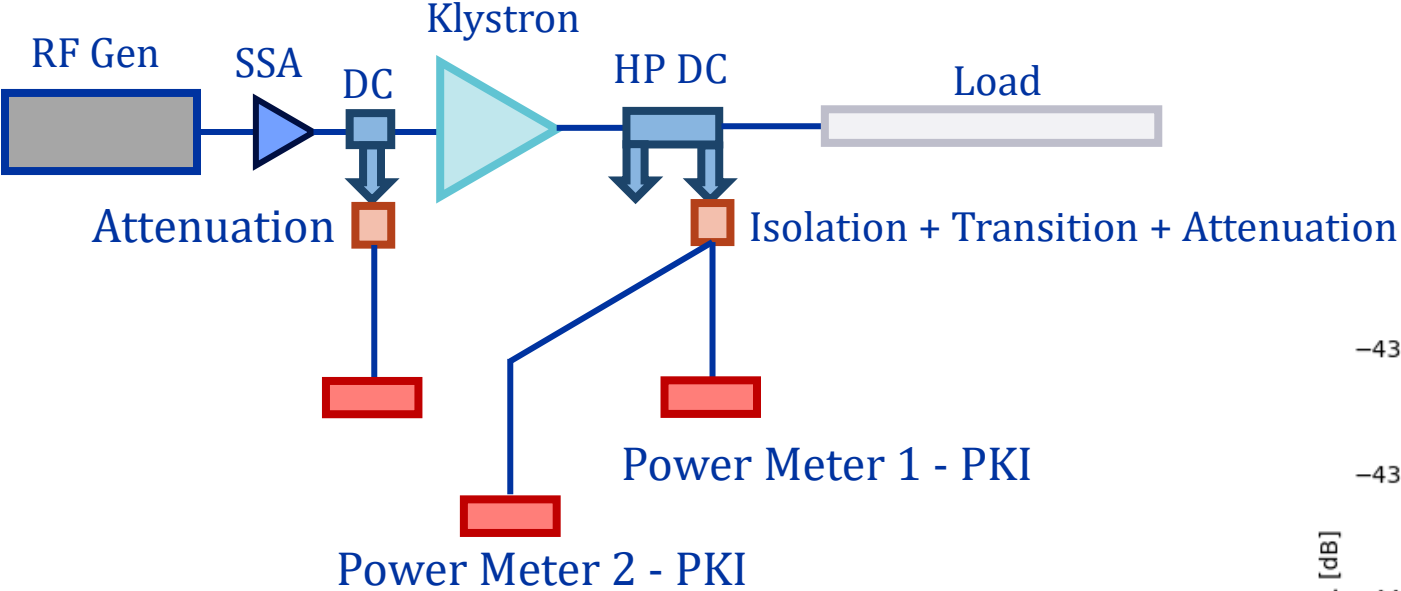
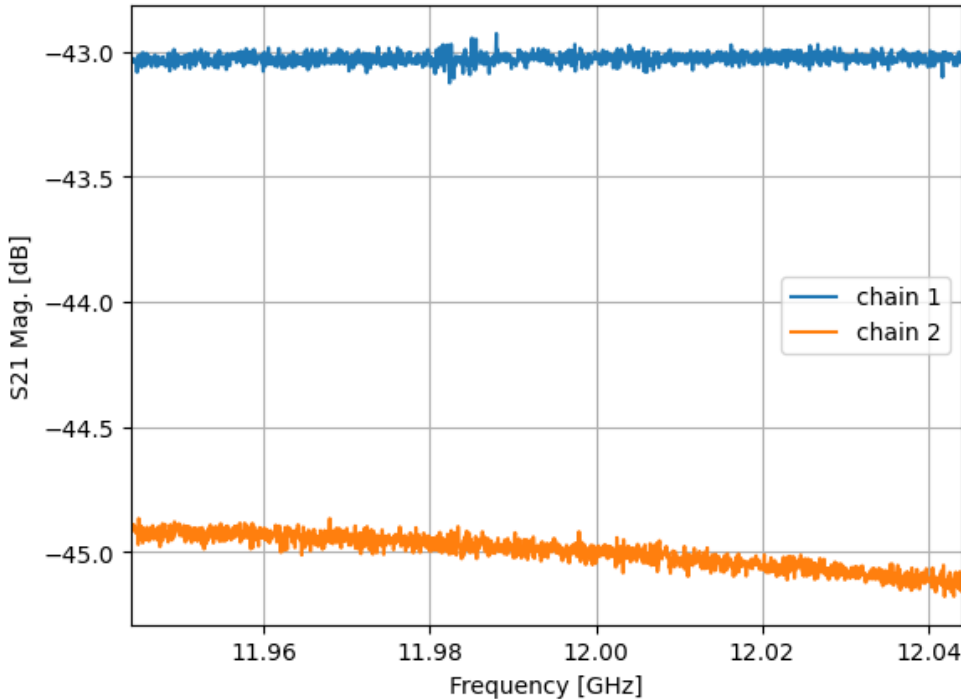
# High Efficiency Klystron ER37117 TUBE1

## Measurement setup

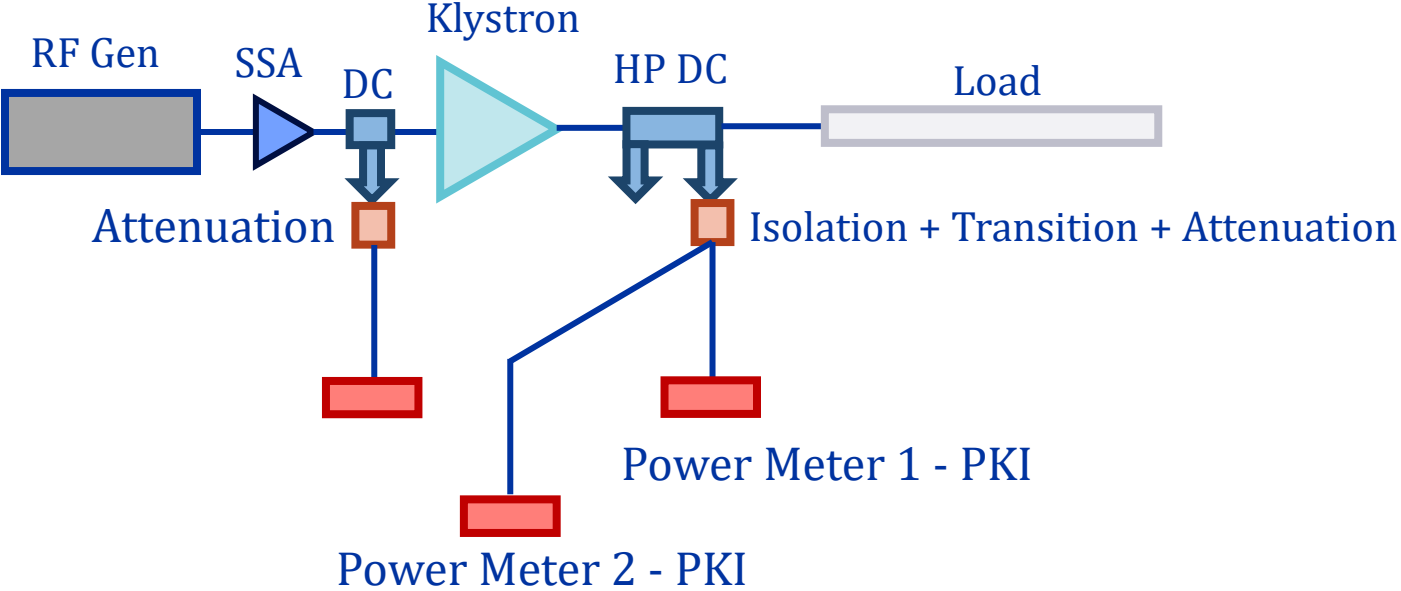
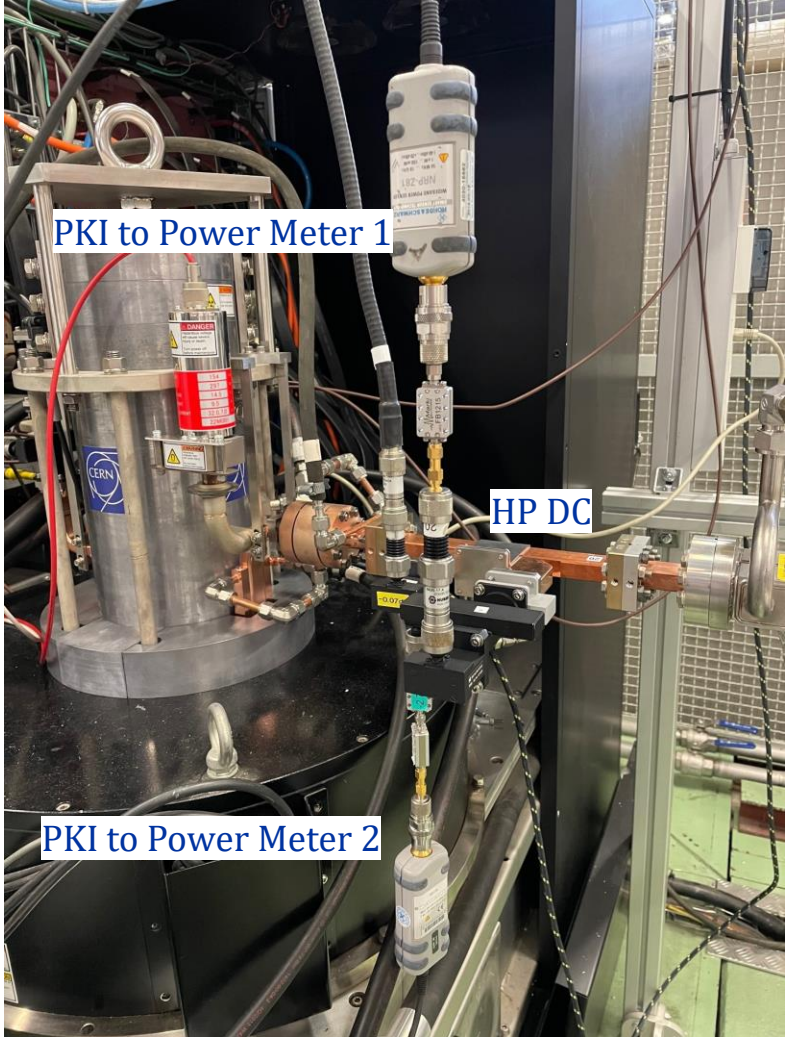
# High Efficiency Klystron ER37117 TUBE1

## Measurement setup

Chain	Att(dB)@11.994GHz
PKI, chain 1	43.04
PKI, chain 2	45.0
KLYIN	49.68

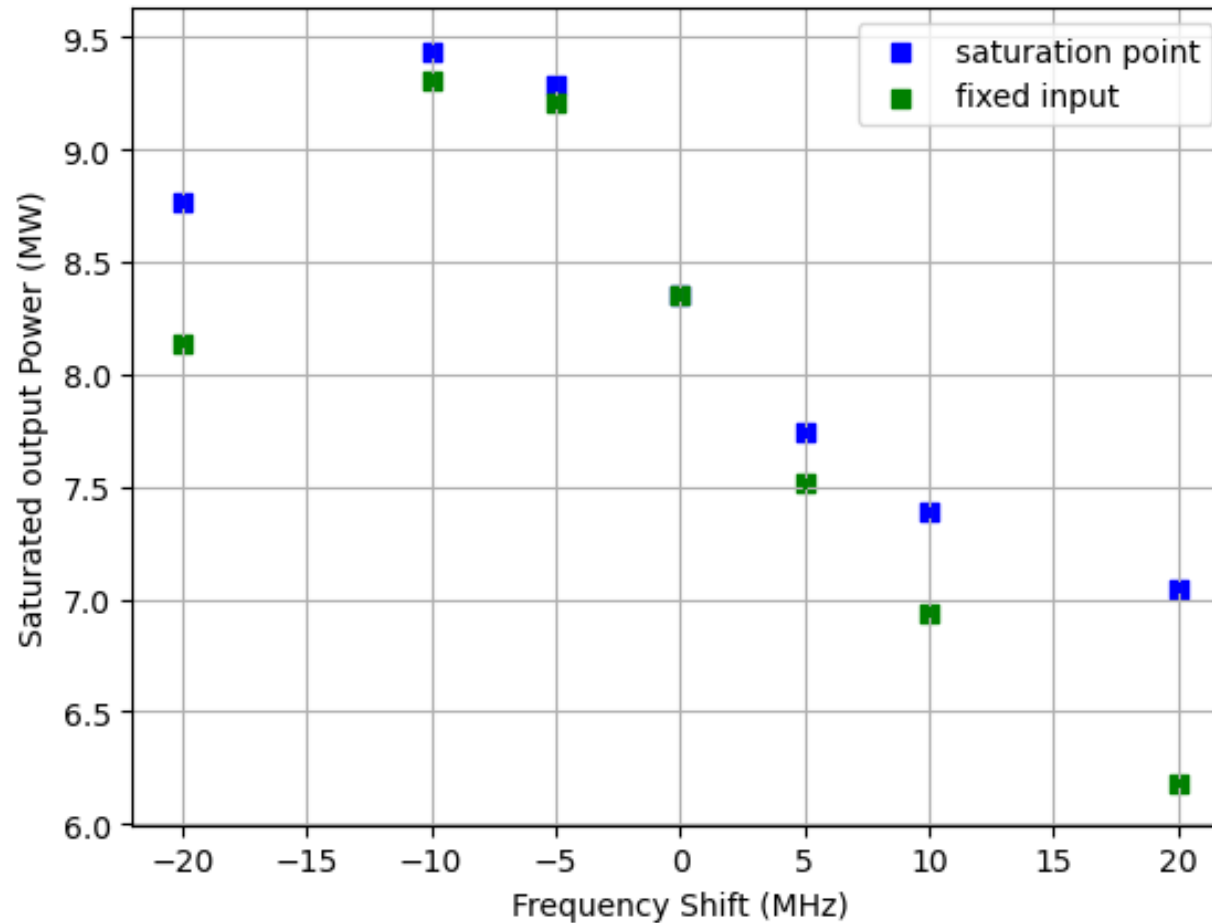
# High Efficiency Klystron ER37117 TUBE1

## Frequency behaviour

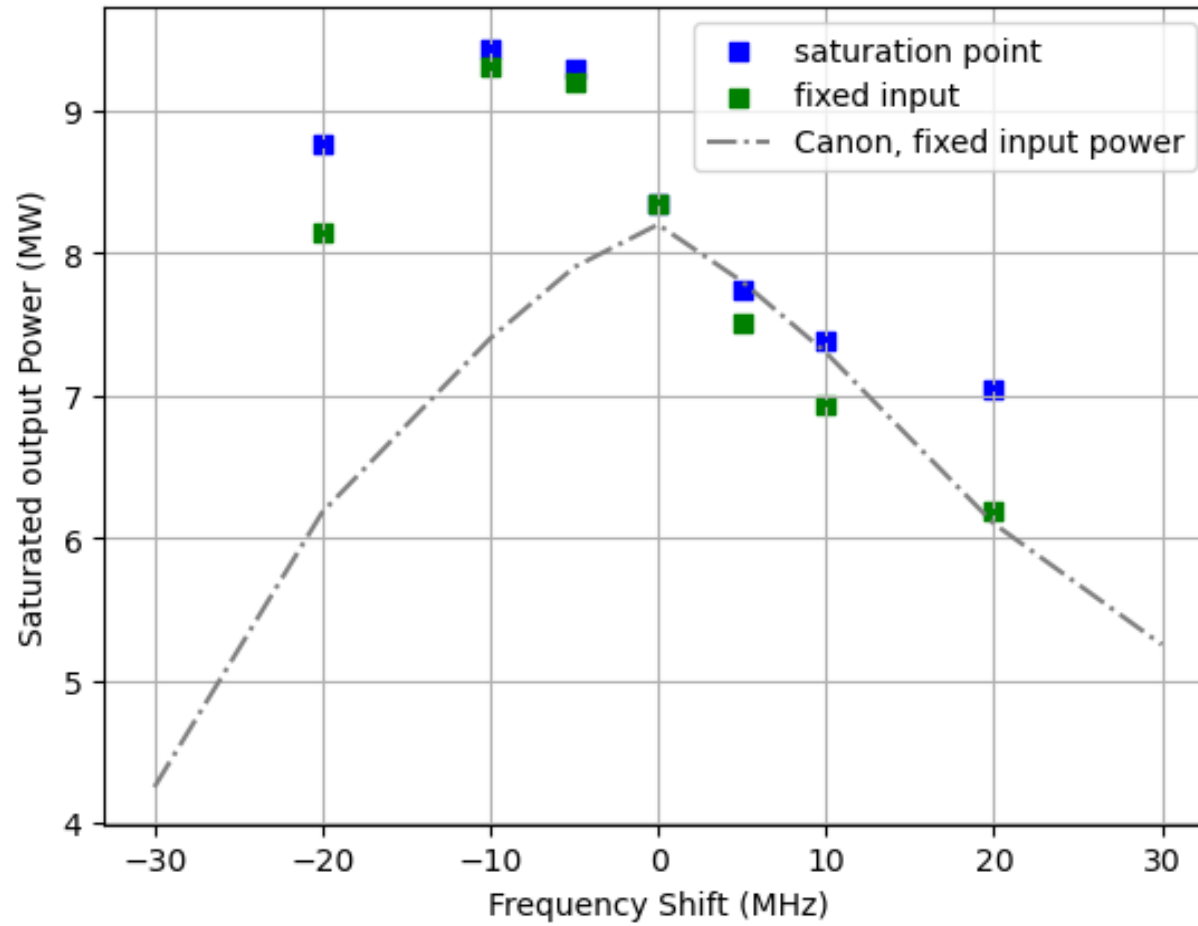
# High Efficiency Klystron ER37117 TUBE1

## Frequency behaviour

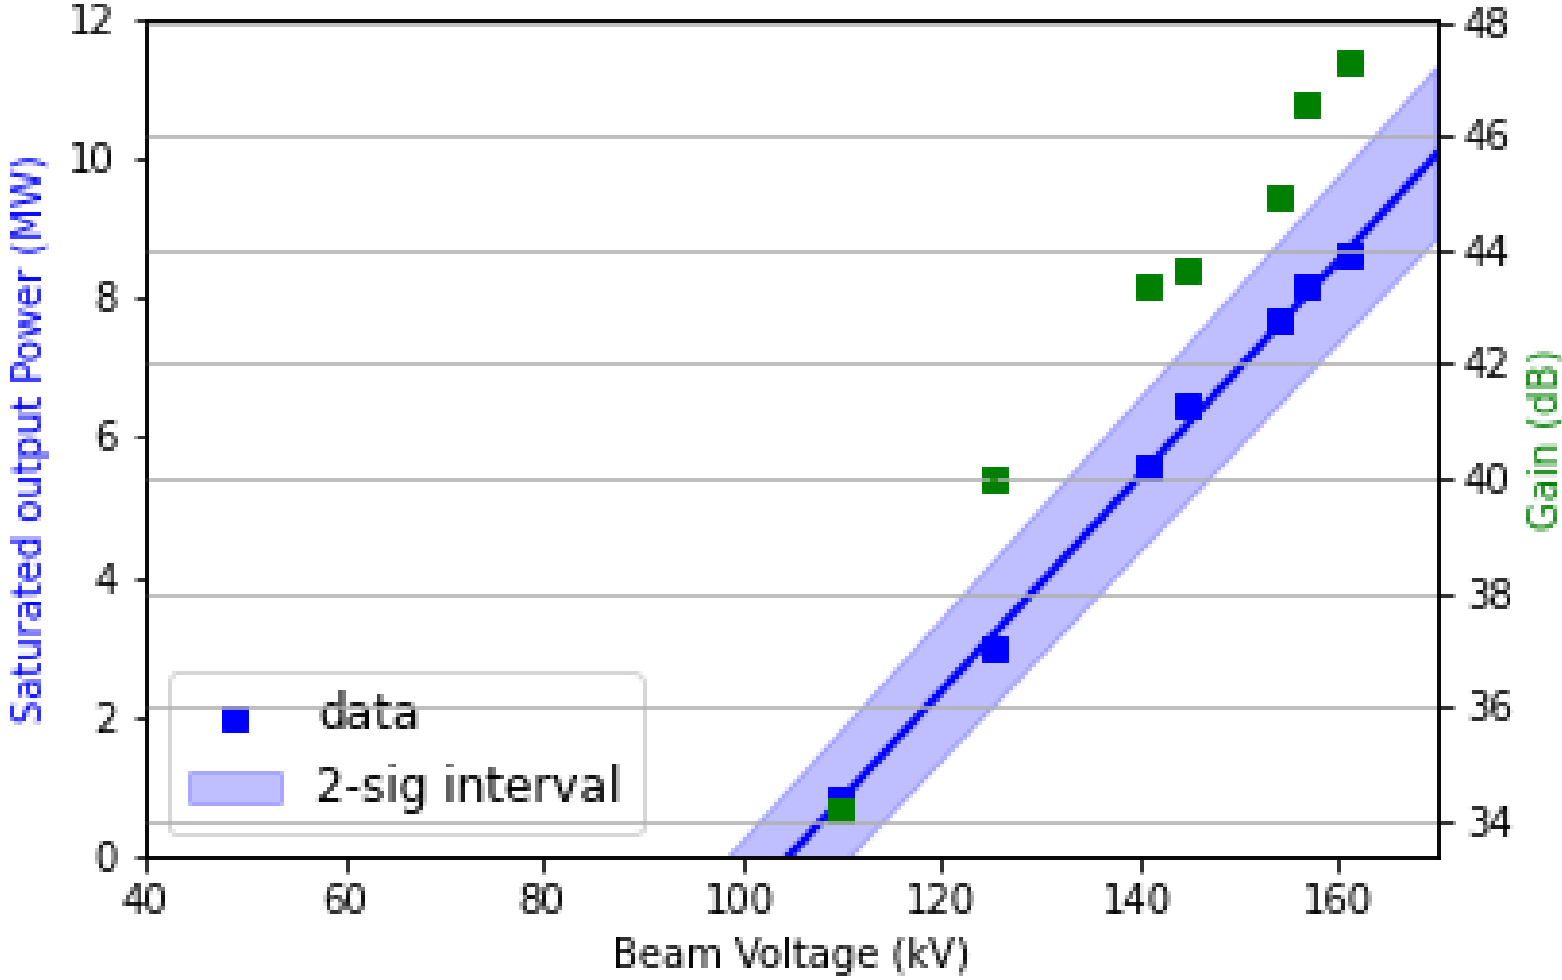
# High Efficiency Klystron ER37117 TUBE1

## Beam voltage dependency
