# Production of CMS GEM detectors for the GE2/1 and ME0 stations

With lessons learnt from GE1/1

Antonello Pellecchia<sup>1</sup> for the CMS GEM group <sup>1</sup> INFN Bari

RD51 collaboration meeting - Dec 4-8 2023

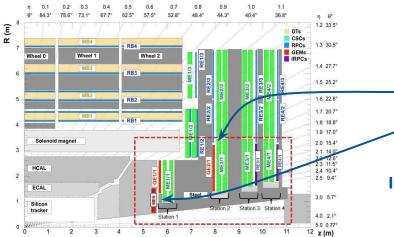
- GE1/1: Complementing CSC system in 1.6 < |η| < 2.15</li>
   Early Phase-2 upgrade: already installed in 2019-2020, commissioned and taking data during Run 3
  - **GE2/1:** Complementing CSC system in  $1.6 < |\eta| < 2.4$
- **ME0:** Complementing other GEMs and CSCs in 1.6 <  $|\eta|$  < 2.4,

extending muon system coverage to  $2.4 < |\eta| < 2.8$

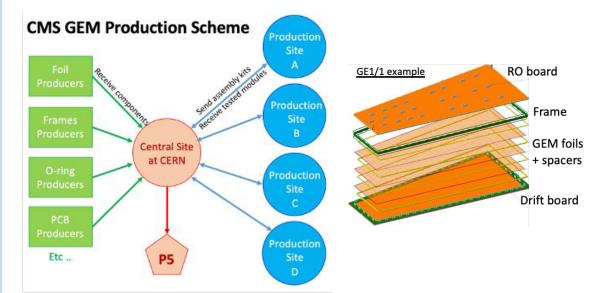
#### Production scheme as for GE1/1:

- Component QC at CERN
- Five production sites (Bari, CERN, Ghent+Aachen, Frascati, PKU) for individual modules
- Electronics, chamber assembly (4 modules together) and final validation with cosmics at CERN

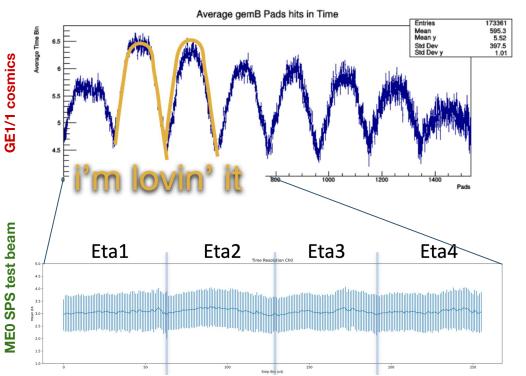
The **PCB bending** was impacting the **time response uniformity** of the detector.

In GE1/1, this caused **non-uniformity in signal** rise time  $\rightarrow$  timing modulation with strip position ("basin effect")

**Fixed in GE2/1 and ME0** design by using pillars to ensure uniformity of induction gap:

SPS test beam results: good timing uniformity over 4 eta partitions

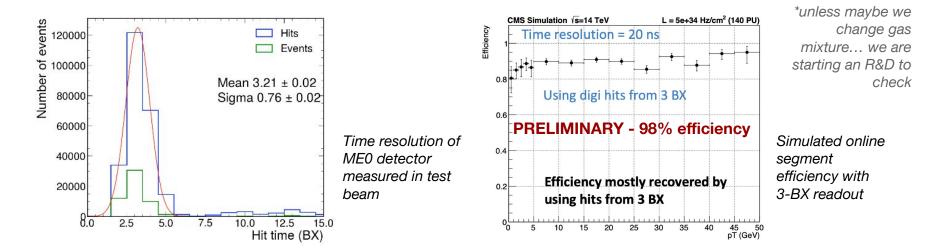
Our time resolution with front-end electronics is 15 - 19 ns, not 8 - 10 ns

- Common issue between GE1/1, GE2/1 and ME0: analog front-end not optimized for GEM signal shape and duration
- We cannot improve the time resolution\*, but we can mitigate effect on online physics performance:
  - Reading out multiple BXs readout in back-end firmware Implemented in emulator, under development in GEM firmware
  - From first simulations, online segment efficiency recovered with matching window 3 BX Slight worsening in bending angle resolution only at "hypothetical" pile-up 300

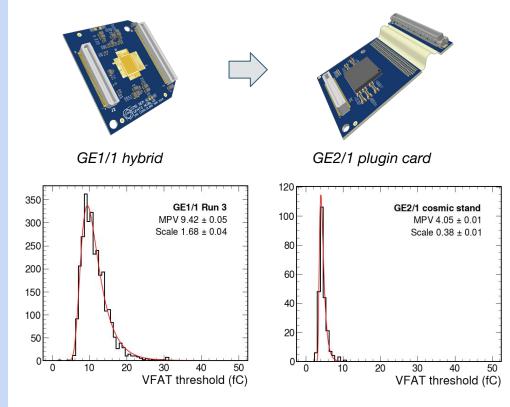
Very **good S/N ratio** verified with high-granularity efficiency measurement in test beam  $\rightarrow$

#### Same front-end ASIC (VFAT3), new PCB

- Chip is now **packaged**, bump-bonded (higher yield compared to hybrids)
- Flex PCB for easier alignment between readout board (ROB) and GEM electronics board (GEB)
- **HRS 140** connector to R/O strips provides more grounding pins  $\rightarrow \sim x^2$  lower noise

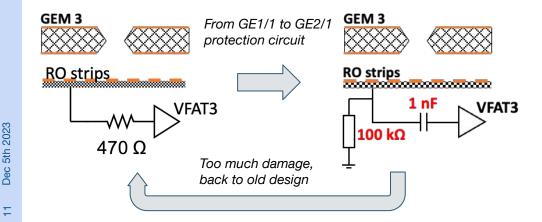
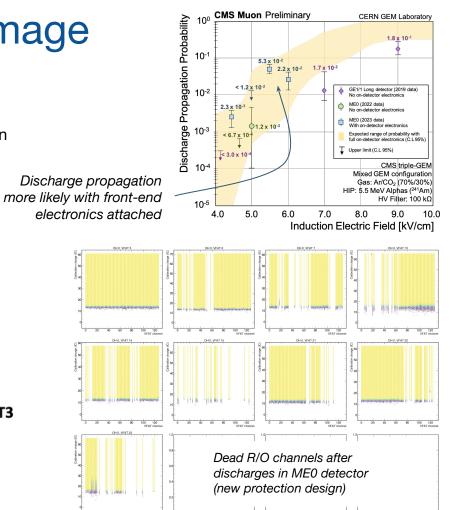
GE2/1 plugin card included new "decoupling" circuit to prevent discharge propagation to front-end

- Operations with GE2/1 and ME0 detectors (demonstrator in CMS, test beam, lab measurements) showed too high probability of discharge damage
- We changed the protection circuit back to the GE1/1 design (470  $\Omega$  series resistor)

Discharge studies now show no damage (expected damage probability per chip  $< 3 \times 10^{-3}$ )

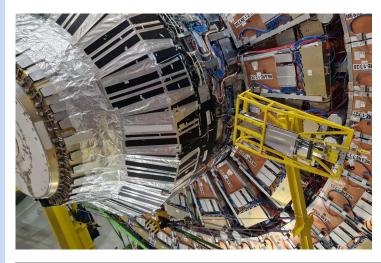
Production schedule **approved by CMS** in GE2/1 manufacturing progress review (MPR), May 2023:

- Install 30 chambers out of 36 (almost one endcap) in year-end technical stop (YETS) 2023-2024
- **Complete** production by **October 2024** (no float)
- Start **ME0** production in **November 2024**
- Complete full GE2/1 system installation in YETS 24-25

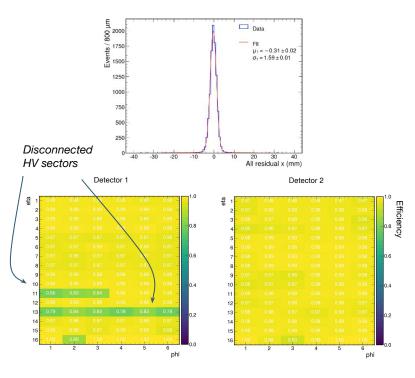
Instead the **refurbished and new** chambers show good stability and efficiency **uniformity**

Fist chambers almost ready for installation
