Target Status

Paul J Smith – University of Sheffield
On behalf of the Target Team

CM 30

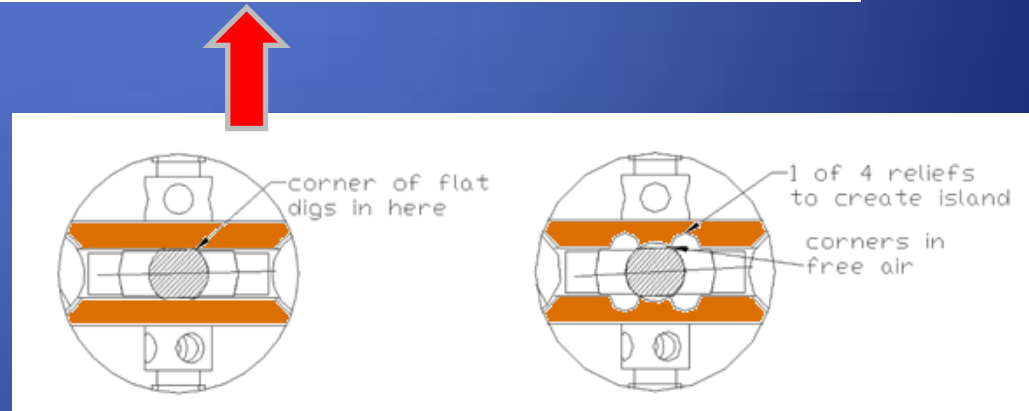
The development of a new stator was underway. The purpose of the redesign is to improve the construction tolerances/reproduction in manufacture.

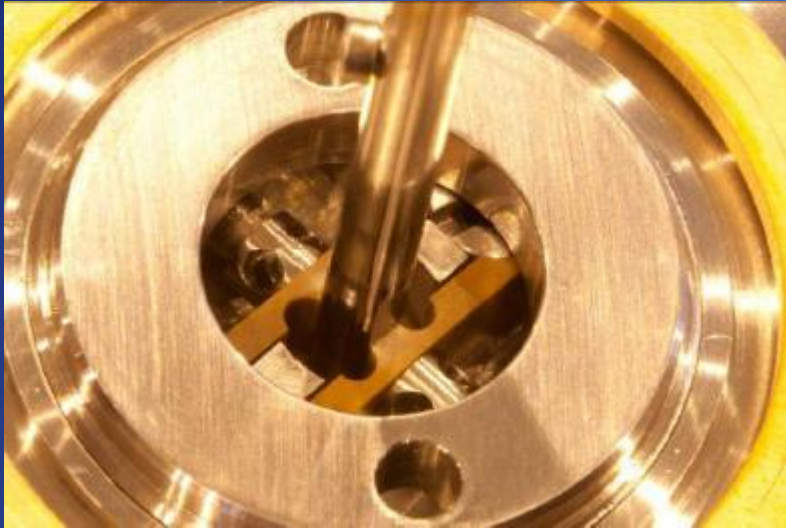
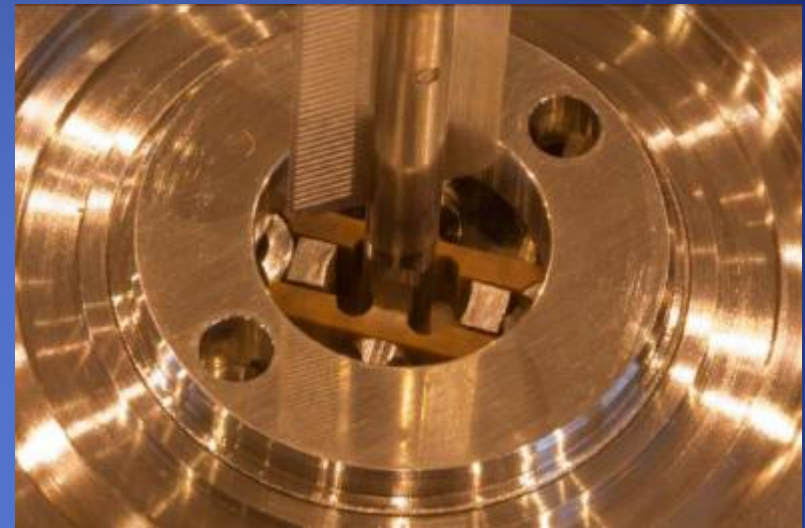
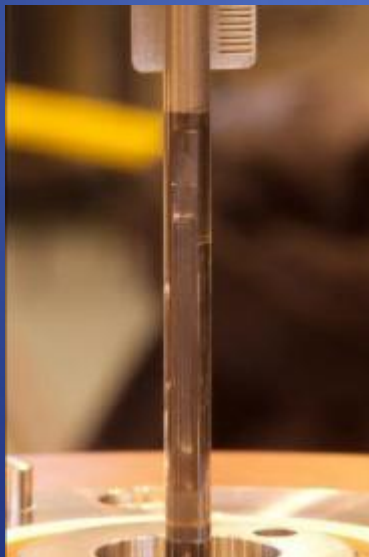
T2.5 (slide from last CM talk)

800 hours of
running

2.3 million
actuations

- Target 1 on ISIS was checked in January 2011 – no major issues.
- Target test 2.5 was underway and had completed 2.3 million pulses with little evidence of any bearing wear. The test was continuing.

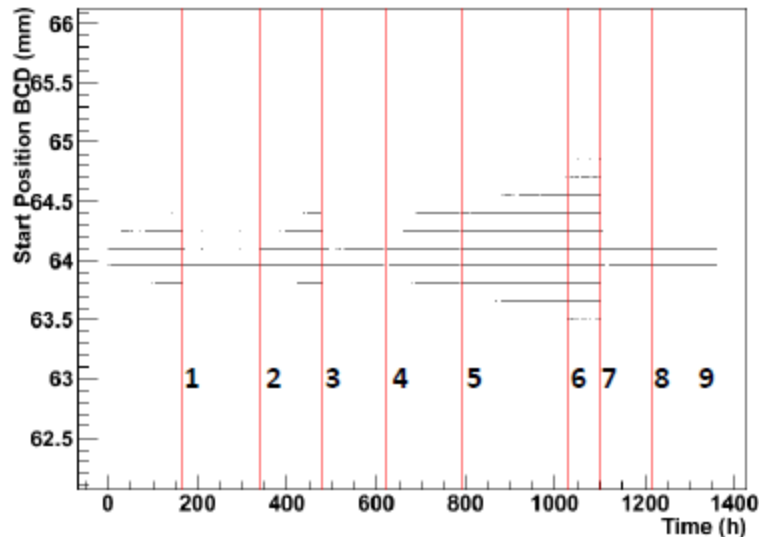
Raw Data from Start Pos BCD

T2.5 – DLC/Vespel – 4.0 million pulses

Stop Time	Actuators	Description
1 - 164	490960	Inspection 1 (14/12/2010)
2 - 338	512865	Pause for Christmas, Inspection 2 (5/1/2011)
3 - 476	412043	Inspection 3 (11/01/2011)
4 - 621	414325	Inspection 4 (18/01/2011)
5 - 790	482527	Inspection 5 (26/01/2011)
6 - 1026	701662	Test Pause in running park for 1hr. (attempt reset)
7 - 1101	219747	Inspection 6 (17/02/2011)(CM29)
8 - 1214	334982	Pause, DAQ pc full
9 - 1361	436588	Final Stop (no line, end of data)

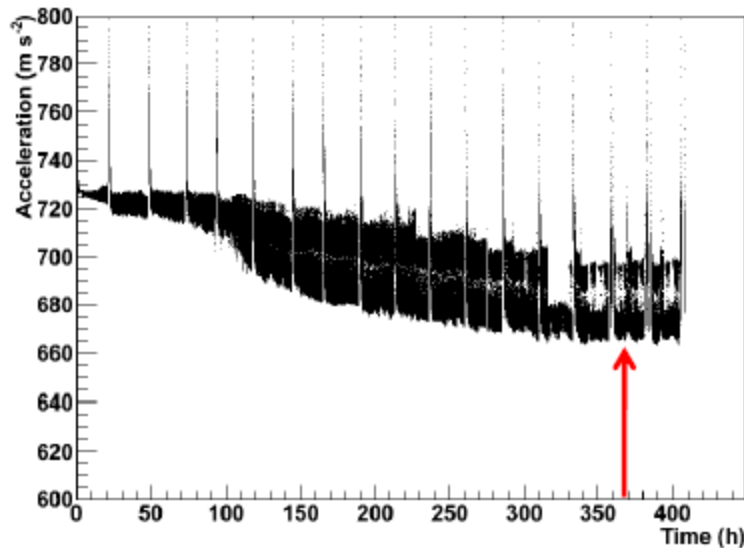
Acceleration to SP1

T2.6 – DLC/Vespel – 1.14 million pulses

Nominally identical to T2.5

Clearances around bearings changed

Several capture sticks occurred, +370 h

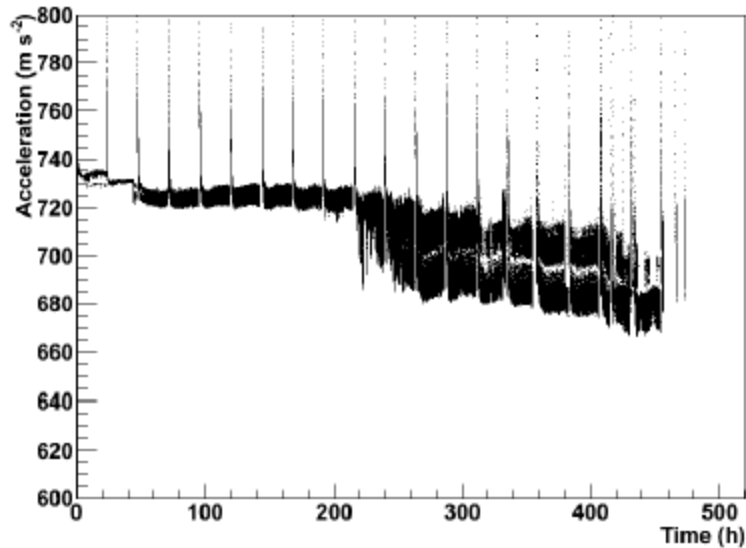
Acceleration to SP1

T2.7 – DLC/Vespel – 1.28 million pulses

Clearances increased around bearings

Again several capture sticks seen

These began at 360 h

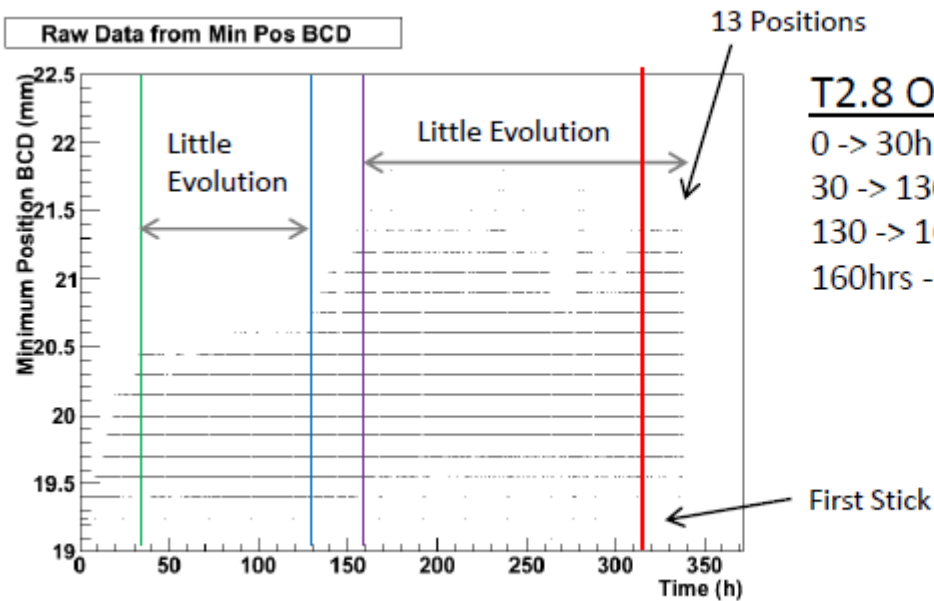
T2.8 Observations:

- 0 -> 30hrs: Rapid increase in number of minimum positions.
- 30 -> 130hrs: Little / no increase in start position
- 130 -> 160hrs: Rapid increase in number of minimum positions.
- 160hrs -> now: Apparent flat, some dips

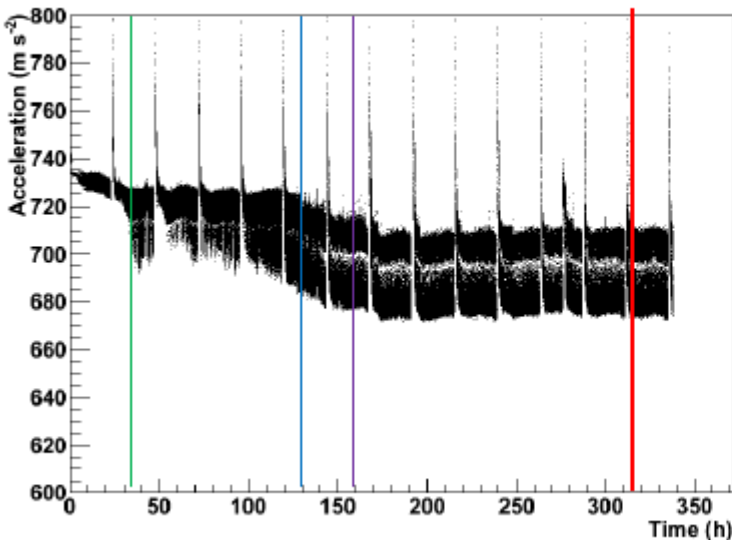
Acceleration to SP1

- Acceleration shows continuous change unlike start and minimum positions.
- Double distribution appeared during flat period (30-130) in start, minimum positions.
- Now two distributions occurring in acceleration.
- At 270Hrs Spike in acceleration, performance during this period was close to performance at 10Hrs.

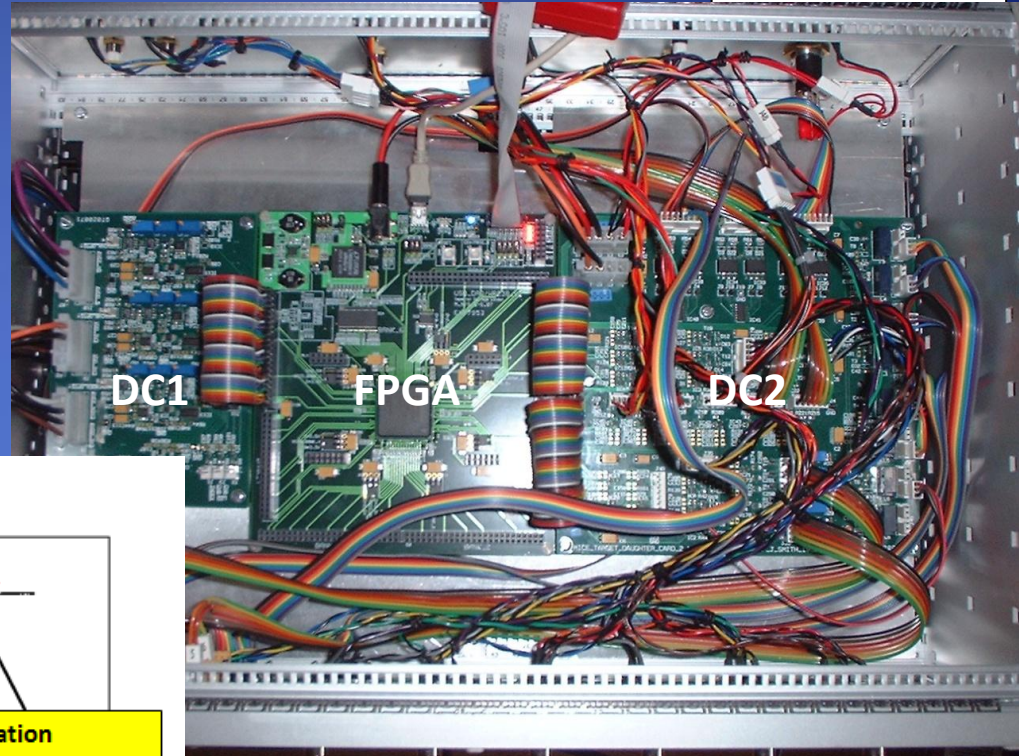
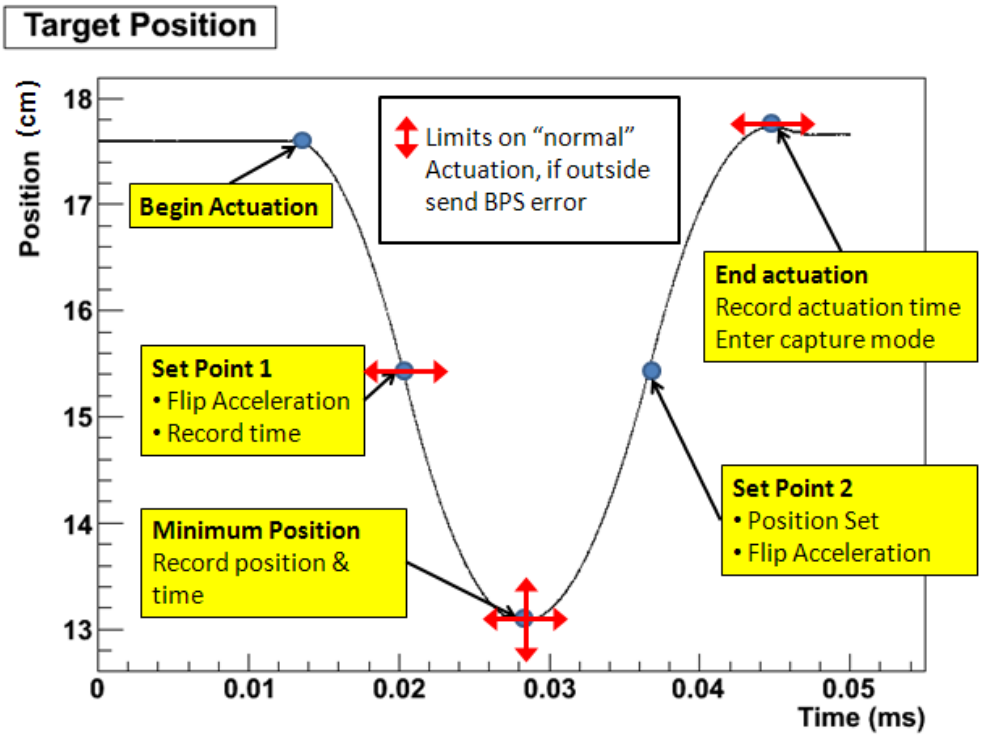
Most of the Controller is now “Fresh Air”. The entire controller unit is 9U high including PSU. (could fit comfortably in 6U but there is space left for expansion)

- The Phase 2 controller is now complete. Externally it looks identical to the Phase 1 controller, internally it is quite different – All the circuitry has now been integrated onto 3 PCBs and additional control functionality has been implemented.

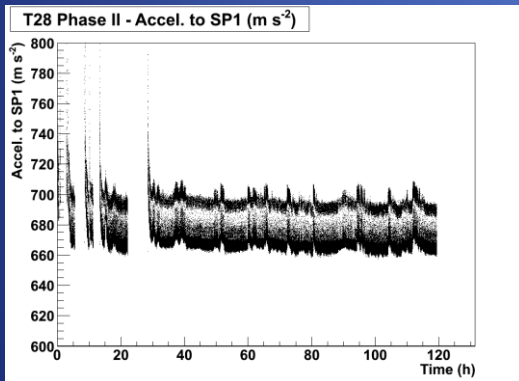
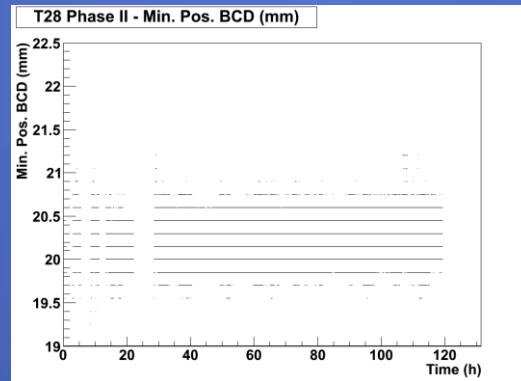
T2.8 after Phase 2 controller upgrade

- A simple firmware change was made to the Phase 2 controller that permits a higher capture current during the first part of the capture. We hope that this will help alleviate the sticking/ reduce the start position spread.
- T2.8 is now being run under the phase 2 controller. (Started 29/06/2011) Note that T2.8 was not disturbed before this switchover.

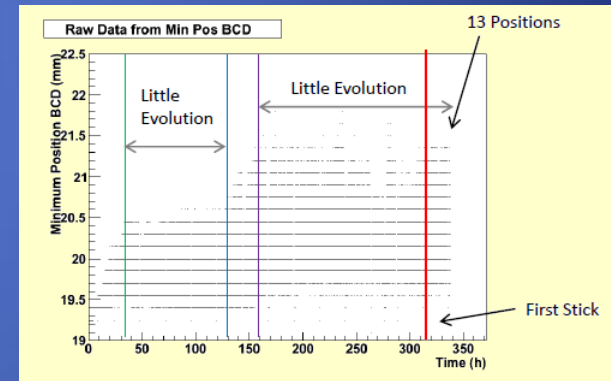
T2.8 before P2 Controller Upgrade

Not claiming victory yet – these plots are provided for early comparison only!
