Status of TileCal Cesium Phase II electronics

Alexander Solodkov
on behalf of the
ATLAS TileCal Cesium team

June 10th, 2024

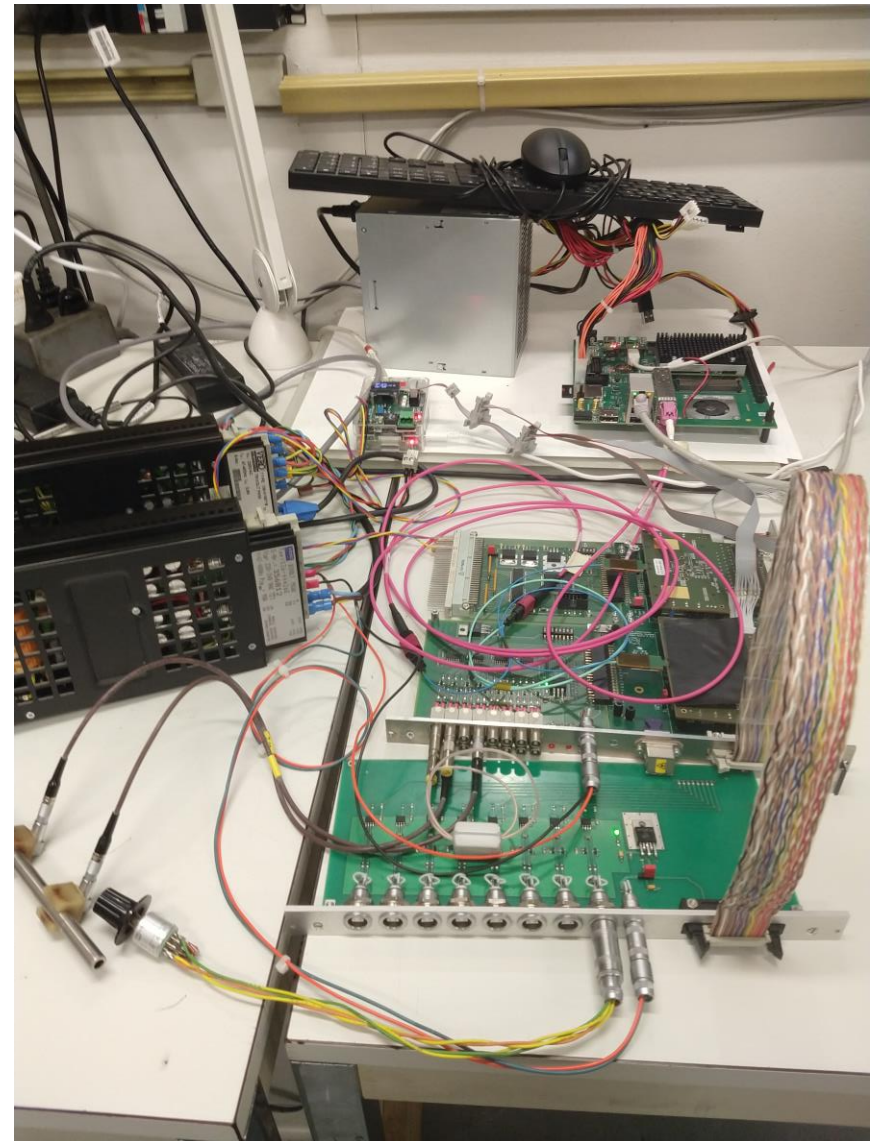
Second Test stand

The second test stand was setup in November 2023, immediately after previous meeting. It is very similar to first test stand but with [Trenz TEBF0808](#) development Board with two SFP+ ports and [Trenz TE0807-0-S014](#) SoM.

In addition to all the boards tested before – 6U-ADC board was connected to another board via 20pin connector on the front panel.
