Cables for PS BPM consolidation

BI technical board
20/06/2024

Project highlights

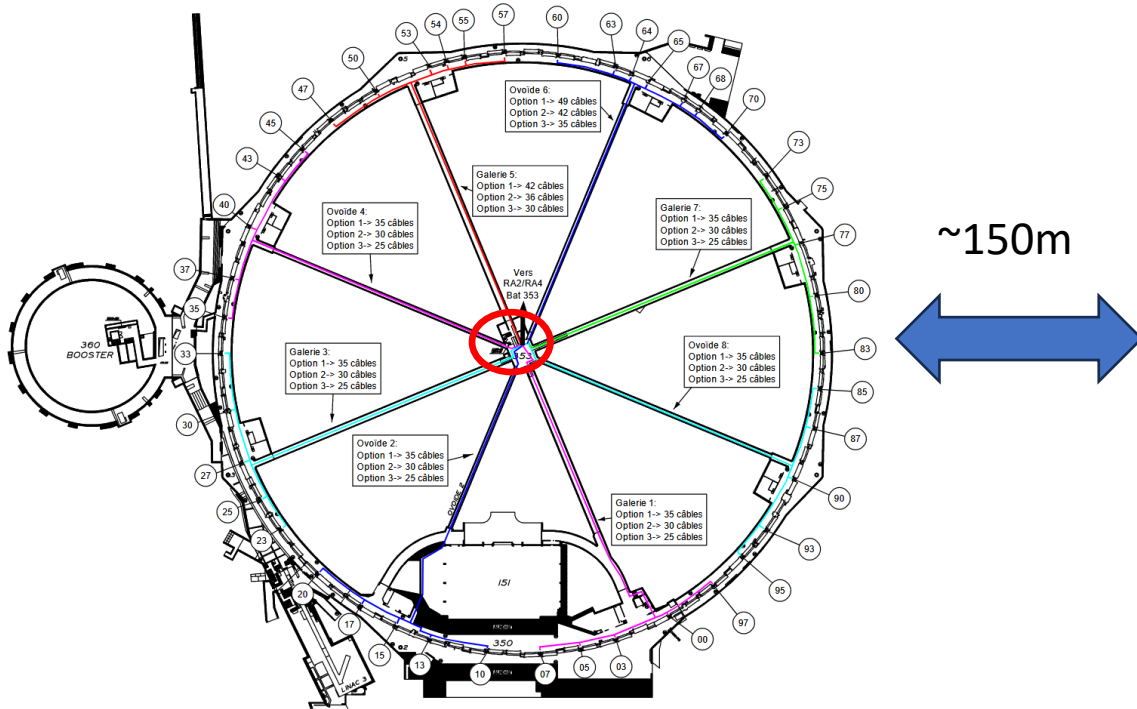
PS racks located in B353 (PS central building)

“Main” cables (surface to the tunnel)

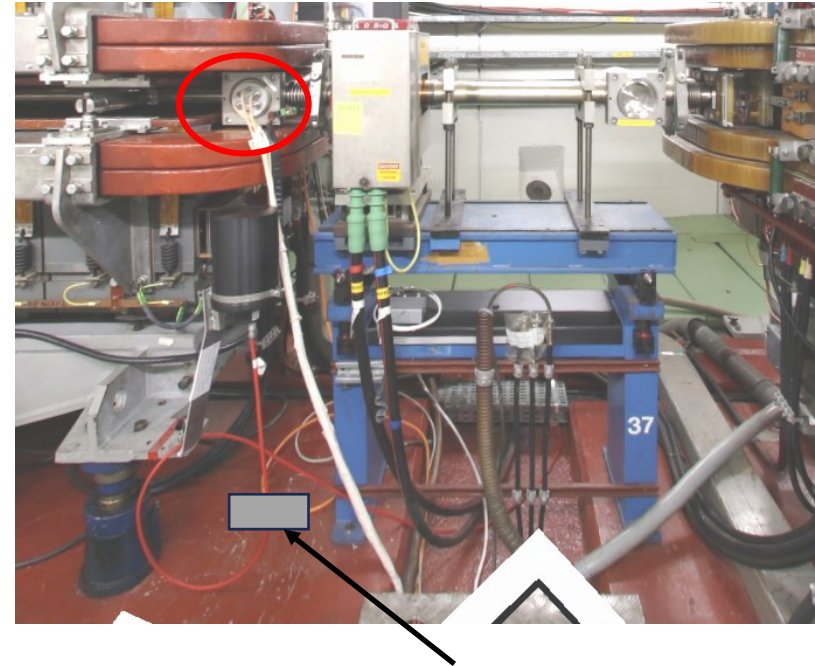
One of the ~45 pickups in the ring tunnel

@ chamber
~40kGy/year
(estimated)

@ floor
~1kGy/year
(estimated)

Possible cables patch location (~20cm above floor)
