Update on OpenIPMC

Regular Technical Meeting

Carlos Ruben Dell'Aquila
(carlos.dellaquila@cern.ch)

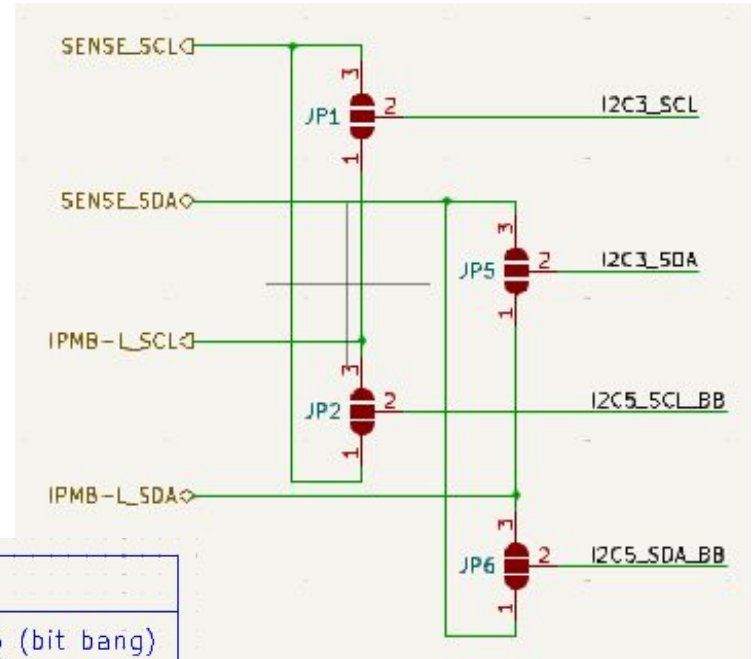
- **OpenIPMC-HW v1.2 jumpers**

- Used to select the MCU I2C buses that are connected to **SENSE_I2C** and the **IPMB-L** pins of the dimm connector
 - **I2C_3**, MCU peripheral
 - **I2C_5**, Bitbang (BB) interface

All 1-2:		All 2-3:
IPMB-L -> I2C3		IPMB-L -> I2C5 (bit bang)
SENSE_I2C -> I2C5 (bit bang)		SENSE_I2C -> I2C3

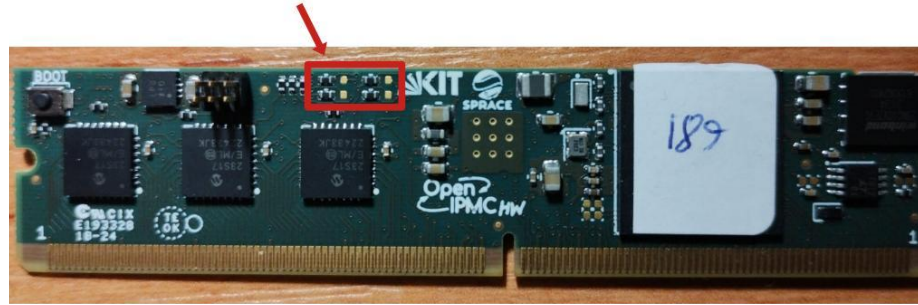
- **OpenIPMC-HW v1.2 jumpers**

- First 82 samples produced at SPRACE in June 2024 have the jumpers in the position 'all 1-2'

- The right choice depends of the firmware implementation
 - **Sensor Reading** functions on **board specific** code can be implemented to use one of these I2C interfaces
- Board fabrication files should be modified according to desired position in order to set it properly during the manufacturing process
 - The stencil and component placement instruction file should be built according that choose

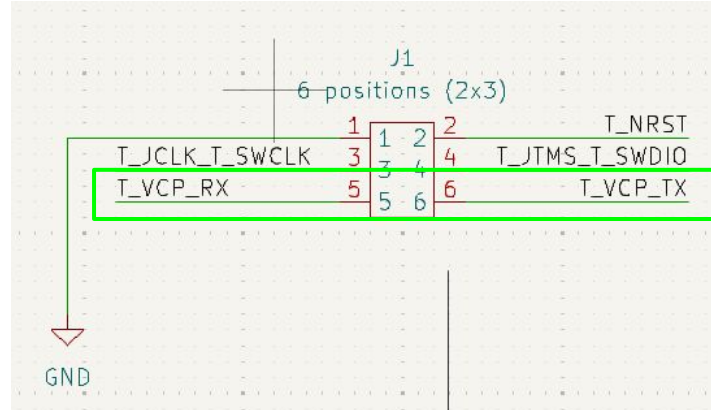
- **OpenIPMC-HW STDC14-to-header Adapter Board**

- Allows debugging the OpenIPMC firmware when the board is seated on an ATCA board
 - <https://gitlab.com/openipmc/openipmc-hw-stdc14-to-header-adapter-board>
 - VCP UART TX/RX signals should be swapped to work properly
 - The actual design requires that modification
