# Problems with unknown capacitance for irradiated sensors

**RD50 Group Meeting**

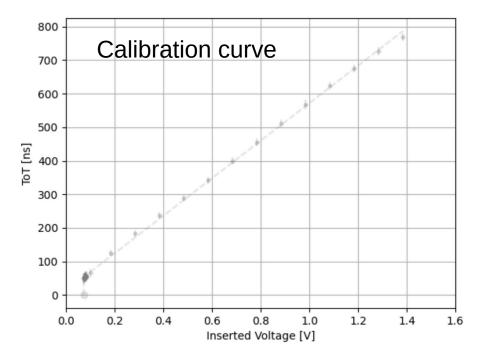
- Allows for a known voltage (charge if capacitance is known)  $\rightarrow$  ToT response curve
- Calibration of charge capacitor typically done using radioactive source
  - Preferably Fe-55 or Am-241 due to distinct peaks

C\_inj is a Varactor not metal traces laying over one another (also true for C\_fb?)

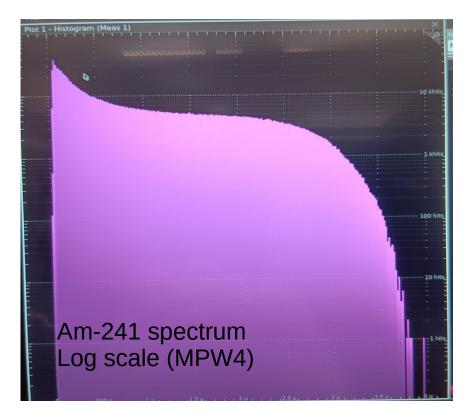
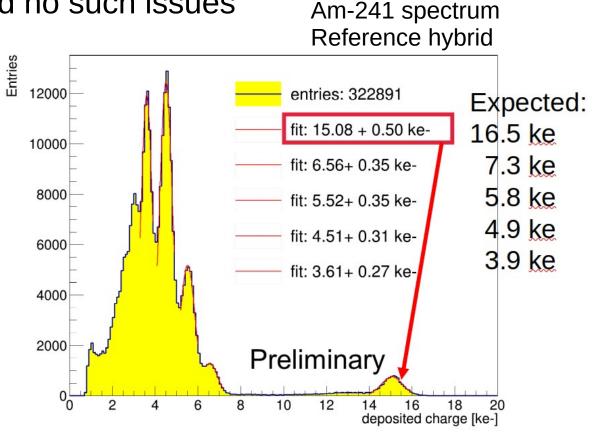
## Measuring capacitance

- Fe-55 is not possible as Q\_Fe55 < Q\_threshold</li>
- Am-241 is not possible as we cannot discern any peaks (noise?)
  - A different sensor (200 micron hybrid) had no such issues

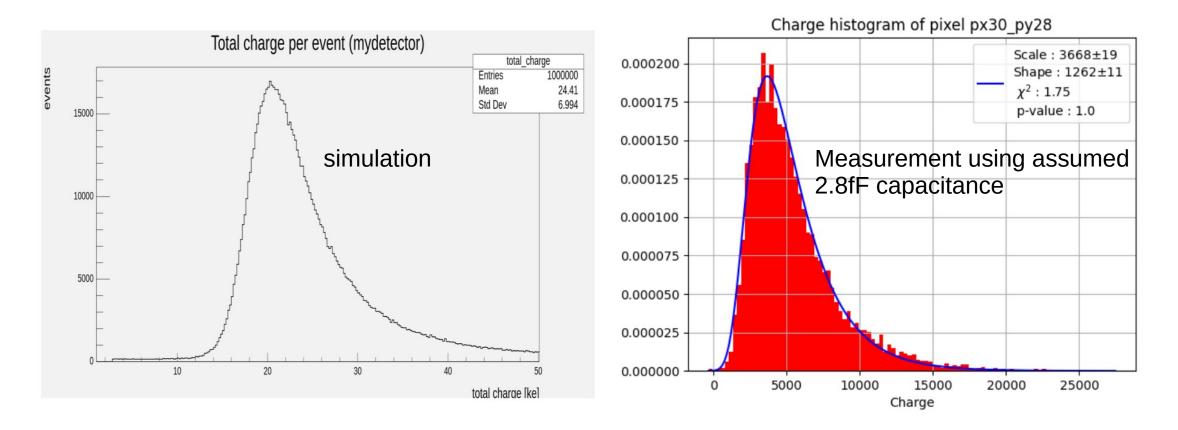
#### Measuring capacitance

- Alternative is using Sr90 using the MPV basing it on MIP deposition
- The ratio of seen charge to expected charge gives the "true" capacitance
- This works only because we make the assumption that we see all charge

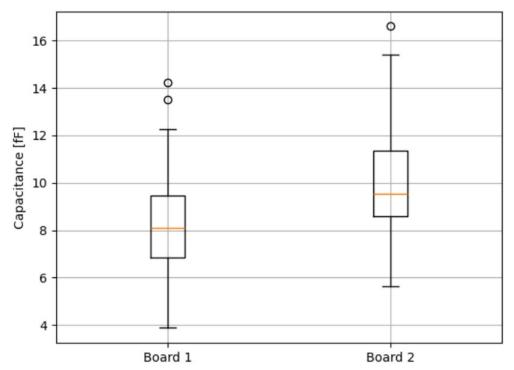
# We make the assumption charge is 20ke-

- The whole basis on which we determine the capacitor is the assumption that we collect 100% of the expected charge
- With this assumption we can see the capacitance in the same board, pixel-pixel varies by up to a factor 3.5
- This assumption does NOT work for irradiated sensors
- At some level we will see charge loss due to
  - trapping
  - insufficient depletion

From Andres presentation last week

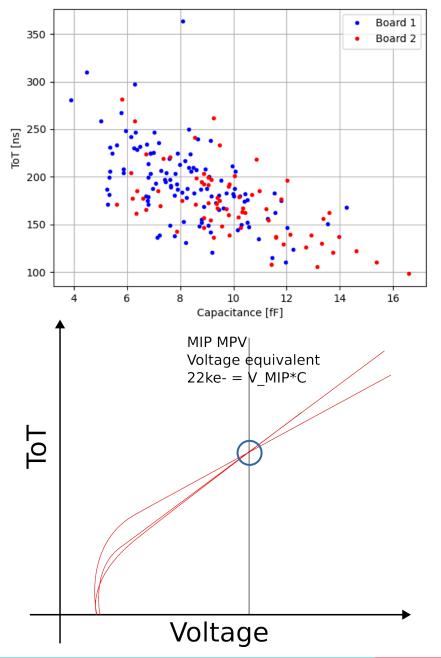
# ToT distribution Sr90

- Variation correlates with measured "capacitance"
- So the charge injection capacitance is not varying as much as we feared
- Will force all ToT values for the MIP to the same point
  - Try to figure out corresponding intersection point in calibration curve
    - $\rightarrow$  Correct voltage for MIP ToT
    - $\rightarrow$  Correct value for injection capacitance and spread
