Pixel Operational Experience Workshop

CMS Pixel

G. Bolla

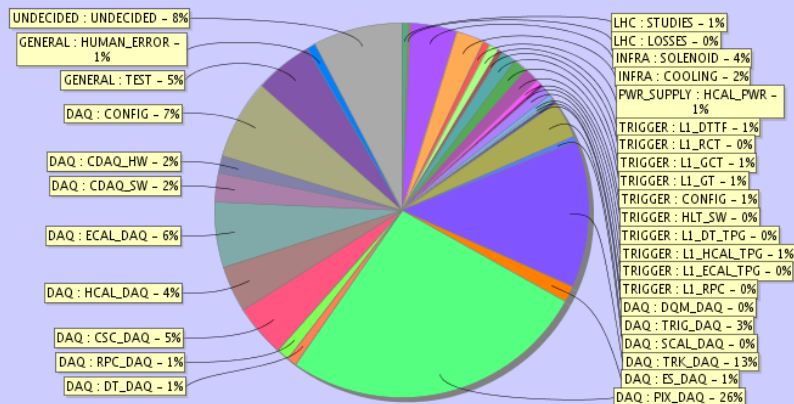
Downtime by categories (Stable Beam only)

2010

It soon became clear that our interruption of data taking could be explained with SEU (Single Event Upset) symptoms.

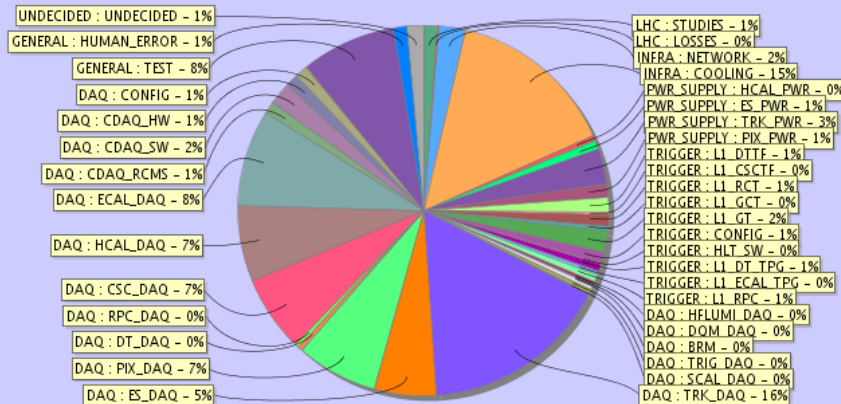
Downtime by categories (Stable Beam only)

2011

Pixel is still one of the sources of downtime.

- No longer the dominant source as we were in 2010.

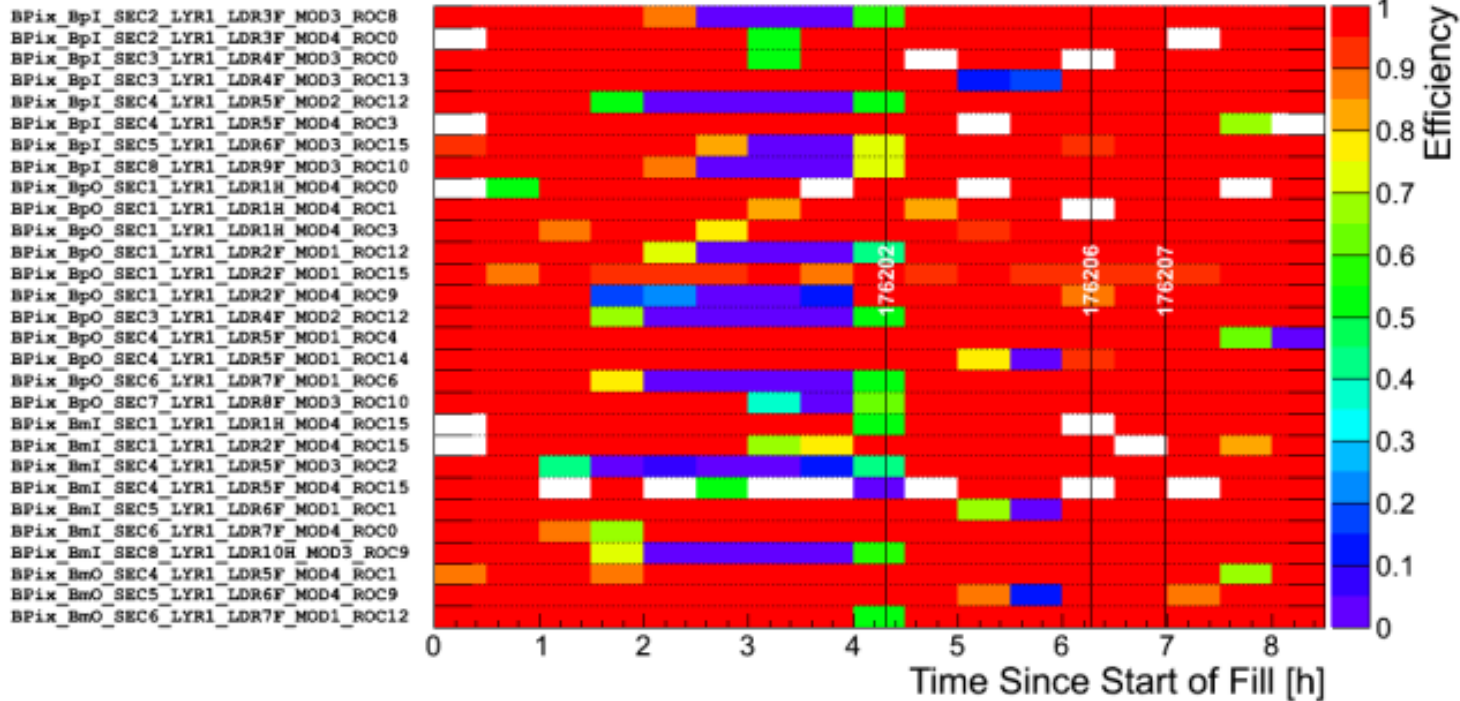
Low Eff ROCs – Fill 2103– Layer 1

This plot shows only the 20-30 ROCs (out of 1E4) that lost efficiency

■ Reconfiguring Pixel and starting a new run works on problematic ROCs

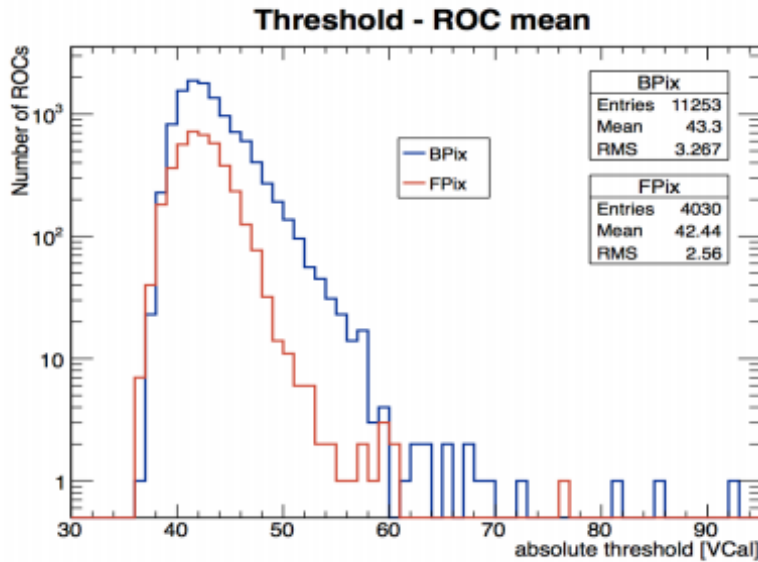
Detector Calibration Results

Average threshold is 43 dac units
= **2400 electrons**.

Like in 2010 (see a later slide).

The main implication is that we had to Recalibrate the detector.

Pessimistic estimate was 2 months, done in 3-4 weeks.

We brought the performance back to what we had in 2010

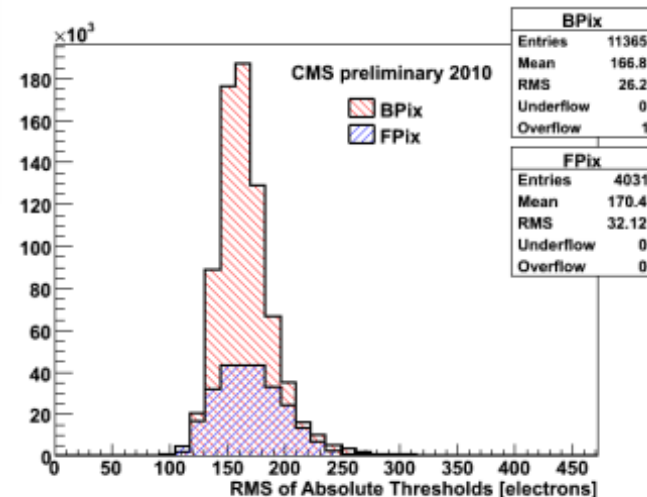
RMS: Shows threshold uniformity

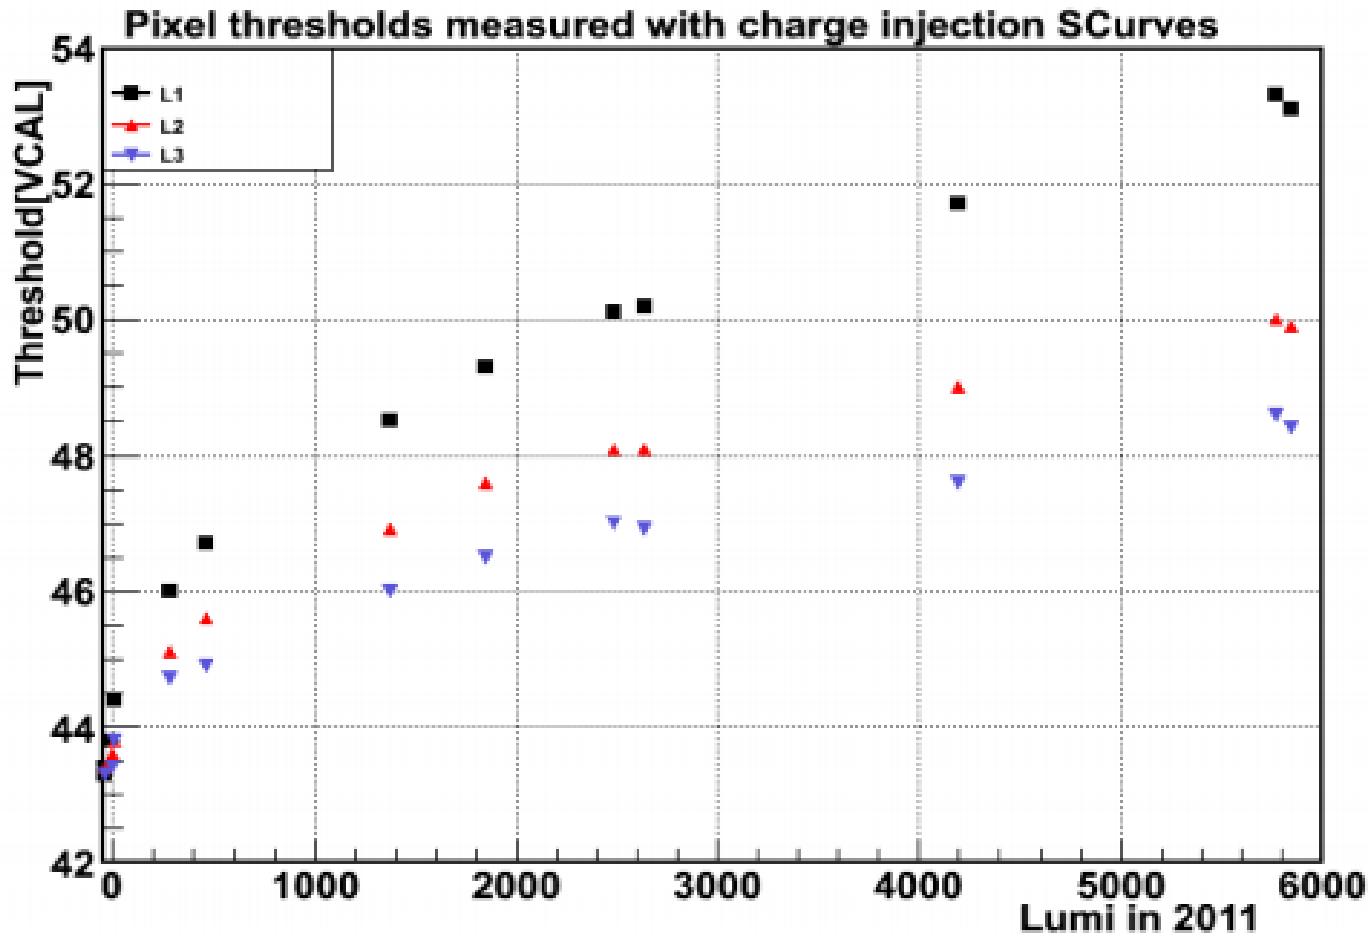
+9.5Vcal=620e

+6.0Vcal=390e

+4.5Vcal=300e

The effects are accompanied by an increase in the LV Analog current. Last year 5A now 5.5A in order to keep the same performance:

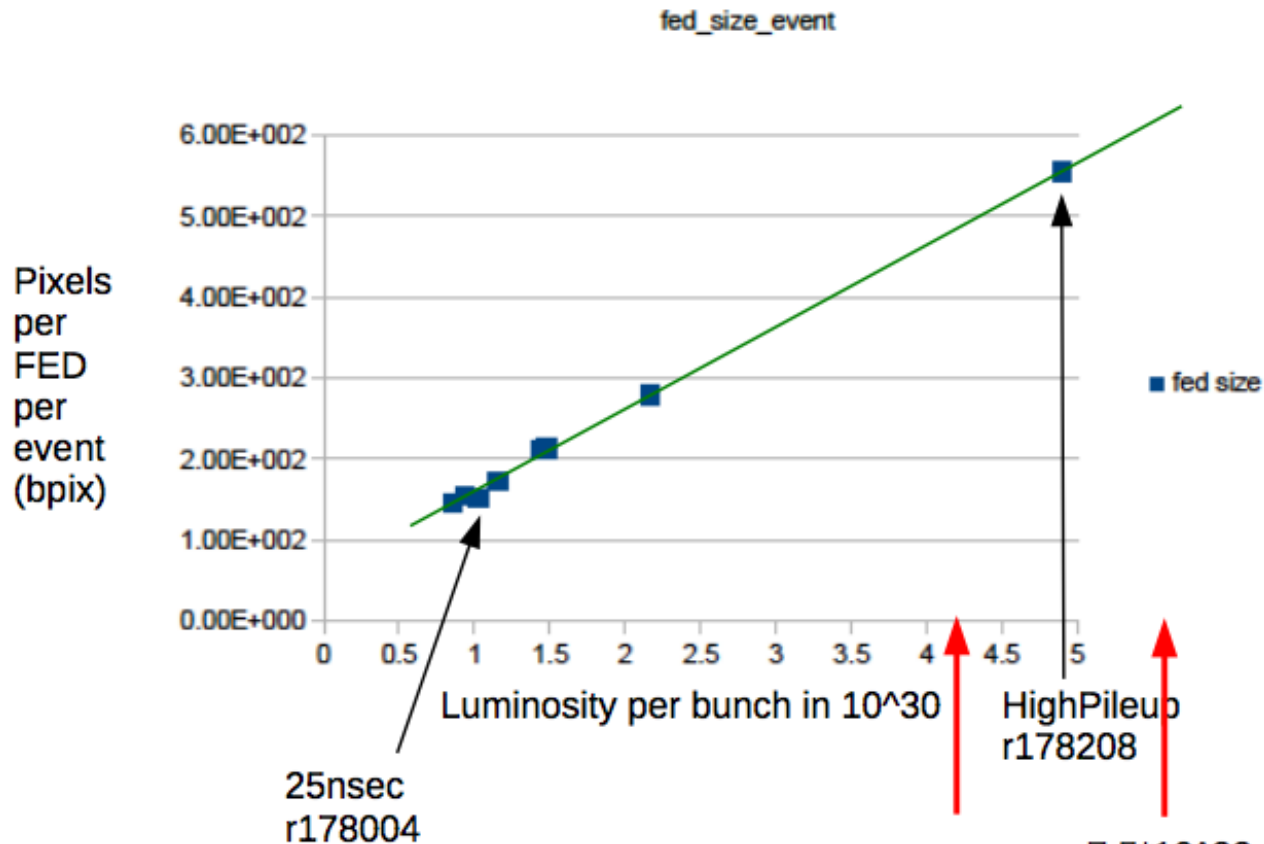
Data size is very predictable (nice linear behavior).
 Pixel detector was designed and built for 25 ns, 100KHz and 1E34.
 Running at 50 ns can in principle limit our capabilities by a factor of 2.
 We should be OK for 2012 but likely we cannot sustain efficiently operation post LS1 still at 50 ns.

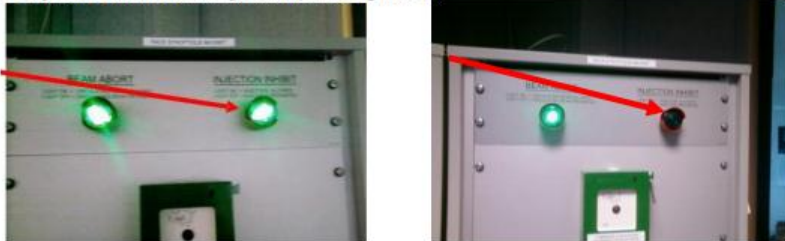
1. The Injection Inhibit must be pressed (Green light OFF)

Figure 1. The injection inhibit button. The left picture show the condition where the pixel HV must be OFF (Injection enabled) while the right picture show the condition where the Pixel HV can be turned ON (Injection inhibited).
