Overview and Status of ATLAS Pixel Detector

Waruna Fernando
The Ohio State University

on behalf of the
ATLAS Pixel Collaboration

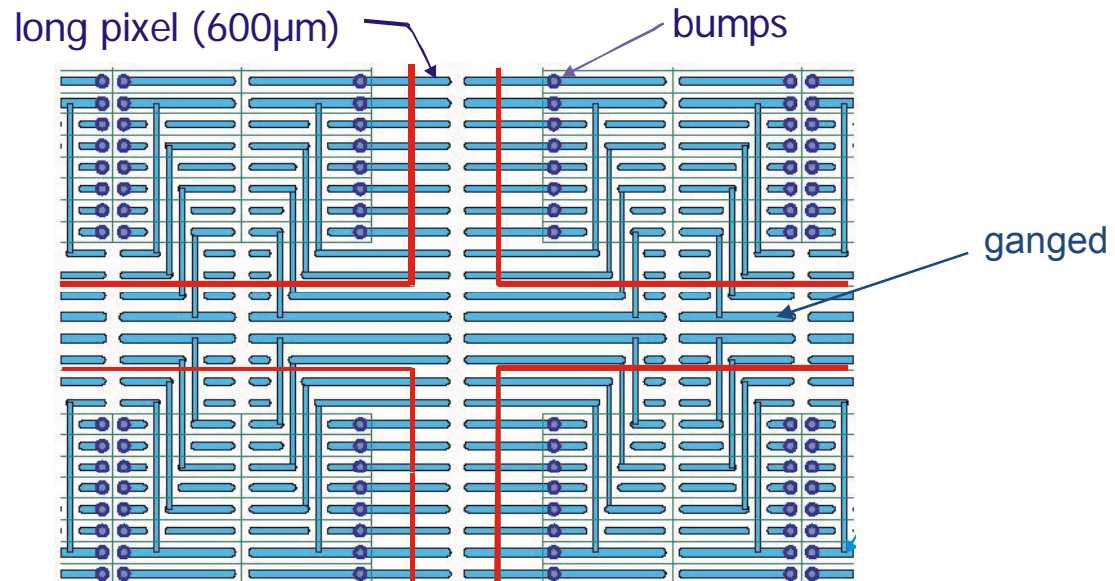
Pixel Sensor

- p^+ pixels on n substrate
- Sensor bump bonded to 16 FE chips
- 41,984 $50\ \mu\text{m} \times 400\ \mu\text{m}$ Pixels
- Special pixels for chip overlap regions:
 - 5,248 “long” $50\ \mu\text{m} \times 600\ \mu\text{m}$
 - Ganged pixels

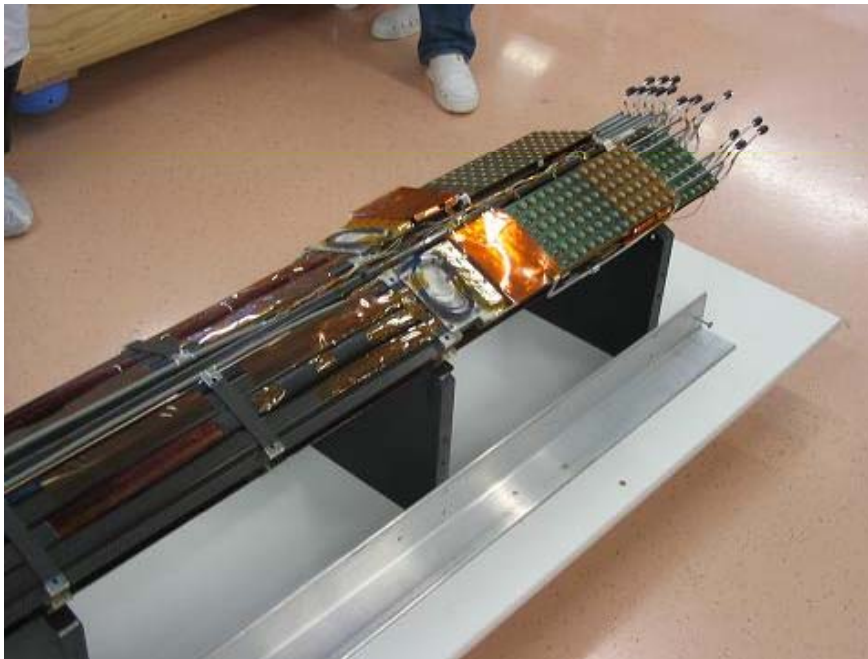
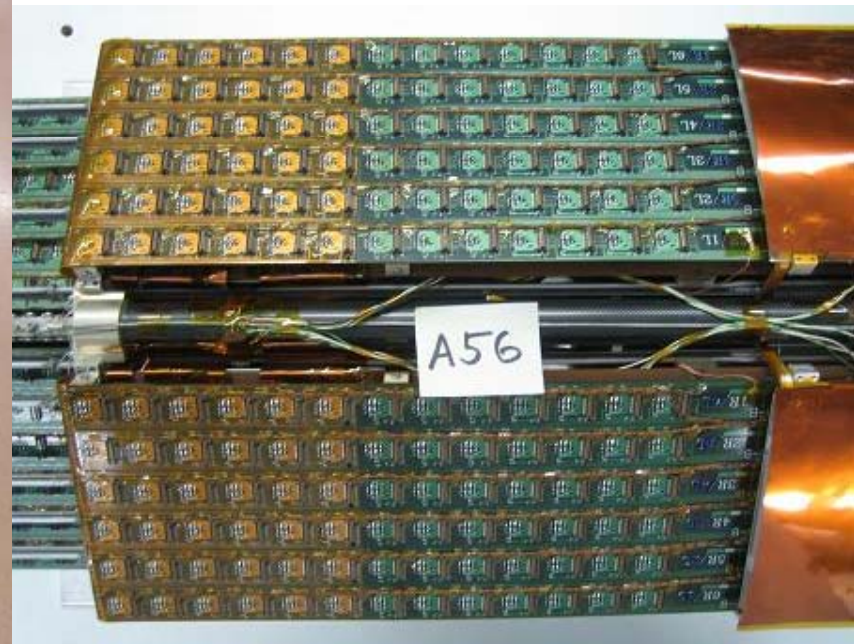
Service Panels

- 4 Service Quarter Panels (SQP) in each side
- SQP to route services to the outside of the Inner Detector Volume
- Module can send data with 40(L2), 80(L1, Disk) or 160(B) Mbit/s
- Opto-board services 6/7 modules
- 36 opto-boards per SQP

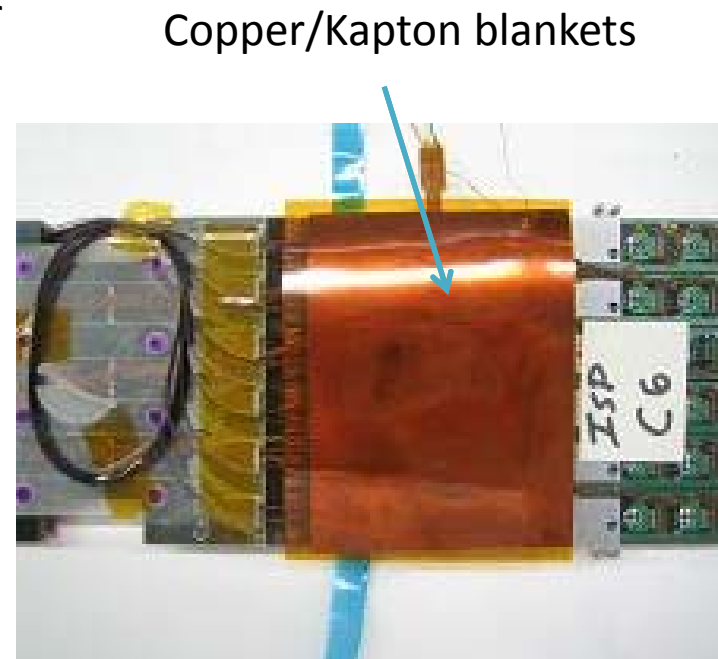
Temperature Dependent (cont.)

- Solution: install heaters

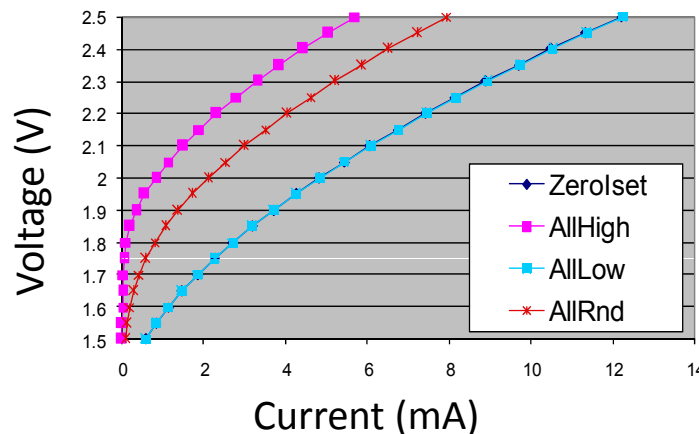
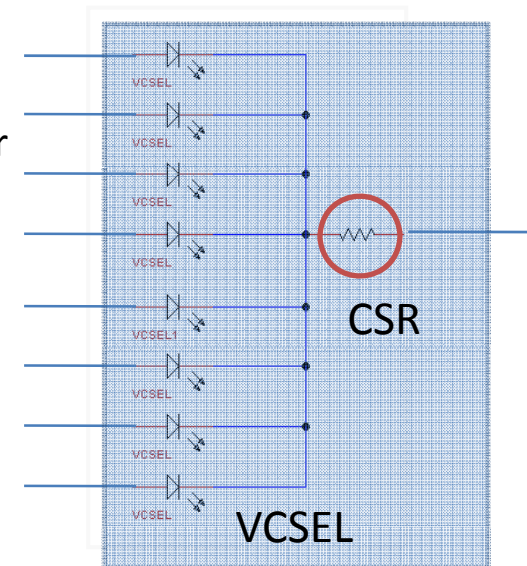
CSR (Common Serial Resistance)

- Symptom: like a dead VCSEL
- Some “failed” boards recovered
 - How to identify those recovered?
- A procedure is developed to measure the resistance of the inaccessible CSR and rejected the worst.(~7%)
- Still not understood the reason
 - conductive epoxy (5 μm) under the VCSEL array is thinner than manufacturer's recommendation (15 μm)

- After installation started in Oct 06, not a single board failed due to this.

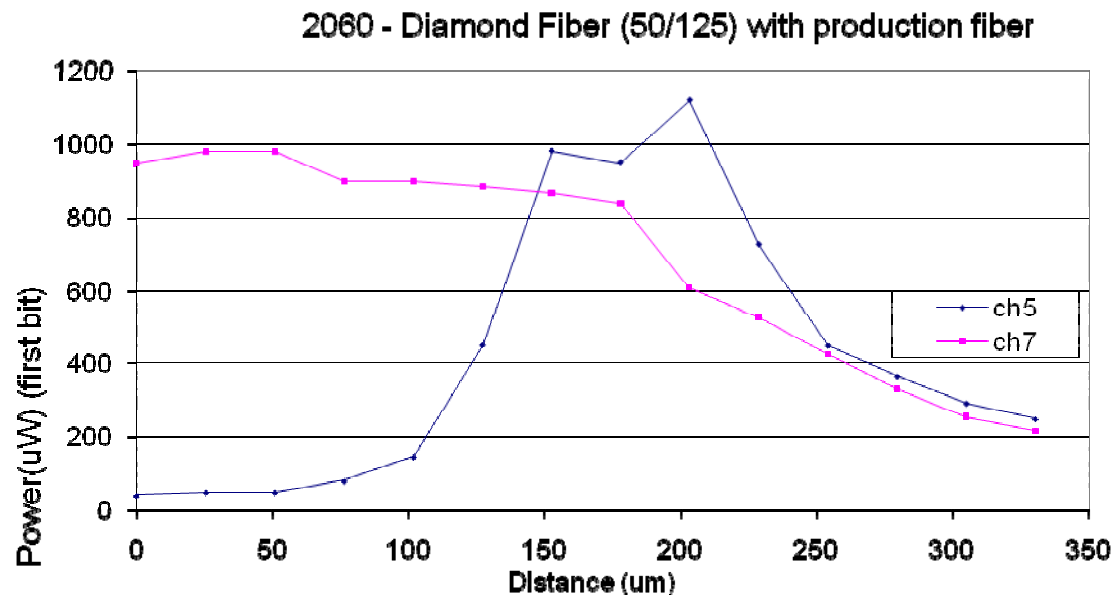
Slow Turn On (STO)

- Was first discovered in SCT, but we failed to find any in our test system
- System test with prototype SQP found some STO
- A new testing procedure added to identify the arrays with STO and rejected ~7%.
- Depends on the distance from the VCSEL to fiber
 - Beveled finish on MT connector in system test allows fiber to be closer to VCSEL
 - Different modes of operation change with time ?
- No board is found to have severe STO after installation

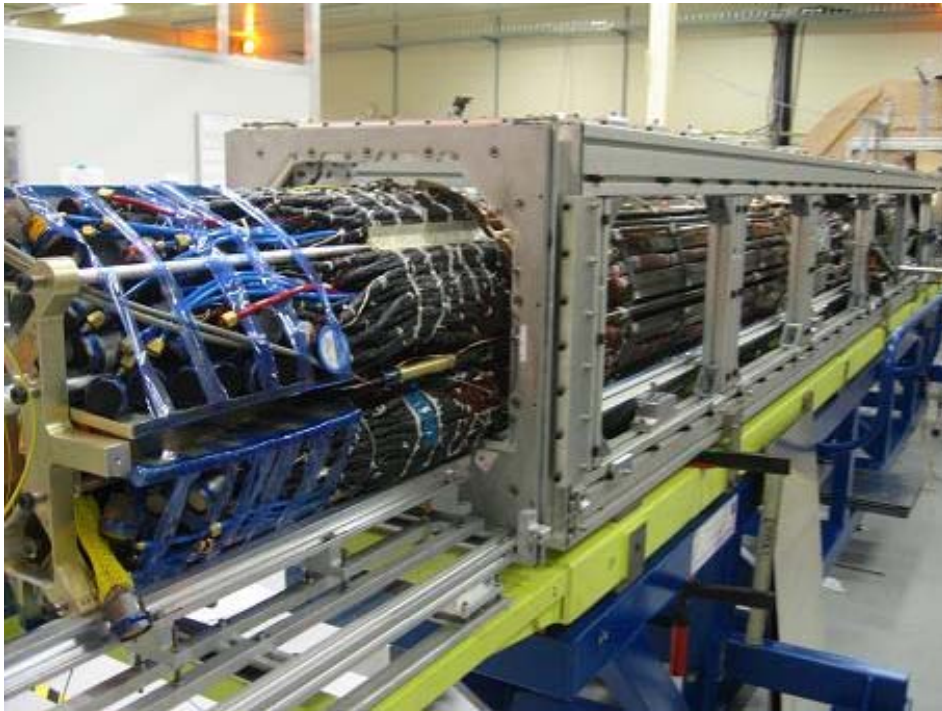
Current Status (cont.)

- Inserted the pixel package into the Dummy Support Tube (DST) and Installation at pit started.
